Collision between a truck and V/Line train 7727

Barwon Terrace level crossing, South Geelong, Victoria on 3 April 2023

ATSB Transport Safety Report
Rail Occurrence Investigation (Defined)
RO-2023-003
Final – 27 June 2025

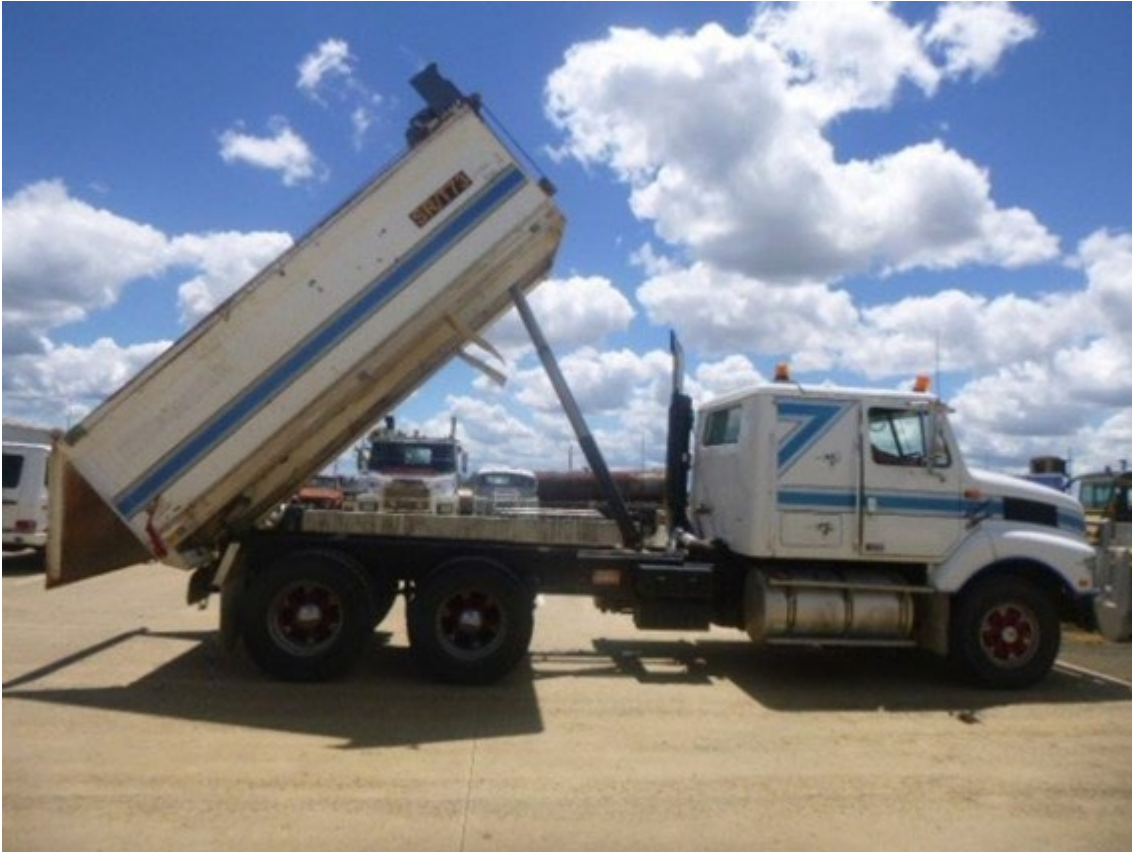
Figure 8: A similar tip truck to that involved in the collision

The truck was a 1997 International tip truck and was owned by the earth moving company (Figure 8). The truck's dump body was empty at the time of the collision.

*The truck involved in the incident was of a type like that at Figure 8, but red in colour.
Source: Google*
