Interrupted engine start and evacuation involving Saab 340B, VH-ZRK

Melbourne Airport, Victoria, on 5 April 2022

ATSB Transport Safety Report

AO-2022-019

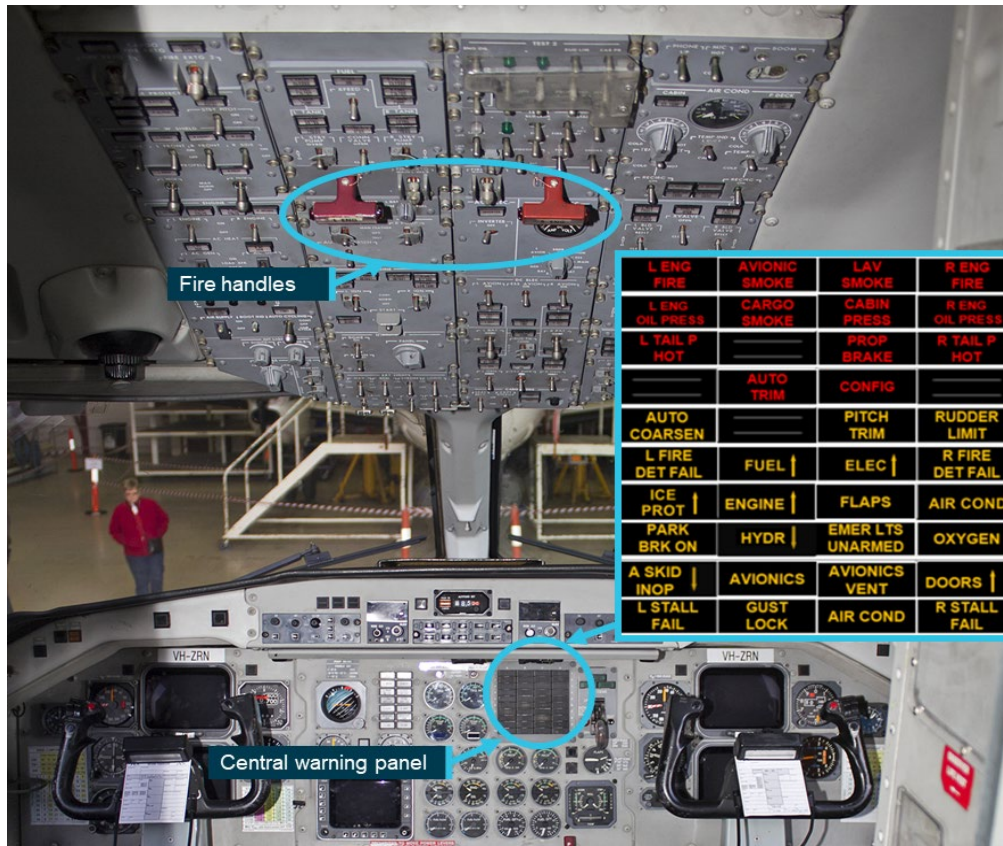
Figure 2: Saab 340B flight deck

Engine fire detection was provided by a continuous loop detection circuit mounted under each engine, outside of the casing when the temperature reaches approximately 300°C. Proximity of fire to this loop would change its characteristics and trigger multiple types of warnings in the flight deck. These warnings consisted of a fire bell, master warning lights, a caption for each engine on the central warning panel, and lights in the fire handle for the relevant engine (Figure 2).

Each engine also had tailpipe overtemperature sensors that triggered the master warning lights and a caption for each engine on the central warning panel (CWP) in the flight deck if the temperature in the tailpipe reached approximately 235 °C. The lights would extinguish after the temperature had reduced.

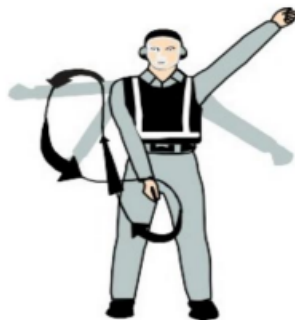
Move right hand in a fanning motion from shoulder to knee, while at the same time pointing with left hand to area of fire.

Night signal, the same with wands.

The Rex policy and procedures manual, referenced by flight crew, included the standard marshalling signals and a description for the hand signal for aircraft smoke, which was the same for fire, but no image was included. The flight crew recalled that they could not remember the signal for fire and had not covered it specifically in their training. The captain recalled learning the signal during their command upgrade through their own initiative and the FO learnt the signal in their previous employment.
