Pilot incapacitation, loss of control and collision with terrain involving Gulfstream 695A, VH-HPY

55 km south-east of Cloncurry Airport, Queensland on 4 November 2023

AO-2023-053

Final – 19 June 2025

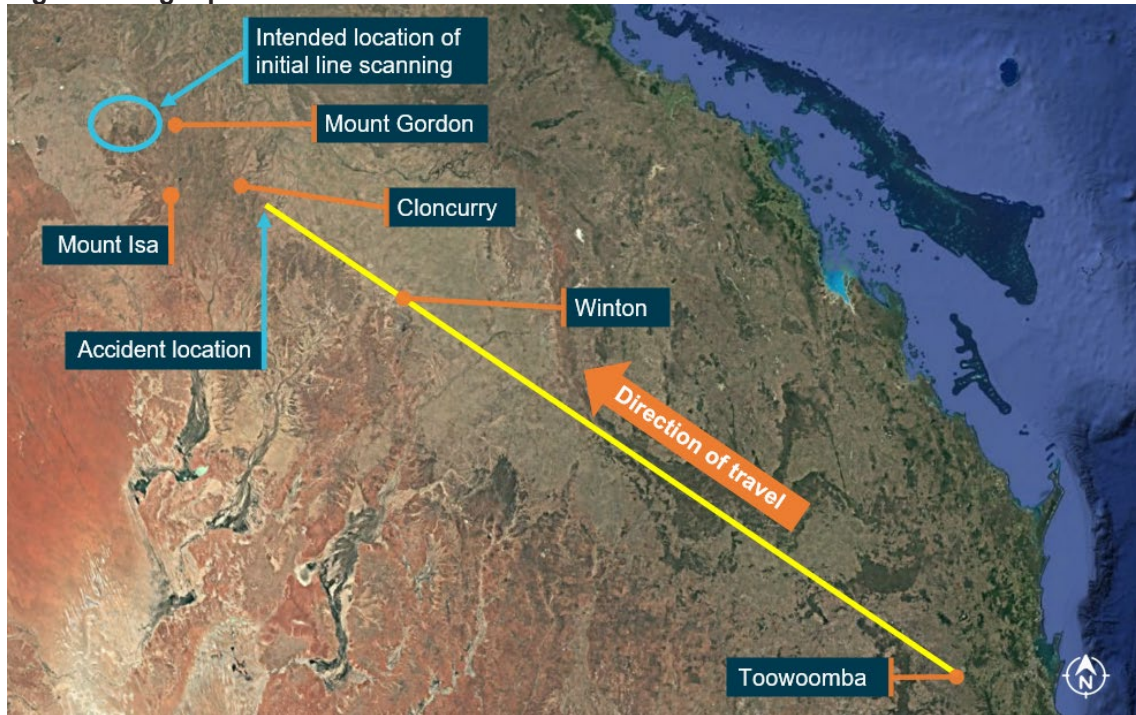
Figure 1: Flight path overview

A series of radio communications were exchanged between the pilot and ATC, during which the pilot was issued a clearance to undertake line scanning north of Mount Isa. The pilot did not respond to any further calls from ATC. The aircraft departed controlled flight and at 1427 (local time) collided with terrain 55 km south-east of Cloncurry (Figure 1). The 3 occupants were fatally injured, and the aircraft was destroyed.

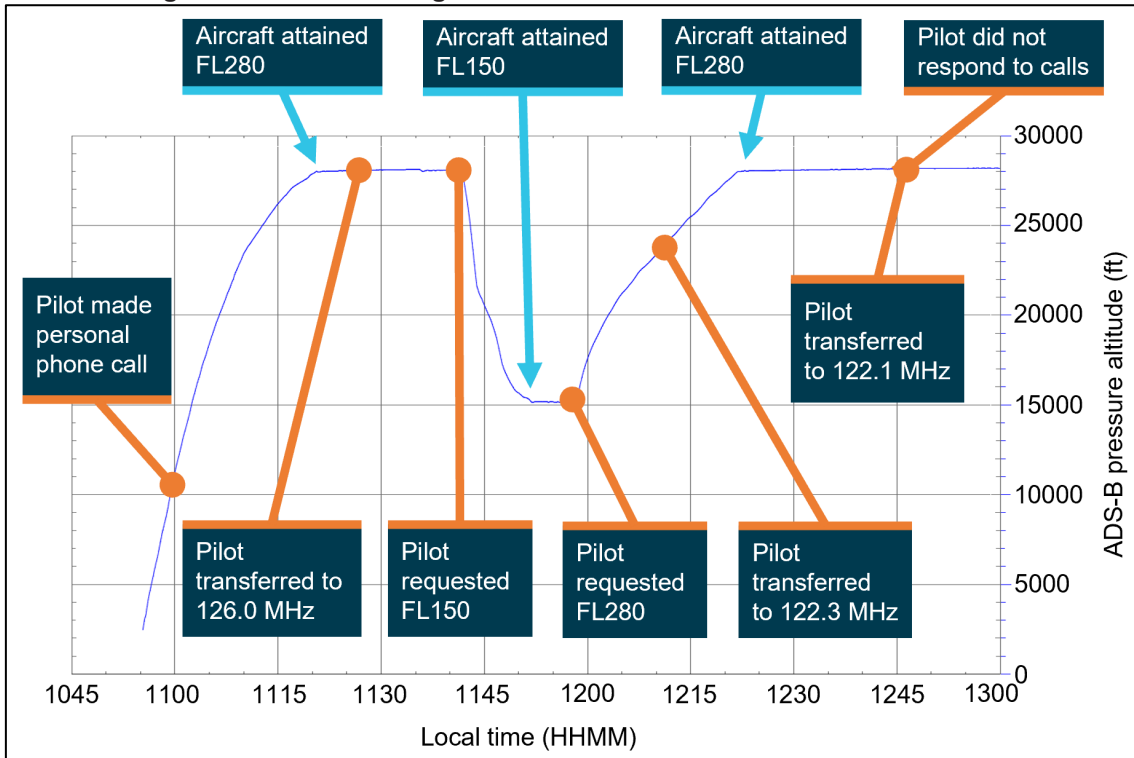
Figure 2: Plot of changes in aircraft altitude and the sequence of radio communication events throughout the accident flight from 1045–1300

At 1055 on the morning of the accident flight, the aircraft departed Toowoomba Airport with the pilot being provided an ATC clearance for the flight to track to Mount Isa. The pilot was initially cleared by ATC to climb to FL160 and was then issued further instruction to continue the climb to the planned cruise of FL280. The pilot made a brief personal phone call at about 1103 (see *Telecommunications*), and the aircraft reached FL280 at 1120:30 (Figure 2).

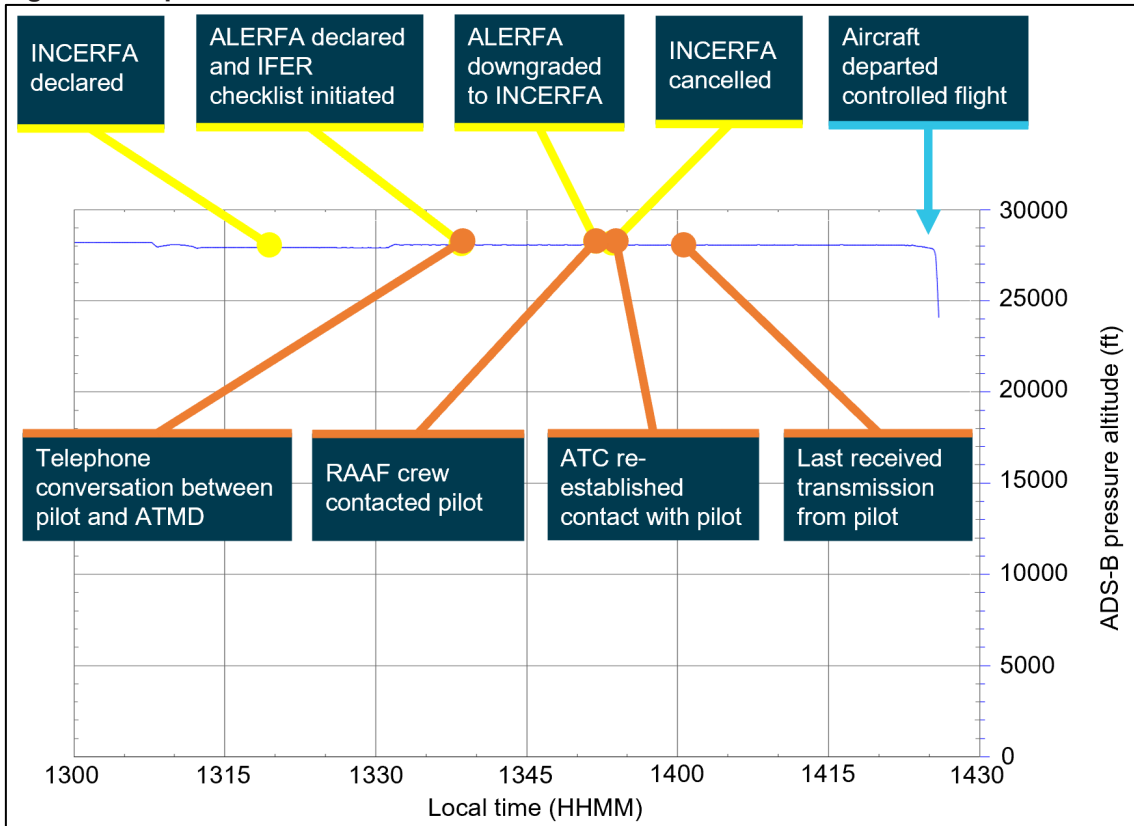
Figure 3: Sequence of ATC actions and communication events between 1300–1430

declared an uncertainty phase (INCERFA)⁴ (see *Emergency phases*) and the air traffic management director (ATMD) was made aware of the developing situation (Figure 3).

At 1337:46, the ATMD attempted to contact the pilot using the mobile telephone number listed on the flight plan, but the pilot did not answer the call. At 1338:36, the pilot returned the ATMD’s phone call, and they had a brief conversation during which the pilot advised that they had ‘no joy’ on radio frequency 122.4 MHz, rather than the instructed frequency of 122.1 MHz (see *Telecommunications*). The ATMD determined that the pilot’s speech was ‘slower’ than normal and ‘flat’, and these concerns were shared with the SM at the conclusion of the call. At 1340:00, the INCERFA was upgraded to an alert phase (ALERFA)⁵ (see *Emergency phases*) and the hypoxic pilot in-flight emergency response (IFER) checklist was initiated (see *Hypoxic pilot procedures*).

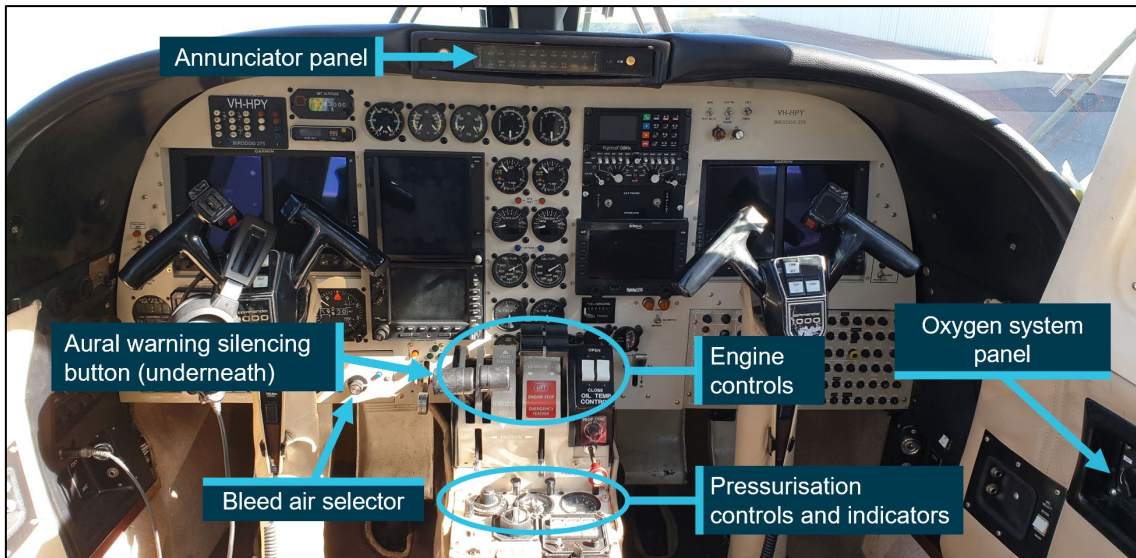
Figure 6: VH-HPY cockpit layout

The Gulfstream 695A is fitted¹⁵ with a cabin altitude visual and aural warning system that activates when the cabin altitude is at or above 11,000 ft (± 500 ft) (Figure 6). When activated, 'CABIN ALT' illuminates in red on the glareshield annunciator panel and flashes for 10–20 seconds before remaining steady. This is accompanied by an aural tone that pulses 6 times per second. The aural warning can be silenced by pressing a button on the left engine power lever (see *Appendix A – Gulfstream 695A systems information*).

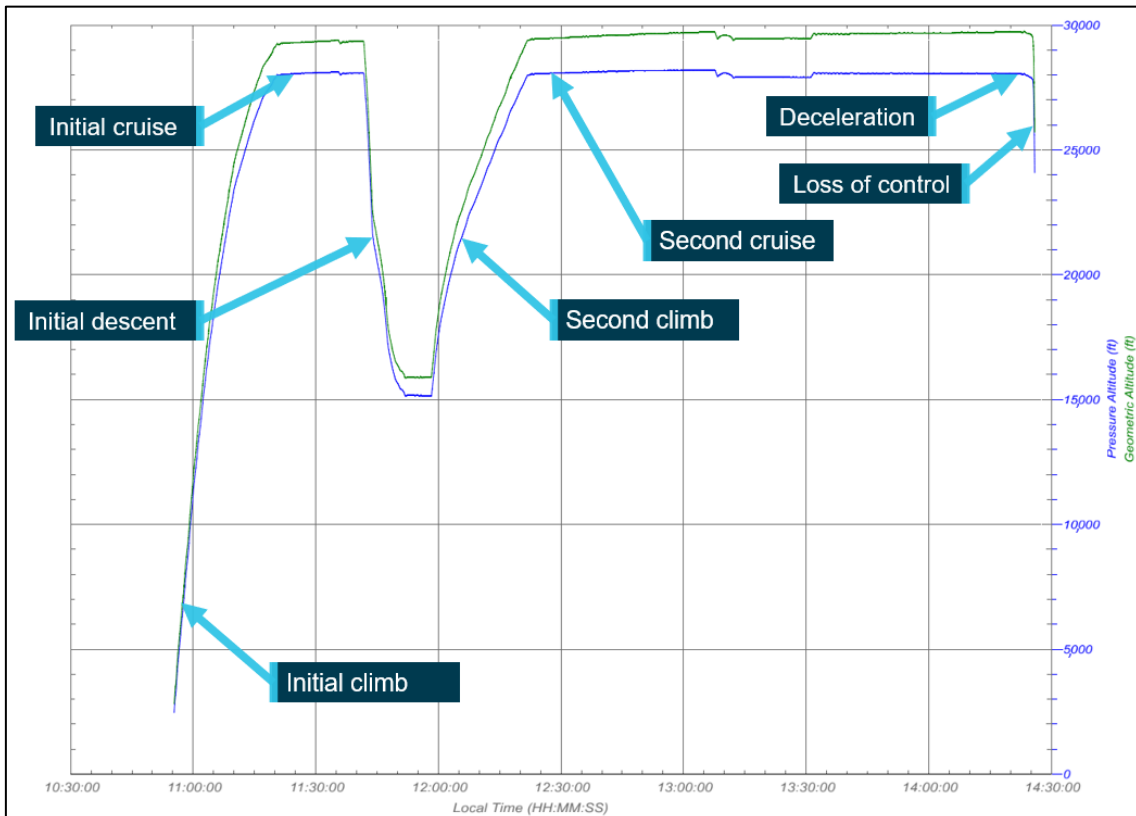
Figure 8: Altitude profile of the accident flight throughout its duration with key moments (phases) displayed

The ADS-B data provided the highest reporting frequency (~0.5 seconds), and altitude was reported to the nearest 25 ft. This data was captured from shortly after departure until the aircraft descended to about FL240 during its final descent (Figure 8).

The ADS-B data that was broadcast from the aircraft during the accident flight contained a discrepancy between the pressure altitude and the GPS altitude (Figure 8).²² At the start of the second cruise phase, the broadcast pressure altitude was 28,000 ft while the GPS altitude was 29,400 ft. At the end of the second cruise phase (approximately 2 hours later), the broadcast pressure altitude was 28,050 ft while the GPS altitude was 29,750 ft. The difference in pressure and GPS altitudes over the entire flight varied with altitude and flight time and is shown on a scatter plot below (Figure 9).

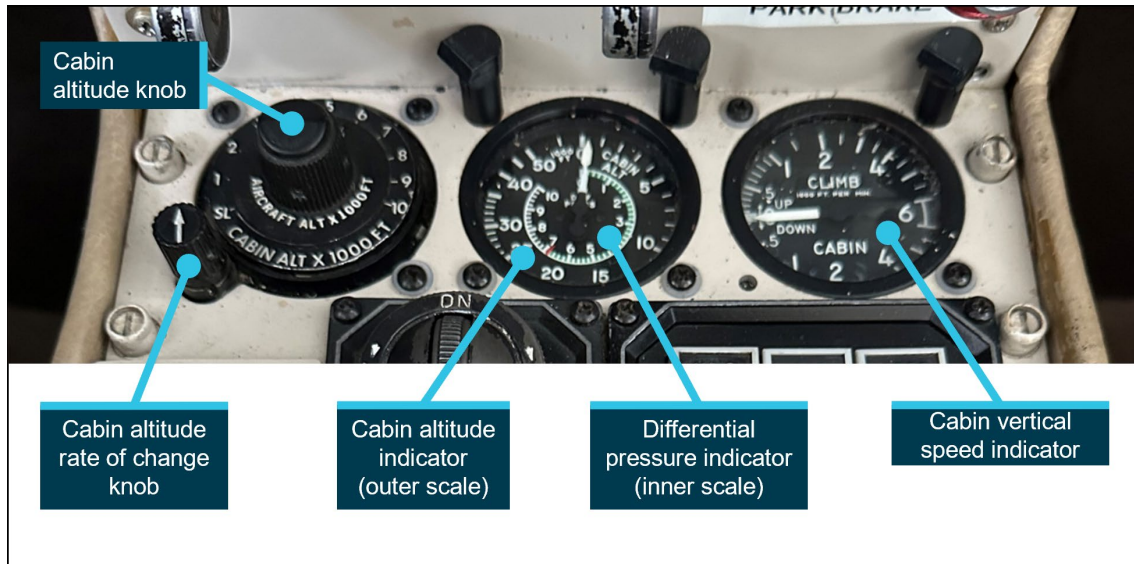
Figure A3: Pressurisation controls and indicators fitted to VH-HPY

A cabin pressure controller is set by flight crew to maintain cabin pressure from take-off, through climb, cruise, and descent. A rate of change knob in its 'nominal' position controls the cabin altitude rate of change (or vertical speed) to 500 ft/min and can be set from a minimum of 50 ft/min to a maximum of 3,000 ft/min. The cabin altitude knob is used to set the desired cabin altitude (up to 10,000 ft) and has an inner scale that shows the corresponding aircraft altitude that can be flown without exceeding the aircraft's maximum differential pressure. The adjacent indicators for the cabin show the cabin altitude, differential pressure, and the cabin's vertical speed (Figure A3).

The cabin pressure controller also prevents the cabin differential pressure from exceeding the maximum differential pressure of 6.8 psi. The Gulfstream 695A is certified to operate up to 35,000 ft above mean sea level. At this altitude, and at the maximum differential pressure, the cabin altitude would be 9,600 ft.
