Loss of control and collision with terrain involving Beechcraft E55, VH-OMD

Cowra Airport, New South Wales on 11 April 2024

ATSB Transport Safety Report

AO-2024-011

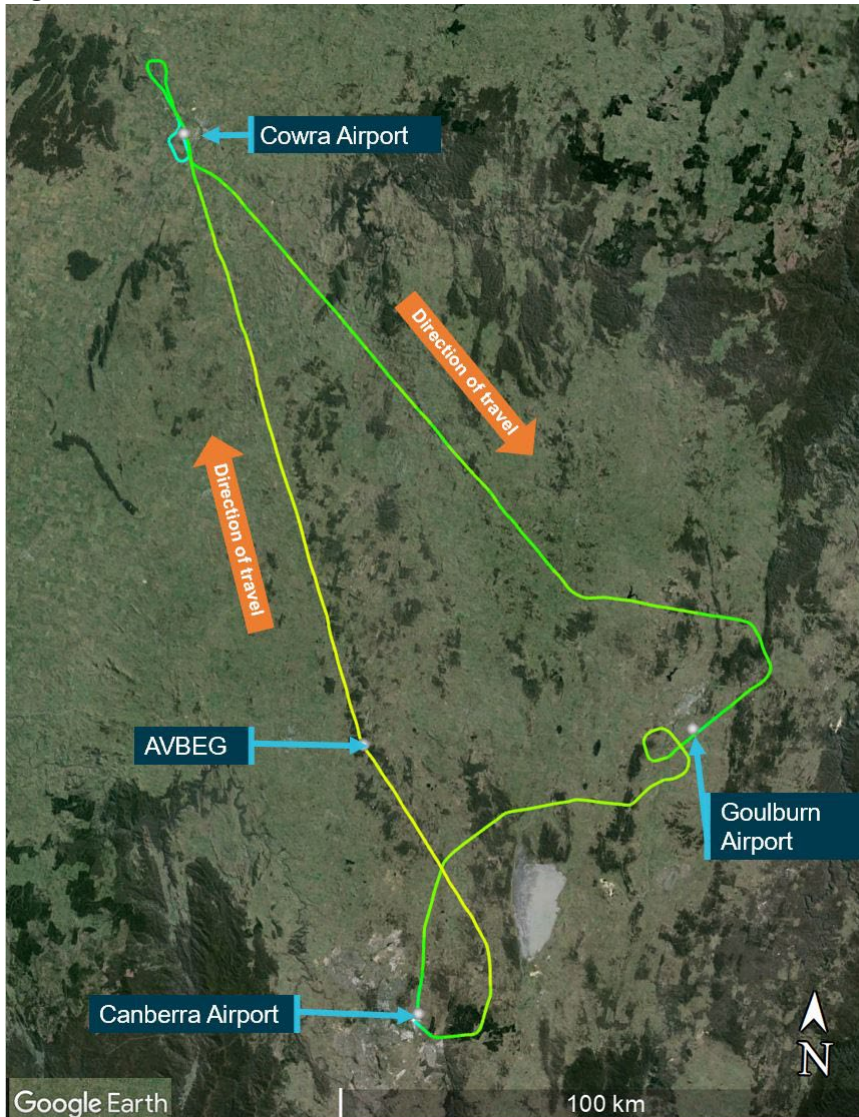
Figure 1: VH-OMD track from Cowra to Goulburn, Canberra and return via AVBEG

OzRunways³ flight path data showed that the aircraft departed Cowra Airport at 1156 local time. En route to Canberra, the student conducted an instrument approach⁴ to Goulburn Airport, NSW, but did not land there. The student then conducted an instrument approach to Canberra, landed and taxied to the general aviation apron. After a short break, and without shutting down the engines, the aircraft departed Canberra Airport at 1323 via a standard instrument departure. The aircraft climbed to 10,000 ft above mean sea level (AMSL), tracked via waypoint AVBEG and commenced a descent when 35 NM from Cowra (**Figure 1**).

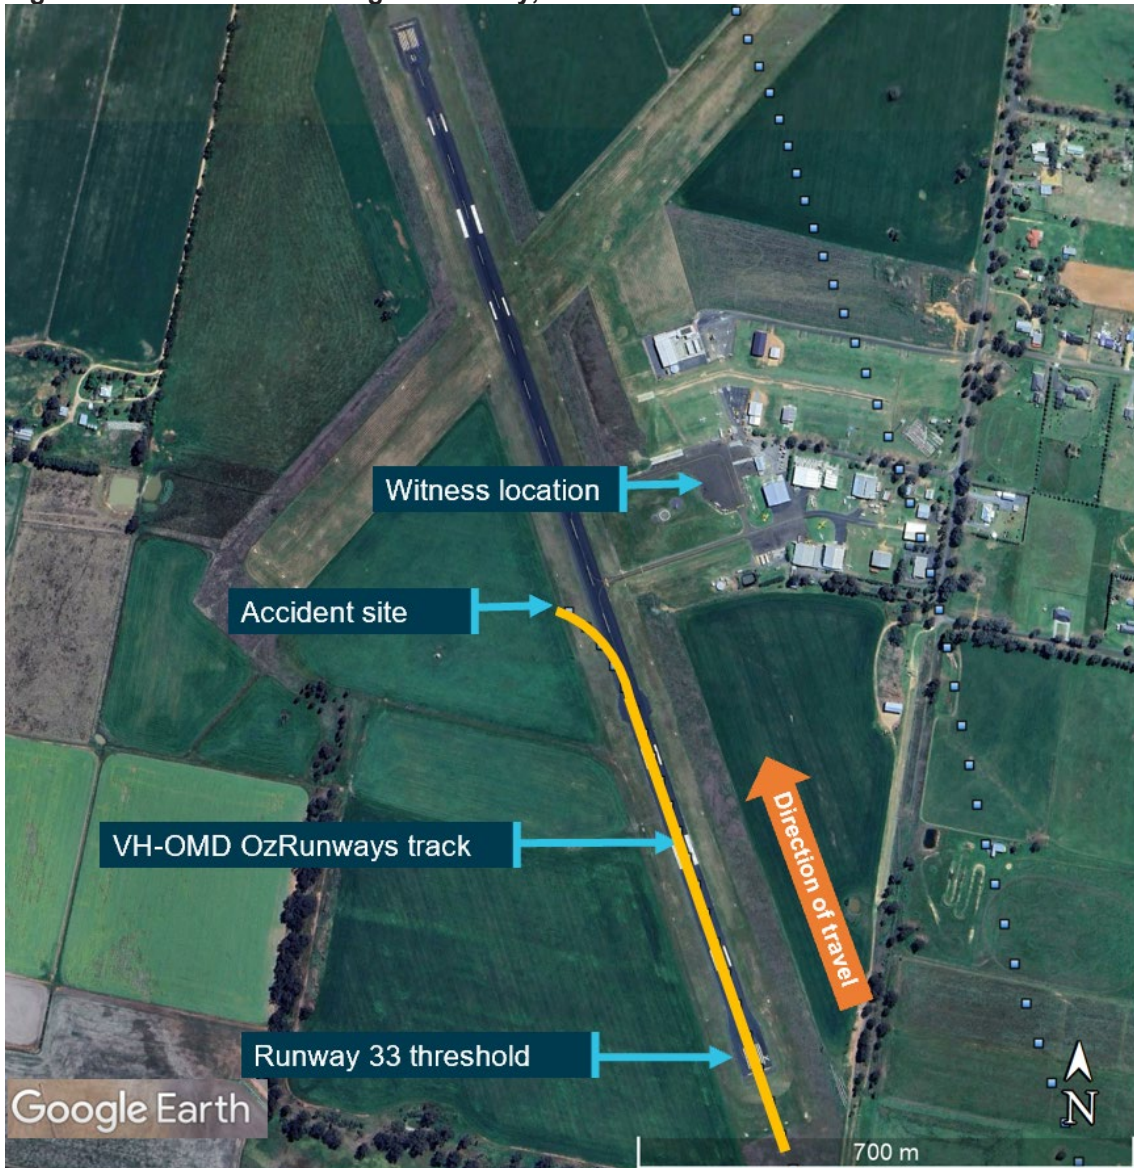
Figure 3: VH-OMD track along the runway, accident site and witness location

OzRunways data showed that the aircraft started to deviate left of the runway centreline at 1416:14 at 69 kt ground speed, but there was insufficient recorded information to determine whether or not it touched down prior to that occurring. The instructor reported taking control of the aircraft from the student and verifying that both throttle levers were fully forward. Assessing that the yaw was due to left rudder input by the student, the instructor called for the student to let go of the controls and applied right rudder, but was unsuccessful in regaining control of the aircraft. A witness facing away from the runway heard what they assessed as one engine power up and turned to see the aircraft 10–20 ft above the runway, pitched 10–12° nose-up, and in a rapid left roll (Figure 3).

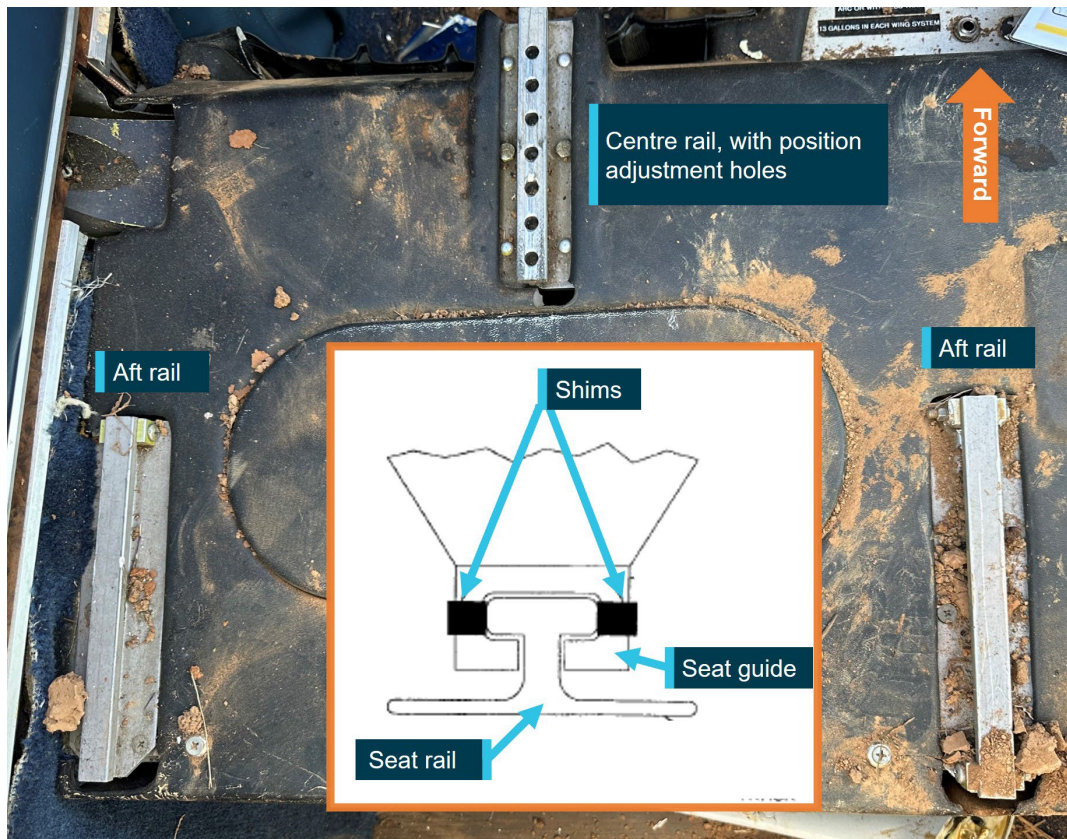
Figure 5: Seat rails

The front seats were fitted with 4-point restraints, each consisting of 2 lap straps connected to the seat frame and 2 shoulder harness straps connected via a Y belt to an inertia reel attached to the upper cabin structure. The inertia reel was designed with a locking device that would secure the shoulder straps in the event of sudden forward movement or impact. The seats could be adjusted forward or aft, with the seat guides sliding along 3 seat rails: 2 main (aft) and 1 centre (forward) (Figure 5). The seat is retained at the desired adjustment by a spring-loaded locking pin engaging in one of the forward centre rail holes. Shims could be added to the inside of the guide to ensure locking pin alignment.

Left seat position depicted in image, right seat rails identical.
Source: ATSB and Beechcraft, annotated by ATSB

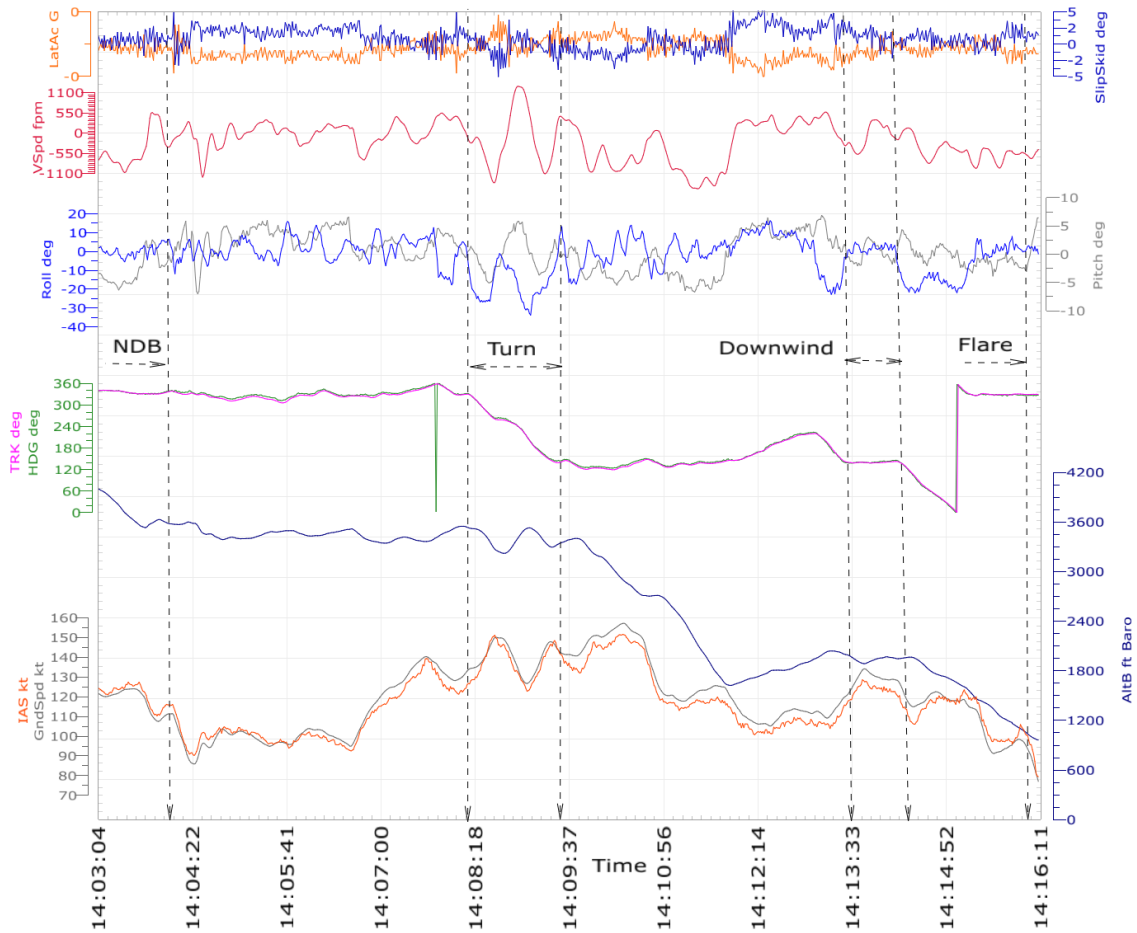
Figure 6: Selected parameters from the Garmin electronic flight instrument

OzRunways¹⁵ data from the student's electronic flight bag application contained aircraft track, altitude and ground speed. The ATSB also obtained flight data from the aircraft's Garmin electronic flight instrument (EFI), which included 40 data parameters. Figure 6 shows key parameters from the EFI data, with the following observations.

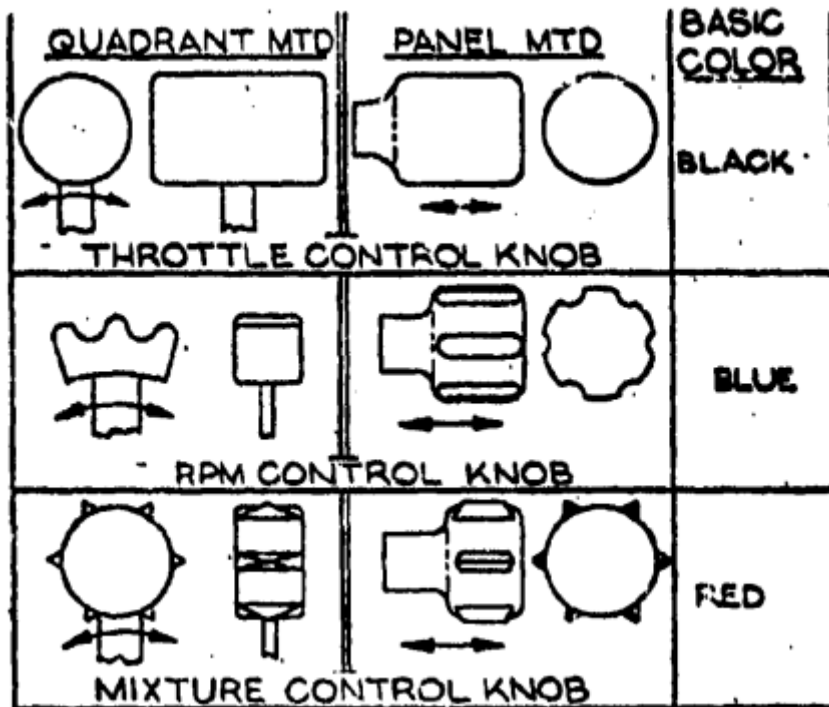
Figure 10: Recommended control standardisation shapes and colours

In 1976, in response to NTSB recommendation A-74-38 regarding fuel control standardization, the US General Aviation Manufacturers Association (GAMA) proposed to the FAA changes to FAR 23.777 through 23.781. It prescribed left to right throttle, propeller and mixture controls, landing gear to the left of the throttle or pedestal centreline, and flap to the right, and included recommended shapes and colours (Figure 10). The FAA's *General aviation (FAR 23) cockpit standardization analysis* (FAA-NA-77-38) recognised that 'increased standardization of cockpit systems can reduce cockpit workload, reduce the potential for habit interference when transitioning to another type aircraft, and provide for application of the best and most error-resistant designs' (FAA, 1978).

However, regarding the subsequent FAR amendment 23–33 1986, the FAA stated, 'that color of control knobs is not a safety issue and will not adopt the proposed color requirement'. As a result, the recommended black throttle control knob and blue propeller control knob standard was not incorporated into FAR 23. A mixture lever was considered an 'emergency control' and therefore under FAR 23.1555(e)(2) must be red. The landing gear lever (left) and flap lever (right) requirement was incorporated in FAR 23.777 (f) and (g)).
