# Unstable approach involving Embraer E190, VH-UYO

near Darwin Airport, Northern Territory, on 12 February 2025

## **ATSB Transport Safety Report**

AO-2025-012

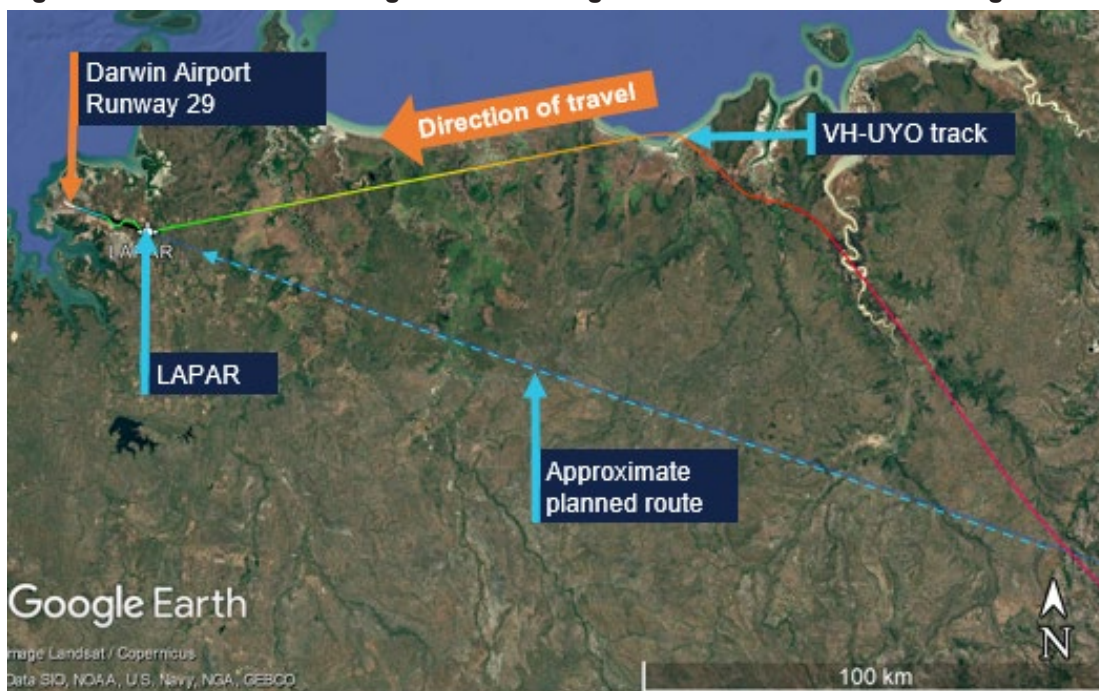
Figure 1: VH-UYO recorded flight data showing weather diversion and tracking to LAPAR

At 1619 the flight crew requested, and received, a clearance to deviate up to 70 NM (130 km) right of route and to track direct to waypoint LAPAR, once clear of the weather. About 2 minutes later, descending through FL 190, the aircraft turned left from a position about 30 NM (56 km) right of the planned route, to track 60 NM (111 km) direct to LAPAR (Figure 1).

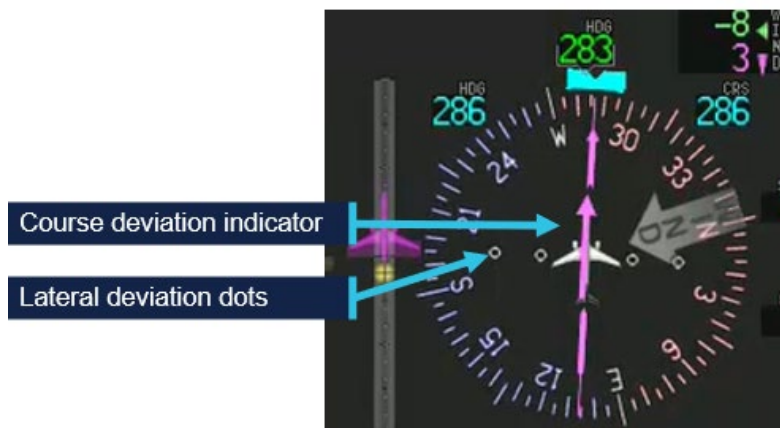
**Figure 4: Compass instrument course deviation indicator aligned with the localiser at 1634:56**

After intercepting the localiser, the ILS frequency became the active navigation source for the aircraft's primary flight display (PFD), for the remainder of the flight. As such, lateral deviation from the localiser and vertical deviation from the 3° glideslope would be depicted on the PFD with 2 dots in each direction (left-right/up-down), with 2.5 dots representing full-scale (or greater) deviation. Localiser deviation was also depicted by a course deviation indicator (CDI) and dots either side of the course on the compass instrument on the lower part of the PFD (Figure 4).

Following activation of the ROLL/FPA modes, the aircraft deviated right of the localiser, maintaining approximately 20° roll for about 20 seconds, as it descended. After

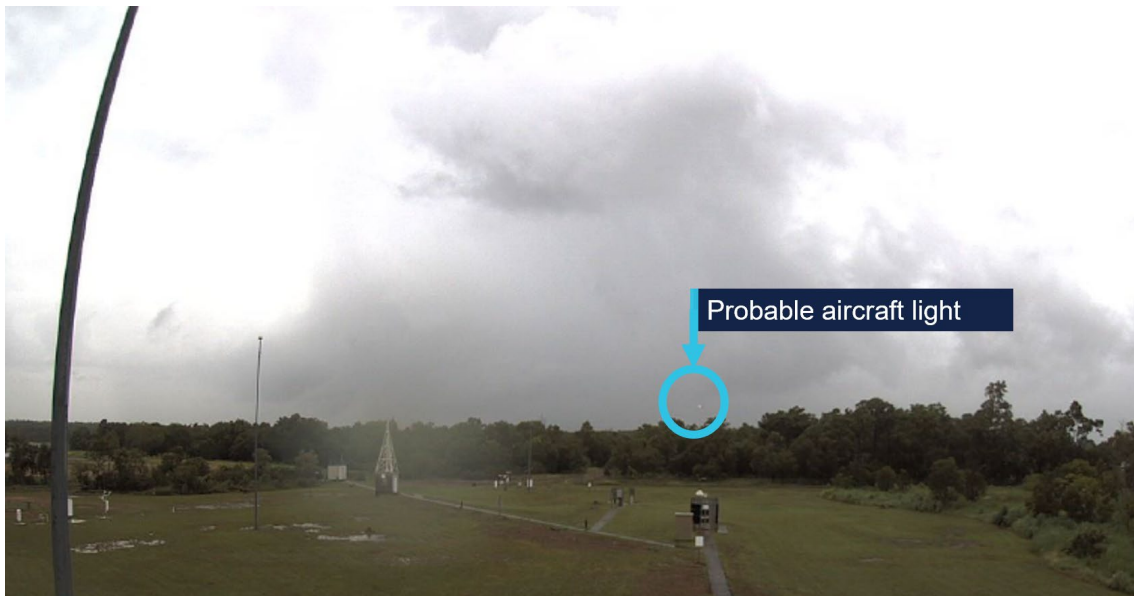
**Figure 7: BoM webcam image facing east at 1638 and probable aircraft light**

At 1638, the aircraft would have been due east of the webcam on final approach, at about 300 ft, probably the light visible in the east view at 1638 (Figure 7).

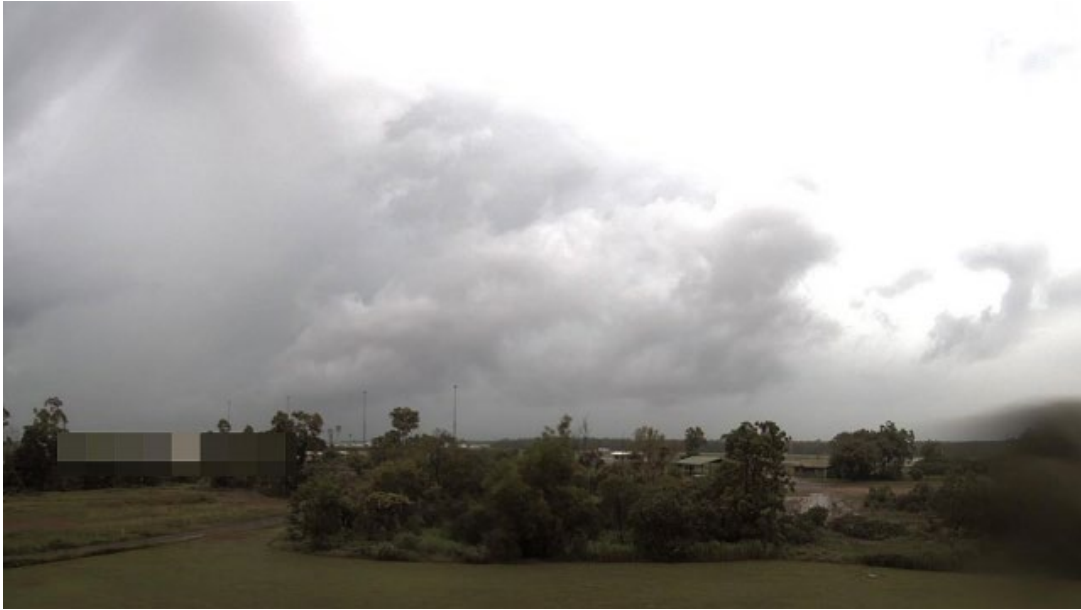
**Figure 8: BoM webcam image facing north at 1638**

The cell with heavier rain to the north was evident in the north view at 1638 (Figure 8).

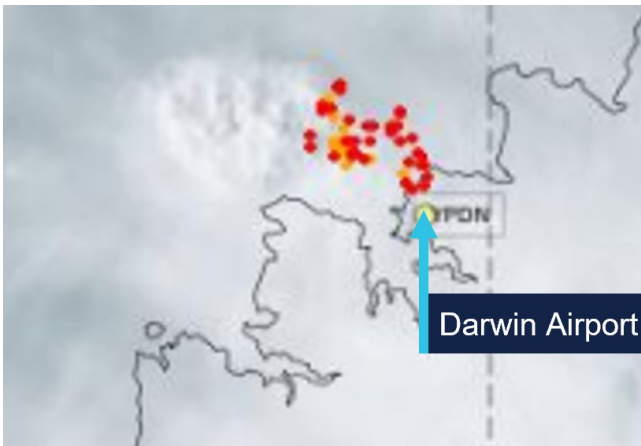
**Figure 9: Cloud cover at 1640 and recorded lightning strikes**

Figure 9 shows satellite imagery of cloud cover at Darwin Airport at 1640, and lightning strikes that occurred in the 10 minutes prior (red) and during the period 10–30 minutes prior (orange).

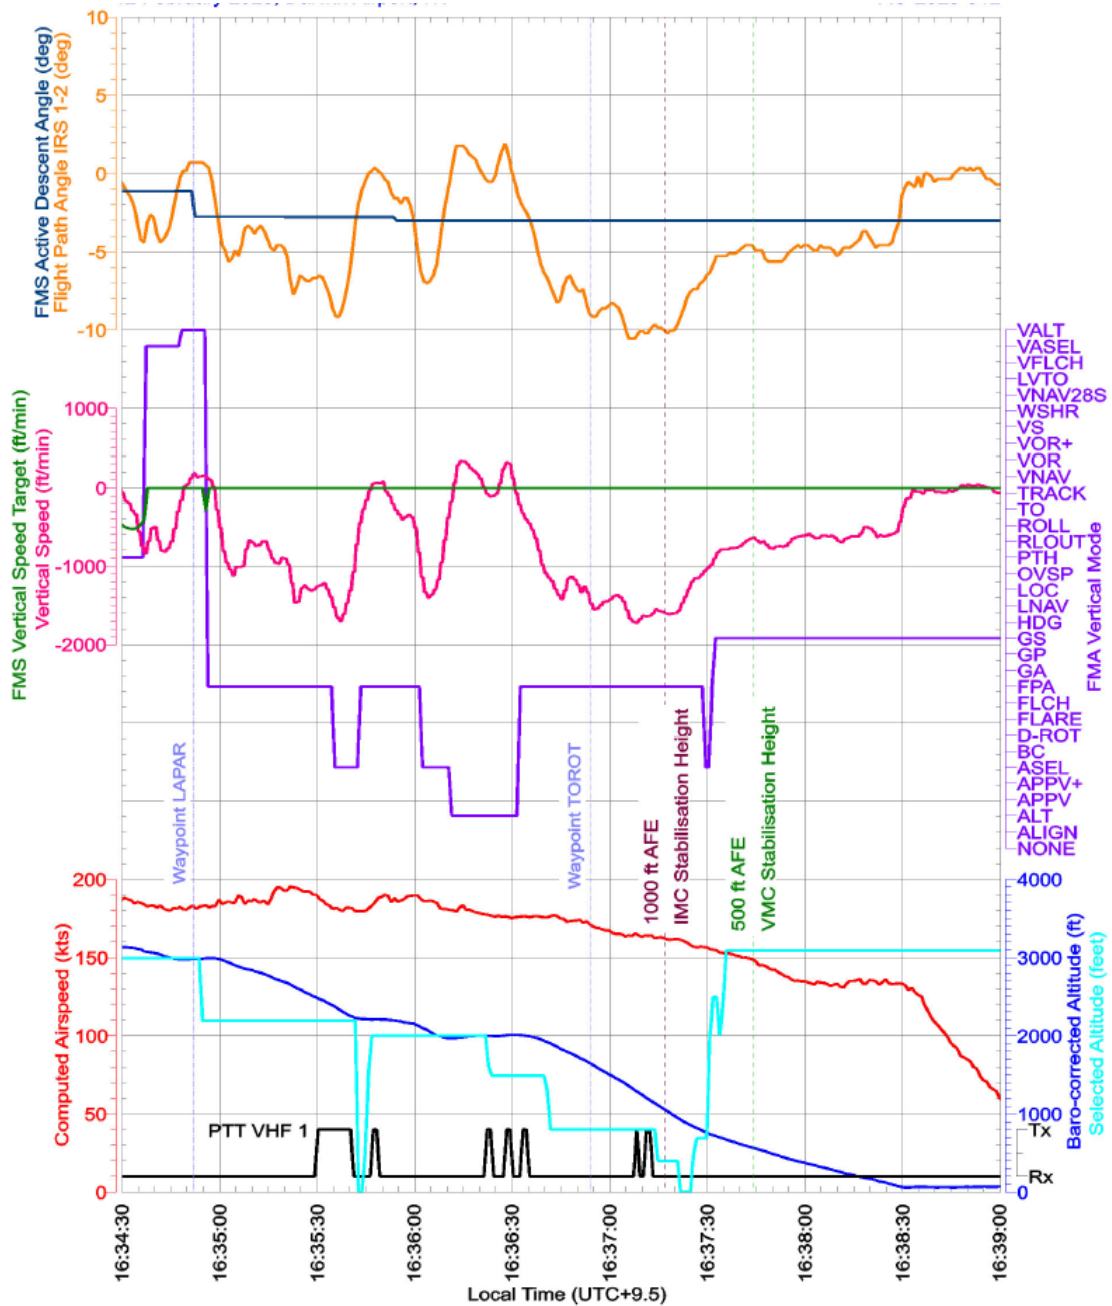
Figure 10: QAR data including key vertical flight path parameters

Key parameters in the vertical flight path, depicted in Figure 10, identified that between LAPAR and about 600 ft AAL, there were:

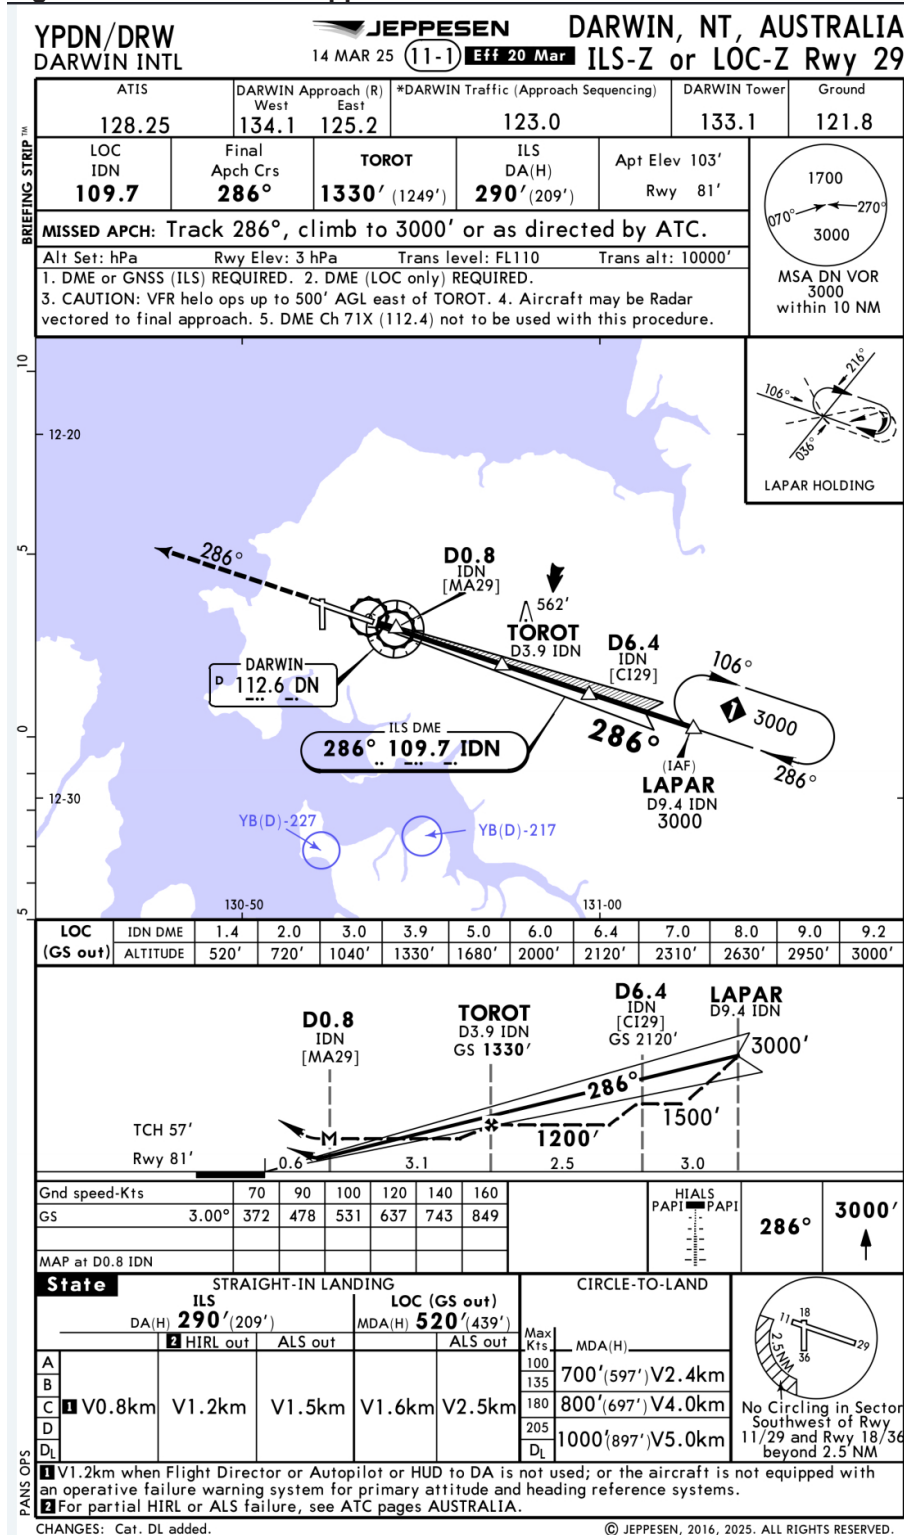
Figure 12: Darwin ILS-Z approach

Darwin Airport runway 29 ILS-Z approach is depicted in Figure 12.
