Breakaway occurrences involving *OOCL Brisbane* and *CMA CGM Bellini*

Port of Brisbane, Queensland, on 16 May and 20 May 2022, respectively

ATSB Transport Safety Report

MO-2022-004

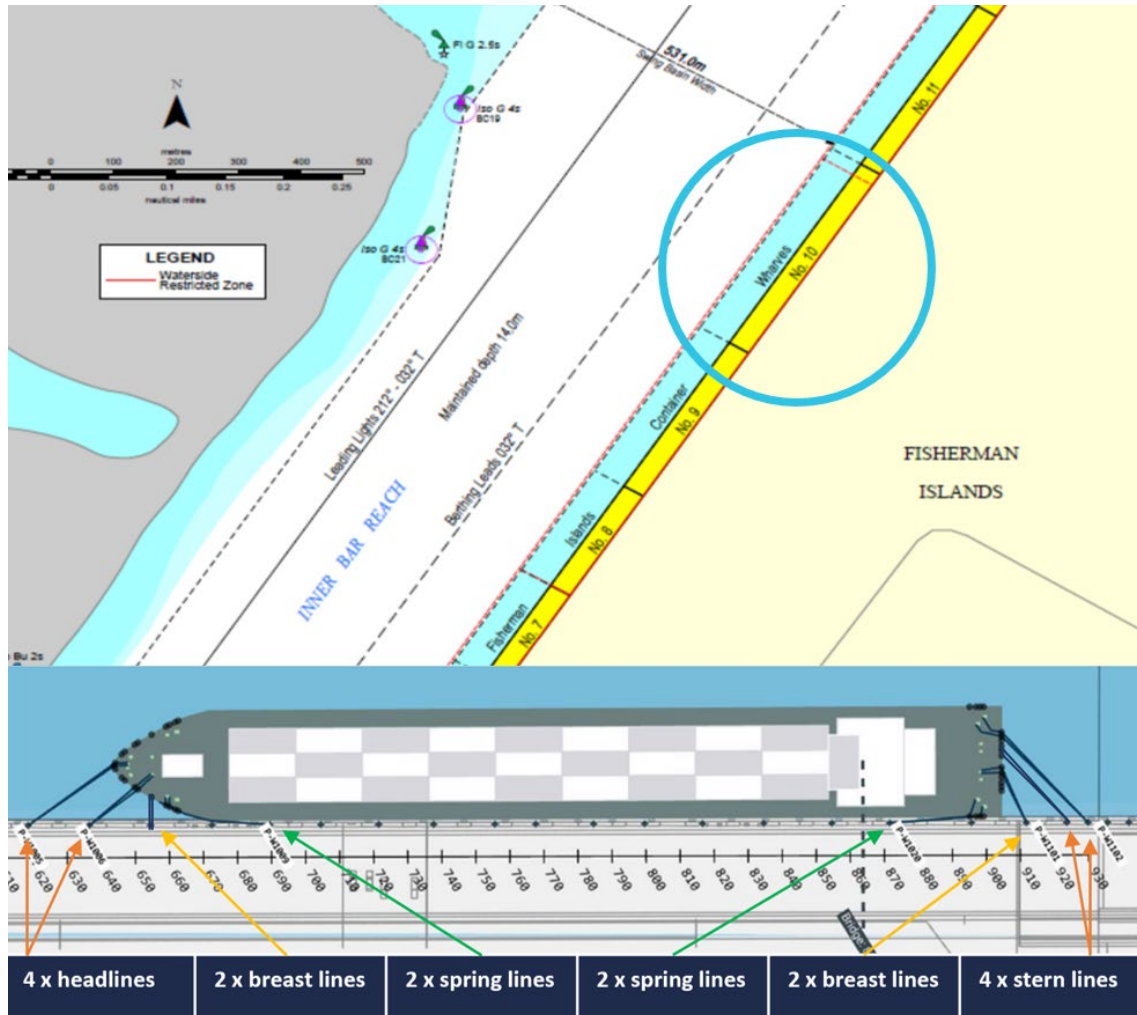
Figure 3: OOCL Brisbane mooring arrangement

At the time of the breakaway, each of the 16 polyamide (nylon) mooring lines used to secure *OOCL Brisbane* alongside (Figure 3) had a minimum breaking load of 72.6 t, while each mooring winch had a brake holding capacity of 52.8 t. Following the breakaway, a surveyor inspected the mooring lines and equipment, as well as the service records relating to them, and determined that prior to the incident, the mooring lines, winches and gear had been properly maintained and were in serviceable order.

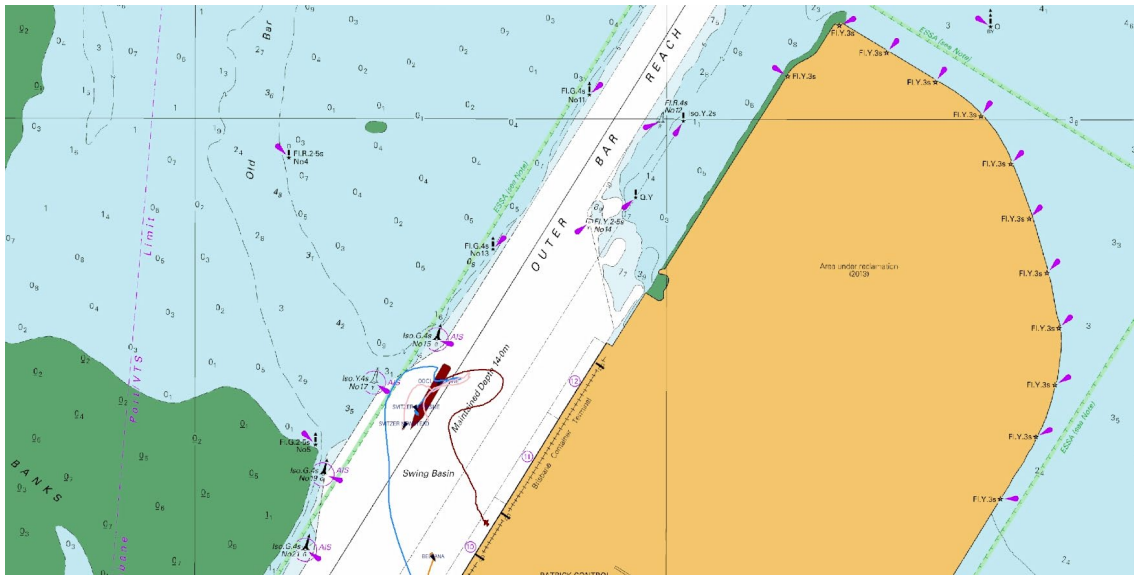
Figure 6: OOCL Brisbane at 1323

Meanwhile, *Delos Wave* had come alongside its berth and, by 1310, had one mooring line out at each end. Astern of it, *OOCL Brisbane* had broken away with its aft winches still paying out. The ship came close to the ship berthed astern of it before moving across to the other side of channel. By 1313, when the tug arrived to assist, all the ship's aft mooring lines had parted or paid-out. One of the tugs attending *Delos Wave* was also released to assist *OOCL Brisbane*.

By 1323, *OOCL Brisbane* was near the opposite side of the channel with the 2 tugs assisting with controlling its movement (Figure 6). Shortly afterwards, the other tug attending *Delos Wave* was

also released to assist *OOCL Brisbane*. The 3 tugs then aided *OOCL Brisbane* to remain within the channel while VTS arranged a pilot.
