# Propulsion failure and near stranding of *Portland Bay*

On the coast 22 km south of Port Botany (Sydney), New South Wales, on 4 July 2022

Marine Occurrence Investigation (Systemic)

MO-2022-006

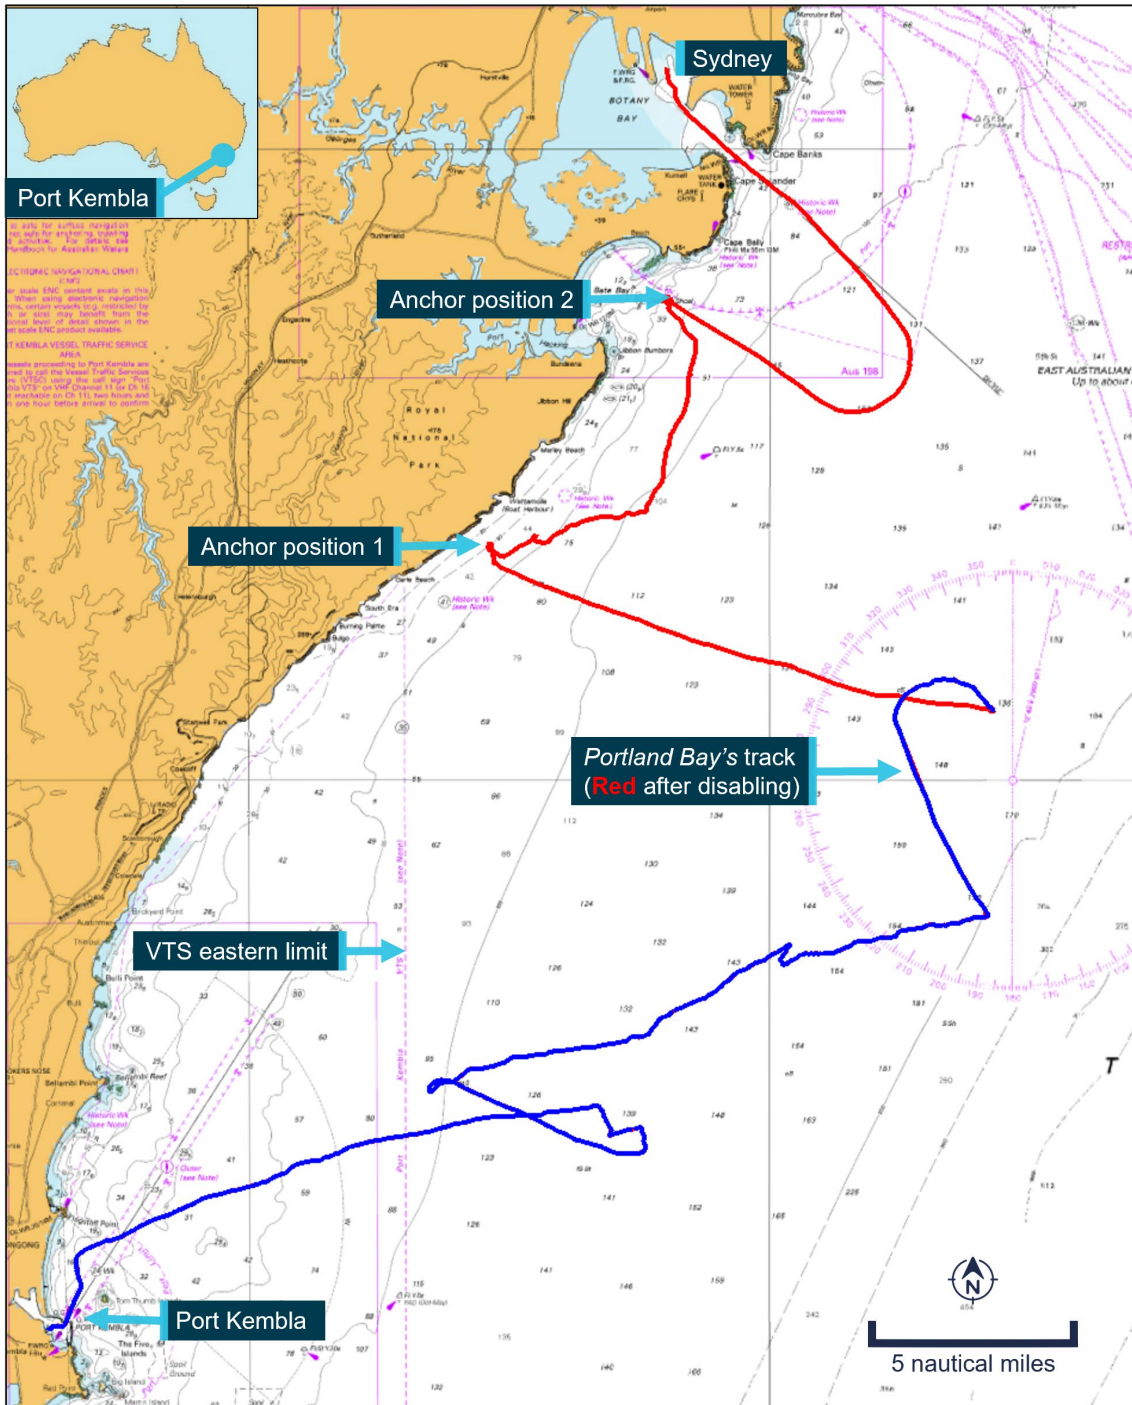
Figure 1: *Portland Bay*'s movements from 3 to 6 July 2022

On 3 July 2022, adverse weather that was forecast to further deteriorate had made it unsafe for the bulk carrier *Portland Bay* (cover) to remain berthed in Port Kembla, New South Wales (Figure 1). Consequently, the decision was made for the ship to leave the port and remain at sea until the weather improved sufficiently to allow a safe return.

*Portland Bay* departed the port in the afternoon and steamed on an east-north-easterly course until that evening when it was about 12 nautical miles (miles) from the coastline where its main engine was stopped. The ship drifted towards the coast in the south-easterly winds and seas and the engine was used intermittently that evening and night to avoid getting closer to the coast.

Shortly before 0500 local time on 4 July, the main engine developed mechanical problems, which limited the engine speed to dead slow ahead (the minimum). The problems could not be resolved, resulting in *Portland Bay* being effectively disabled about 12 miles from a lee shore. In the prevailing conditions, the ship began drifting at a rate of 2–3 knots<sup>1</sup> towards the coast.

At 0905, when about one mile from the shore, the master deployed the ship's anchors to prevent stranding on the rocky coastline of Royal National Park (Figure 1, Anchor position 1). Subsequently, unsuccessful attempts were made to evacuate the crew by helicopter.

At 2035, the ship was anchored about one mile from the shore to prevent stranding in Bate Bay near Sydney (Figure 1, Anchor position 2). Both tugs, one with its towline connected, remained with the ship. Later that night, the nominated emergency towage vessel (ETV) for New South Wales was deployed from Newcastle (about 90 miles north of Bate Bay) to tow the ship to safety.

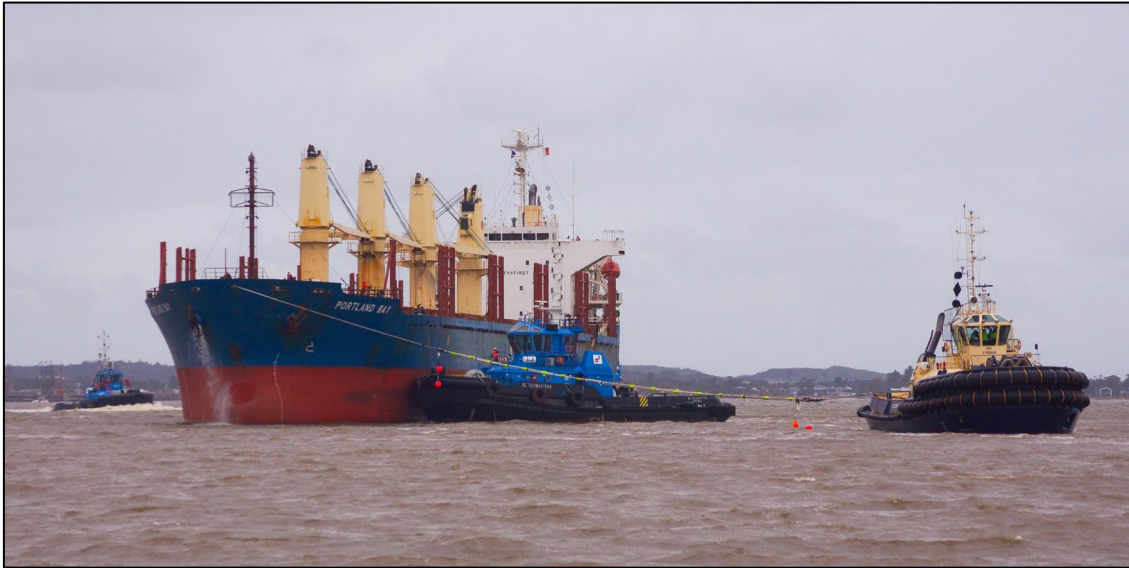
**Figure 2: *Portland Bay* under tow on 6 July**

On 6 July, at about 1100, the ETV and 2 harbour tugs began towing *Portland Bay* to shelter in Port Botany (Figure 2). By late afternoon, the ship had been safely berthed in the port. Over the following week, the main engine was repaired to make the ship seaworthy.

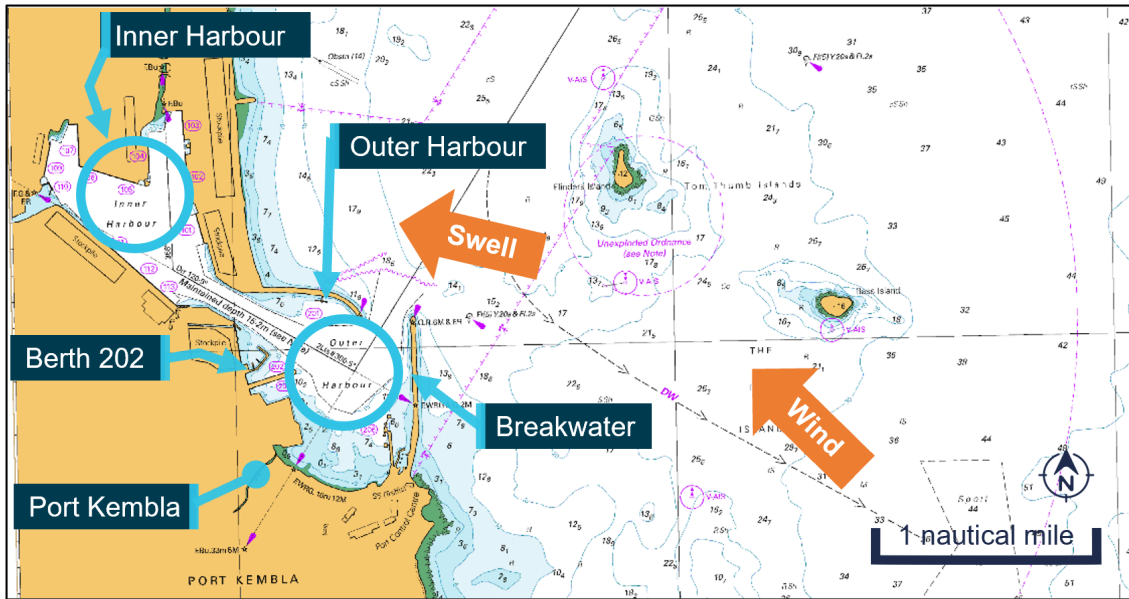
**Figure 3: Location of berth 202 (wind and swell direction at 1100 on 3 July)**

At 0154 on 2 July, *Portland Bay* was secured starboard side alongside berth number 202 in the outer harbour (Figure 3). At 0410, the Bureau of Meteorology (BoM) issued a forecast for gale force winds up to 35 knots and an easterly swell of 3 to 4 m for the seas off the port on 3 July. At 0500, entries in the ship’s logbook indicated easterly winds at ‘force’<sup>3</sup> 3 (7–10 knots).

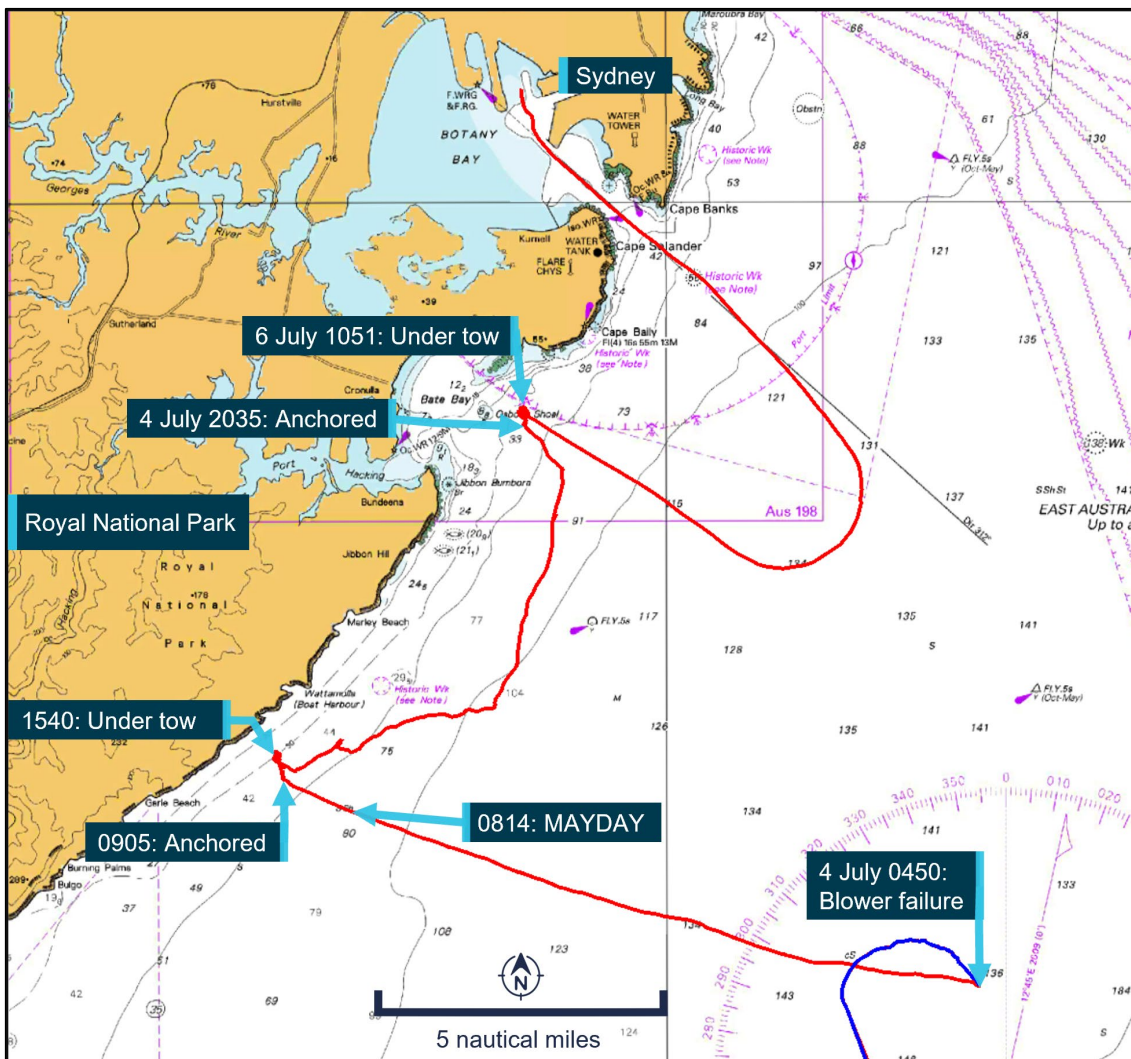
**Figure 4: Time and location of key events during the incident**

At 0450, when *Portland Bay* was about 12 miles from the coast, an alarm on the bridge fire alarm panel alerted the chief mate to 2 fire detectors in the lower, starboard side of the engine room that had been activated (Figure 4).

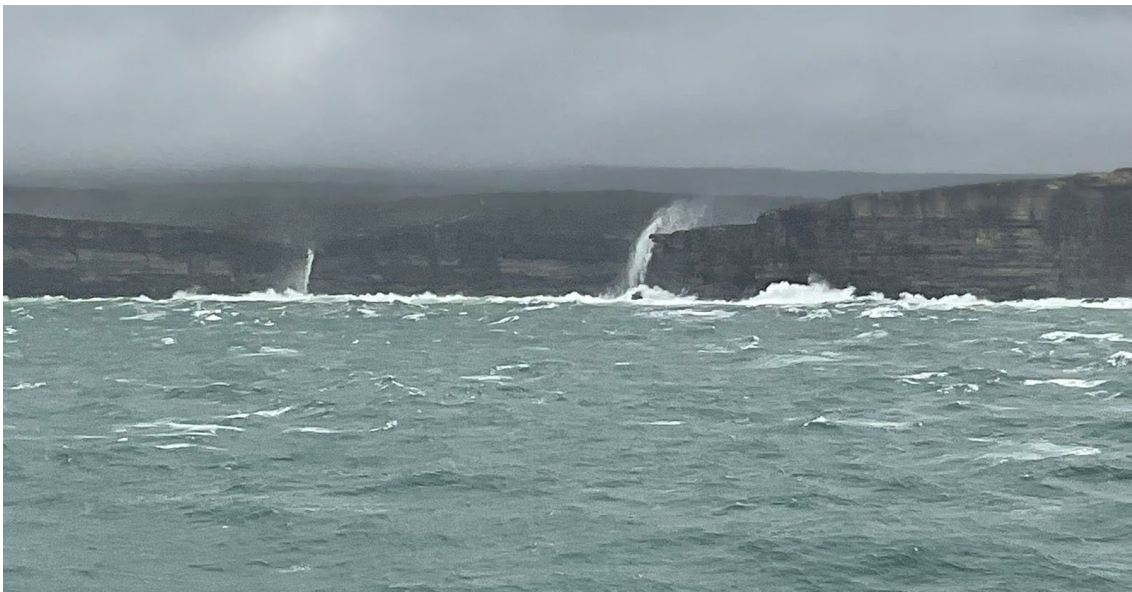
**Figure 6: The shore seen from the ship's bridge**

Meanwhile on the ship's bridge, at 0937, the third mate informed the master that the distance to the shore had reduced to 9 'cables'<sup>29</sup> (Figure 6). The master was still discussing the situation with Pacific Basin and suggested evacuating all non-essential crew, including the 2 trainees on board.

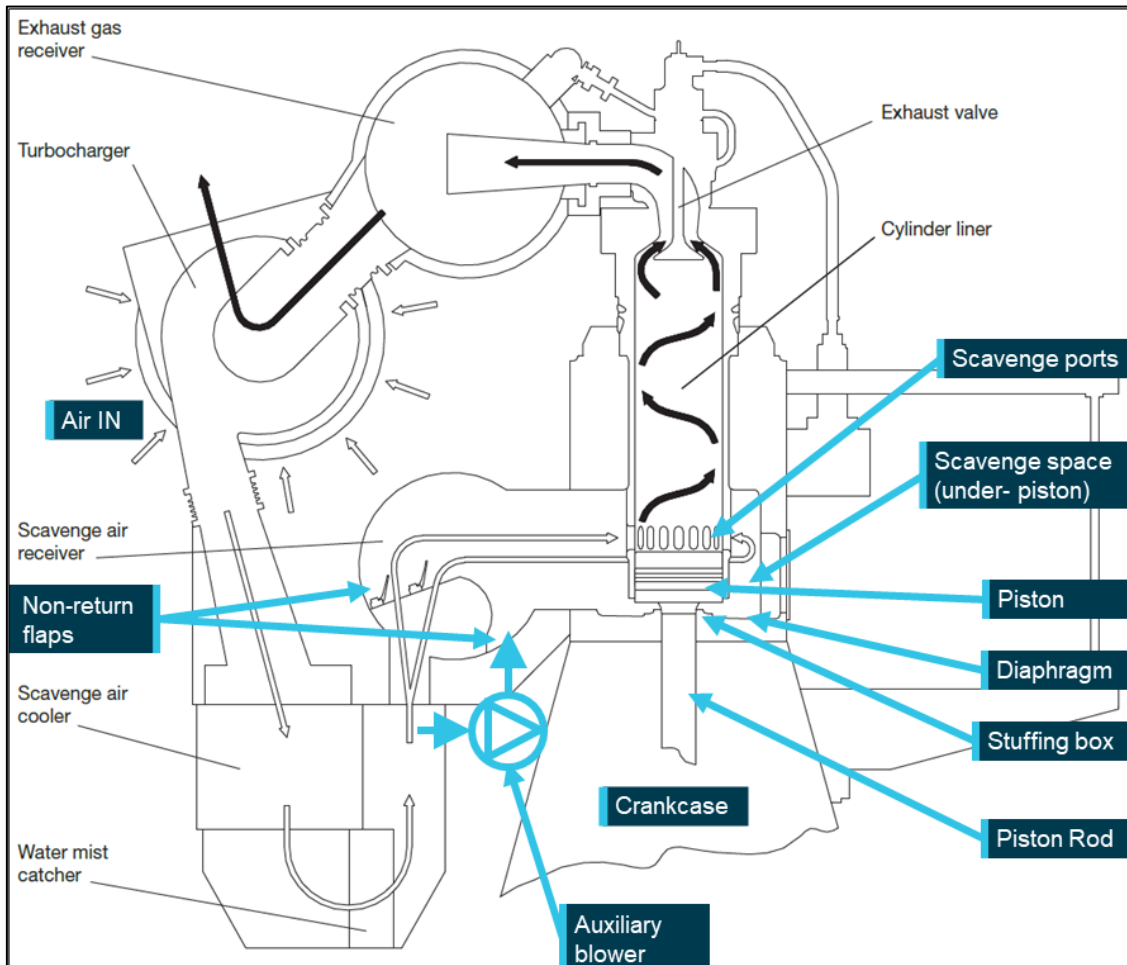
**Figure 7: Slow speed MAN B&W diesel engine combustion air and exhaust system**

Air for fuel combustion (scavenge air) was drawn from the engine room through filters into the turbocharger compressor (Figure 7). The turbocharger compressed the air and discharged it to the scavenge air cooler, which cooled and dried the air before passing the outlet via non-return flaps.

Pressurised air from the cooler went into the scavenge air receiver or trunk, which extended the entire length of the engine and was connected to each cylinder through a pipe in the under-piston scavenge space. As the piston came down, scavenge ports (cutouts) in the lower cylinder liner were exposed, allowing air into the cylinder above the piston. In combination with the now open exhaust valve at the top of the cylinder, the scavenge air cleared the cylinder of combustion gases and provided fresh air for the next combustion cycle. As the cycle continued, the piston moved up, blocking the scavenge ports, the exhaust valve closed, the air was compressed (increasing its temperature), atomised fuel was injected in and when the piston reached top dead centre, combustion occurred. Expanding gases then forced the piston down for the repeat cycle.

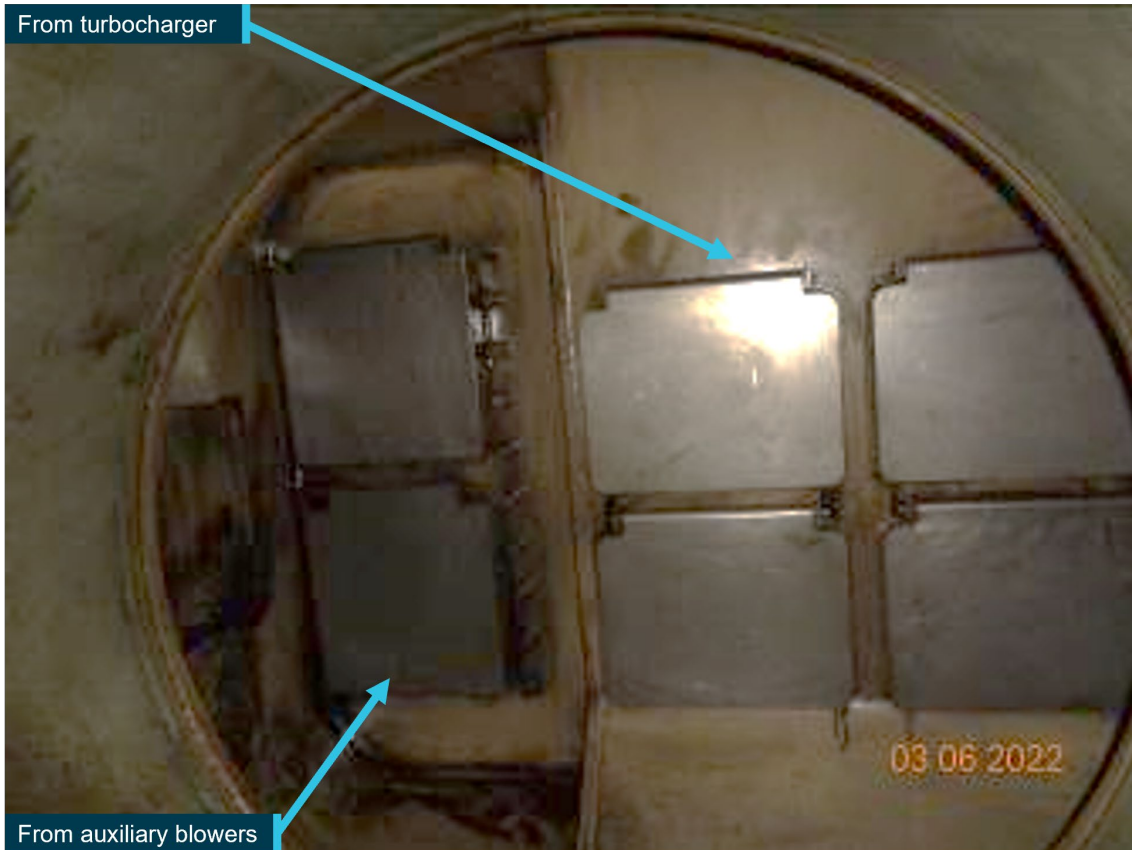
**Figure 8: Air system non-return flaps**

providing air at low engine load (speed) and stopped operating at higher load (speed) when the exhaust gas-driven turbocharger could meet the demand for air. The blowers drew air from the charge air cooler outlet and discharged it through non-return flaps, directly into the scavenge trunk (Figure 8). In effect, the blowers pumped air around the turbocharger non-return flaps.

Complete combustion was essential for the efficient operation of the main engine. The combustion, in turn, relied entirely upon a consistent, reliable air supply. It was therefore critical for the scavenge air system to be sufficiently airtight, particularly at low engine load/speed. The following 3 running surfaces in the air system sealed the system from leakage:

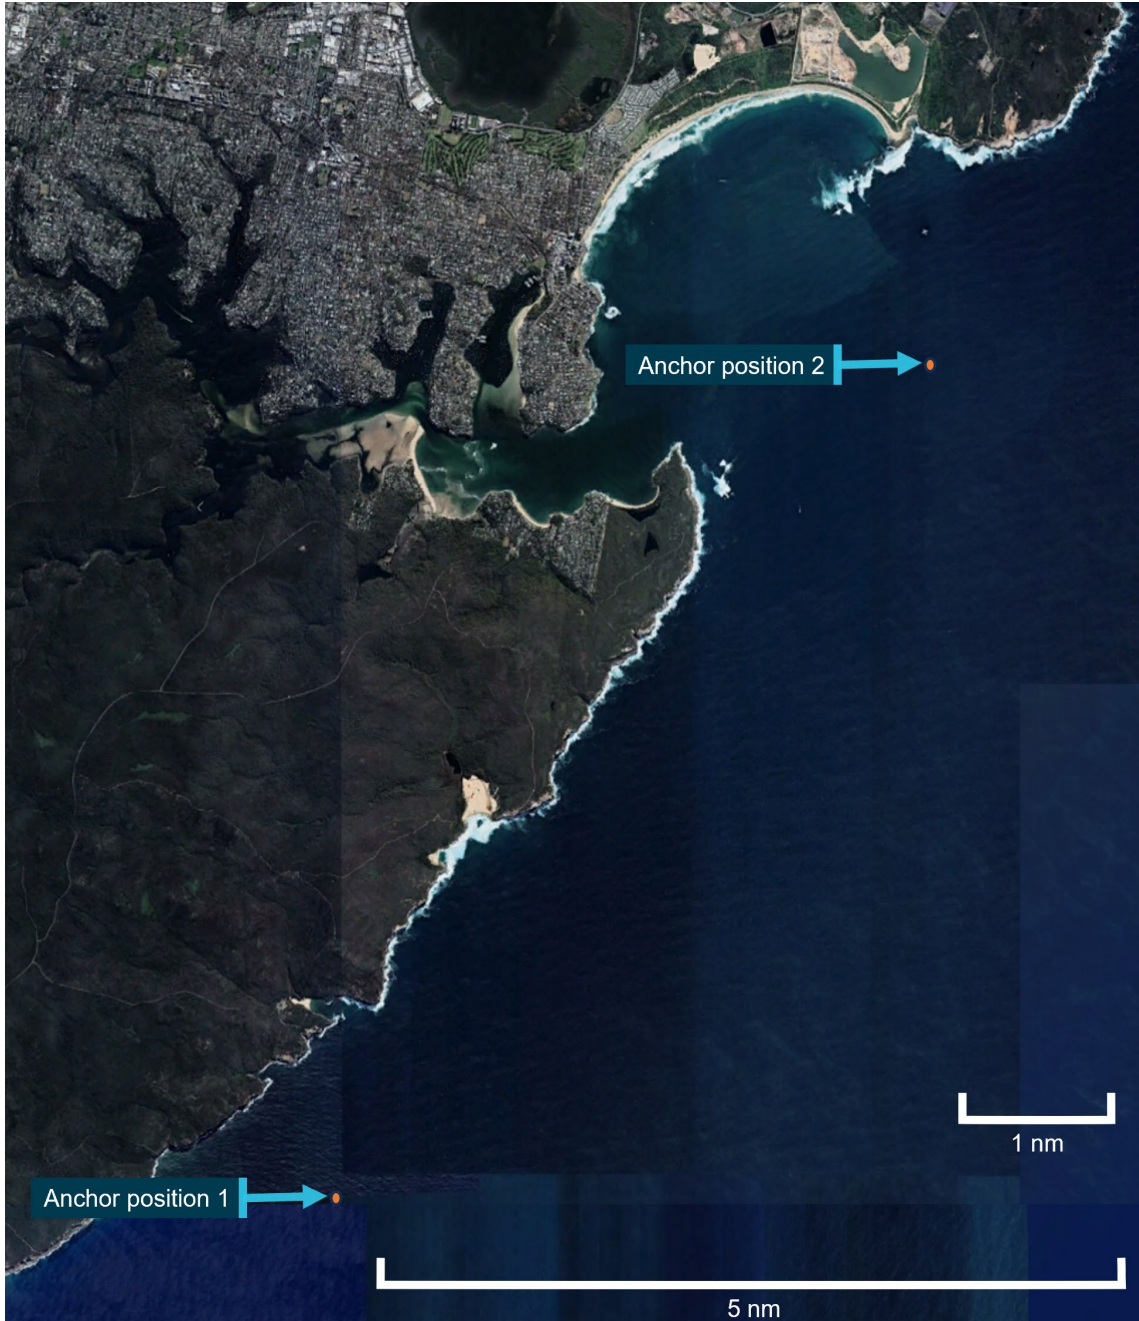
**Figure 12: Anchor positions off Eagle Rock and Bate Bay on 4 July 2022**

As previously described, *Portland Bay* anchored in 2 separate locations, each off a dangerous lee shore (Figure 12).

Anchor position 1 was about one mile from the cliffs near Eagle Rock south of Wattamolla (Figure 13). Similarly, anchor position 2 was about one mile from the nearest reef in Bate Bay. The ship dragged its anchors towards the shore in both locations. As described in the Admiralty Sailing Directions,<sup>46</sup> the coastline between Port Kembla and Sydney offers little to

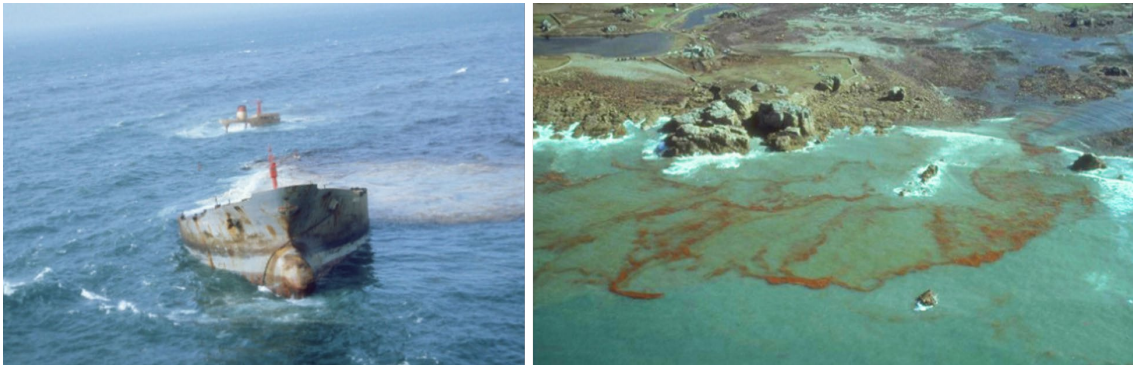
**Figure 14: The stranding of *Amoco Cadiz* and resulting environmental disaster**

The major catalyst to change the law of salvage was the environmental disaster involving the oil tanker, *Amoco Cadiz* (Figure 14). On 16 March 1978, the ship, laden with 220,000 tonnes of crude oil, broke down in heavy weather off the coast of north-west France. The ship drifted onto the lee shore, where it grounded (stranded) and widespread pollution resulted.

A salvage tug had been made fast well before the ship grounded but there was a long delay before the salvage contract was agreed. While many attributed the stranding to the delay, the salvors denied that assertion. The public furore which followed this disaster resulted in the IMO commissioning a review of the 1910 Salvage Convention to ensure that modern needs and protection of the environment were addressed.

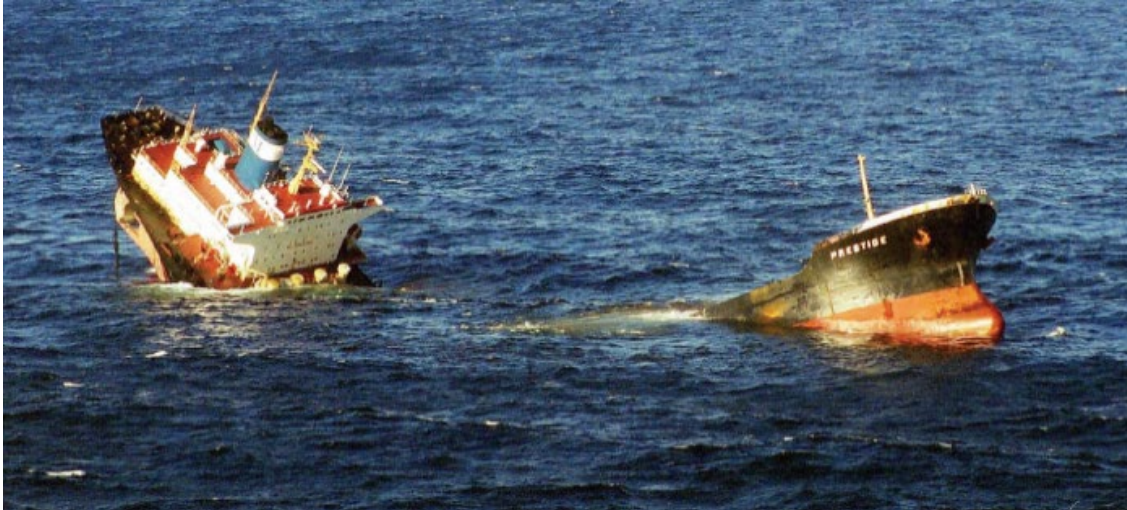
**Figure 15: *Prestige* sinking**

19 November, the ship broke in 2 and sank 160 miles off the Spanish coast (Figure 15). Much of its cargo spilled and most of what remained within the hull escaped into the sea over the following days and months, washing up on the coasts of Spain, France and Portugal (to date it remains Spain's worst ecological disaster).

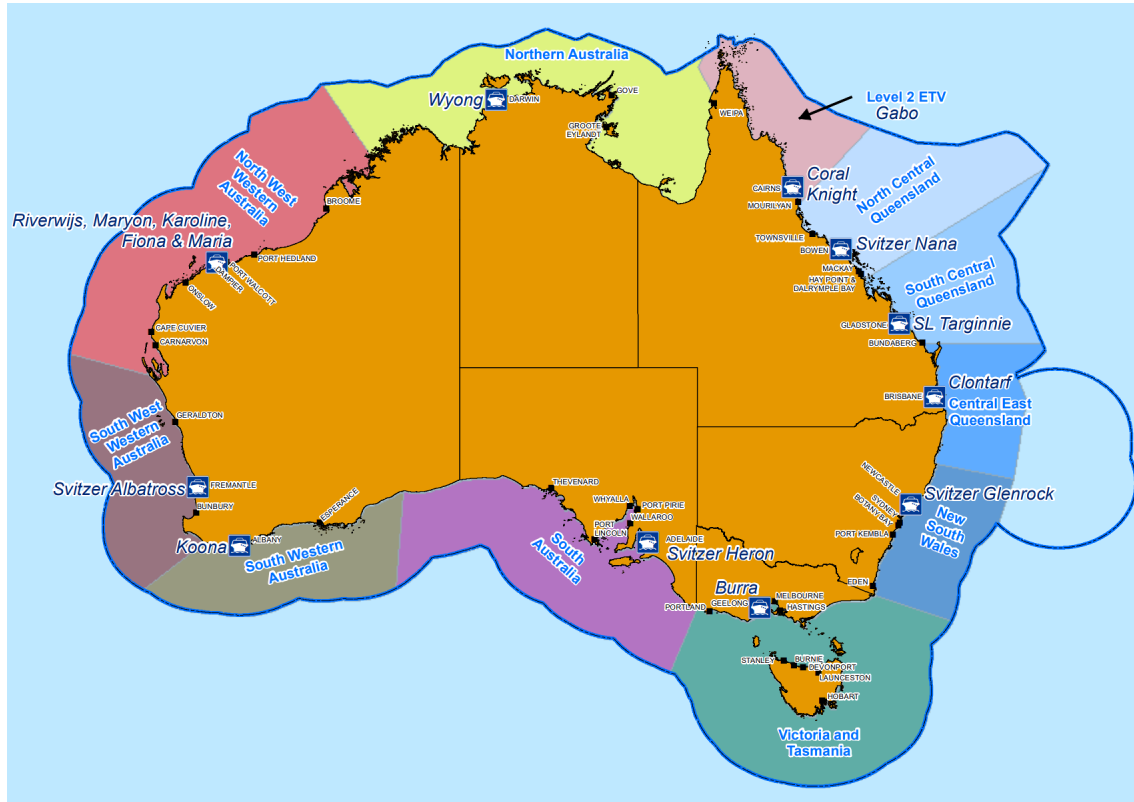
Figure 16: Emergency towage capability arrangements at the time of the incident

Pacific Basin submitted that *Svitzer Glenrock*, the only ETV in the area arrived 18 hours after the ship first anchored. With respect to the emergency towage capability described in the report and shown in Figure 16, it stated that 'the lack of quick availability of proper salvage tugs close to Port Kembla is concerning' and proper positioning of salvage tugs should be considered.

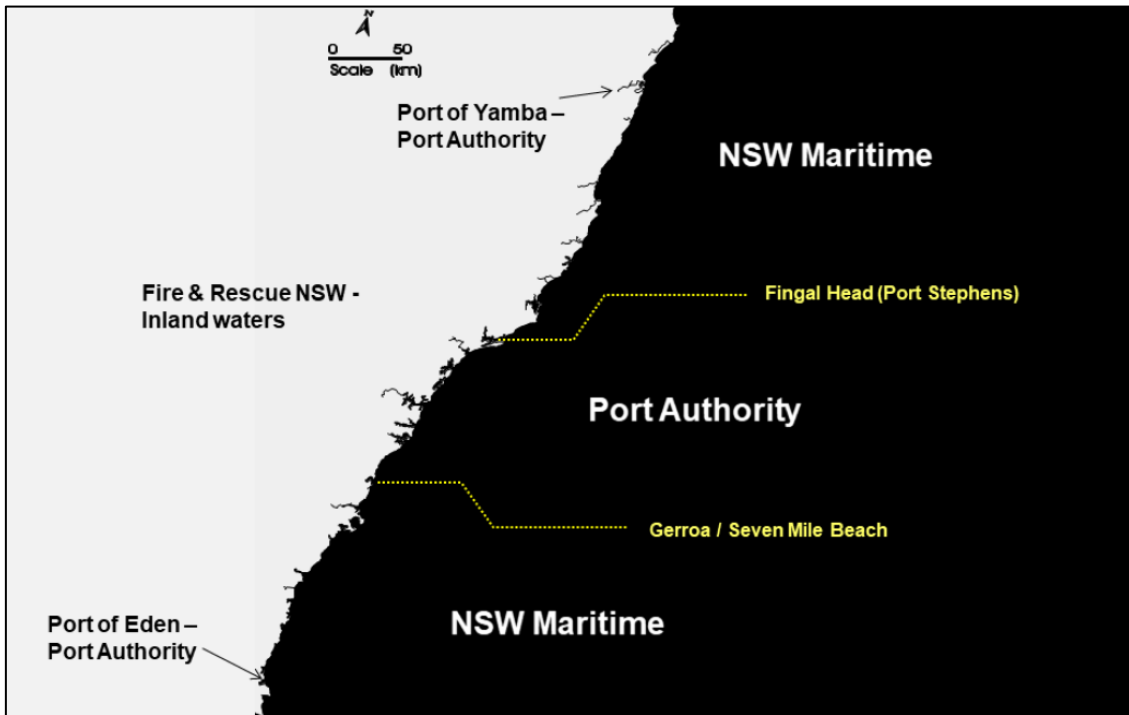
**Figure 19: Regions and their boundaries for the purposes of notification and response**

The NSW Plan stated that the aim of responding to an incident was to minimise damage to the environmental and socio-economic resources and reduce the time for recovery. It was noted that as each incident or emergency was different, the Plan must be flexible in its implementation to respond in the most effective and timely manner. A map titled ‘regions and their boundaries for the purposes of notification and response’ allocated the area between Gerroa (located south of Port Kembla) and Fingal Head (located north of Newcastle) to the Port Authority (Figure 19).

The Port Authority claimed that as per appendix 2 of its PSOL it was required ‘to respond to oil and chemical spills, not emergencies’. It stated that the ‘area of operations’ defined by the NSW Plan (Figure 19) ‘were limited to marine pollution incidents, not maritime emergencies such as a disabled vessel’. It argued that the emergency response requirements in the PSOL for ‘port-related emergencies’ within ports should be

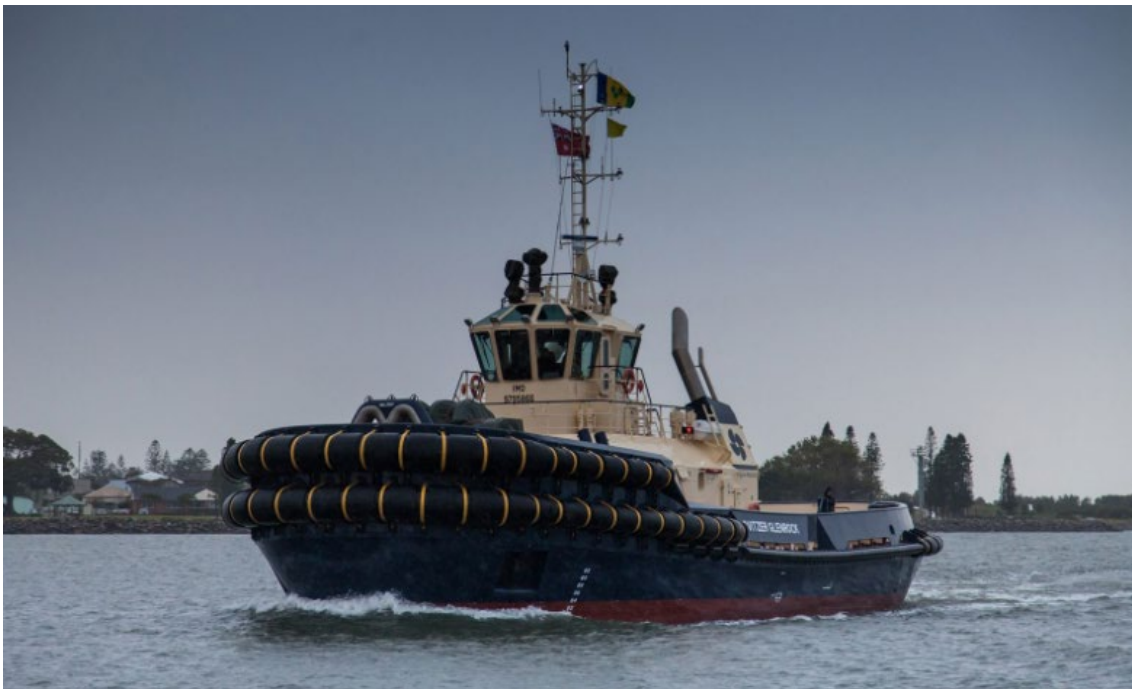
**Figure 20: *Svitzer Glenrock***

*Svitzer Glenrock* had a length of 32 m, beam of 12 m and enough propulsive power to provide a BP of 85 t (Figure 20). The tug was built in 2018 and began operating in Newcastle that year. In 2019, it was contracted to AMSA under the ETC level 2 services contract as the nominated ETV for the New South Wales region based in Newcastle, where it was at the time of the incident.

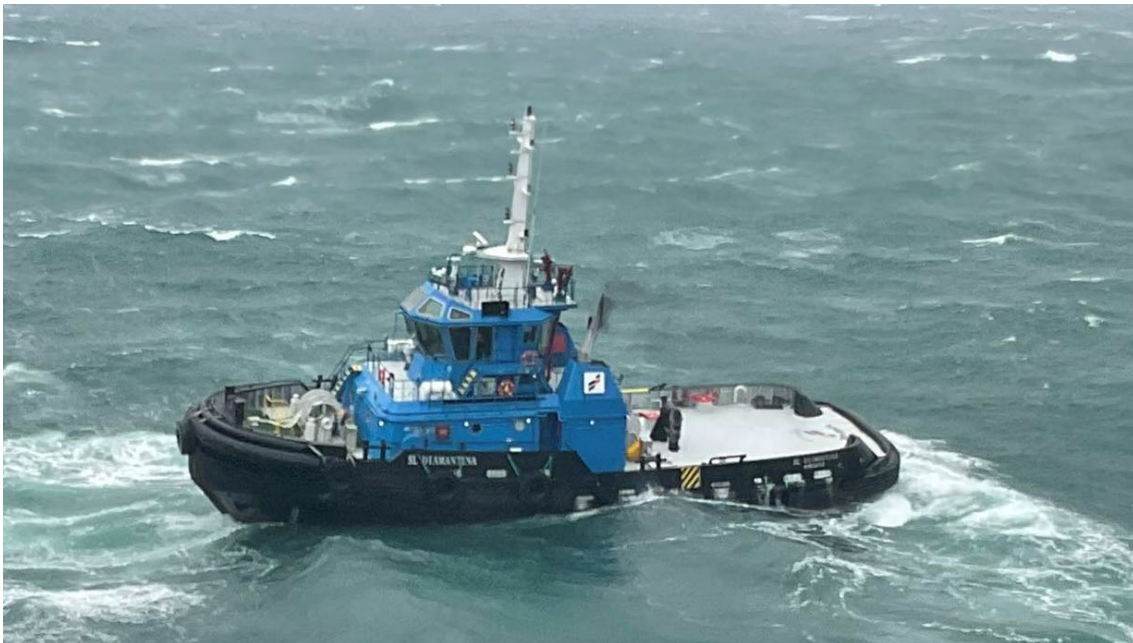
**Figure 21: *SL Diamantina* off the ship on 4 July**

The Port Botany-based *SL Diamantina* (Figure 21) initially deployed on 4 July to assist *Portland Bay* at the request of the Port Authority. It was the first tug to arrive near the anchored ship by which time United Salvage had partnered with Engage Towage for the salvage operation and directed the tug.

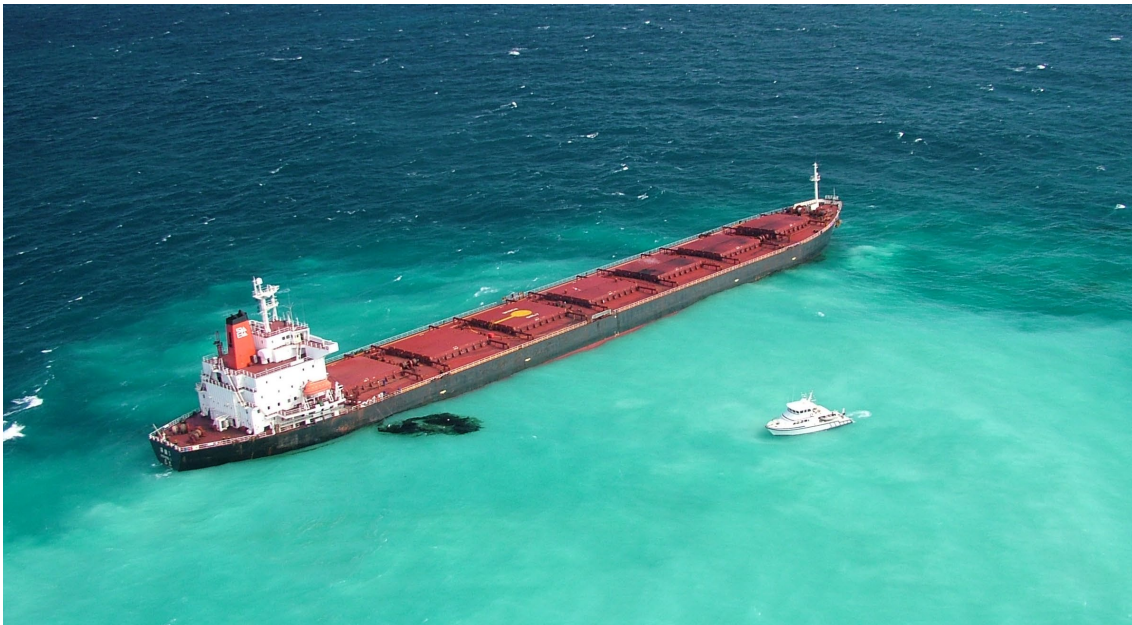
**Figure 23: *Shen Neng 1* stranded on Douglas Shoal, Great Barrier Reef, Queensland**

Since it was developed in 1973, the National Plan has been used to manage numerous casualties and pollution incidents. Since 1991, AMSA has managed the Plan and many incidents, including those that involved *Sanko Harvest* and *Kirki* in 1991, *Era* in 1992, *Iron Baron* in 1994, *Laura D’Amato* in 1999, *Global Peace* in 2006, *Pacific Adventurer* in 2009 and *Shen Neng 1* in 2010. The principal contributing factors to these incidents were different and included hull failure, hull damage and stranding, however all resulted in oil spills. Even relatively limited pollution in an environmentally sensitive area is significant, such as the 4 tonnes spilled from *Shen Neng 1* in the Great Barrier Reef (Figure 23).

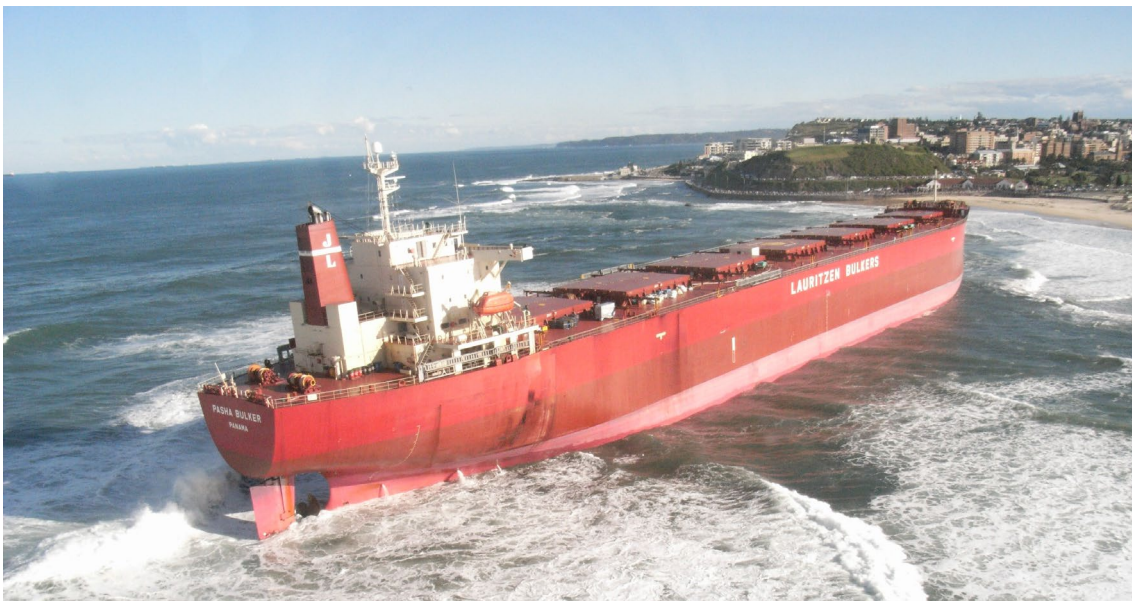
**Figure 24: *Pasha Bulker* stranded on Nobbys Beach, Newcastle, New South Wales**

In 2007, *Pasha Bulker* did not clear the coast in a storm, which drove it on to Nobbys Beach, Newcastle (Figure 24). Two other ships narrowly avoided stranding by resorting to emergency use of their anchors. The salvage operation to refloat *Pasha Bulker* was monitored by AMSA and succeeded after a couple of months. There was no pollution but the incident's location on the beach of a major city made it significant.
