Derailment of freight train Y279

Traveston, Queensland, on 23 February 2022

ATSB Transport Safety Report

RO-2022-003

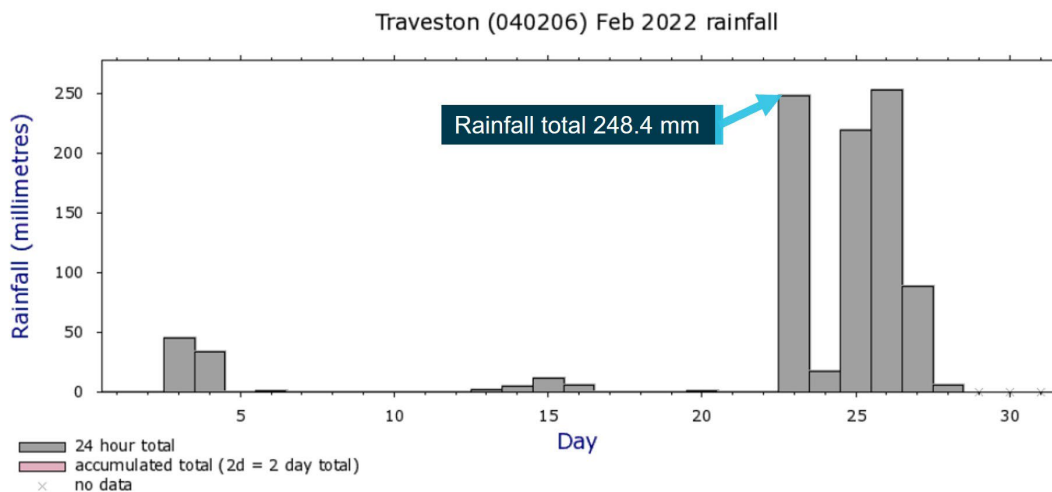
Figure 6: Traveston weather station daily rainfall data

The Traveston weather station (040206), operated by the BoM, was located approximately 570 m north-west of the derailment site. The weather station recorded rainfall data only. During the 24-hour period between 0900 on 22 February 2022 to 0900 on 23 February 2022 it recorded a total rainfall of 248.4 mm (Figure 6).

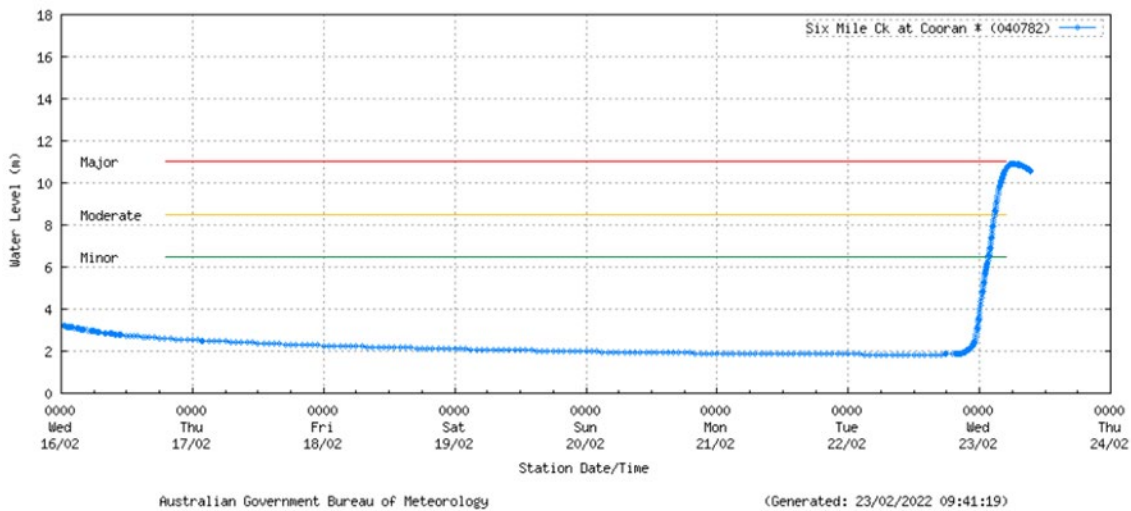
Figure 7: Cooran weather station river height data

For the 24-hour period between 0900 on 22 February 2022 and 0900 on 23 February 2022, a total rainfall of 326 mm was recorded to have fallen. The river height recording for Six Mile Creek recorded rapidly rising water levels with major flooding recorded on the morning of the 23 February 2022 (Figure 7). The river height data reflected the current level, not the accumulated totals over the previous 24 hours as was the rainfall record.

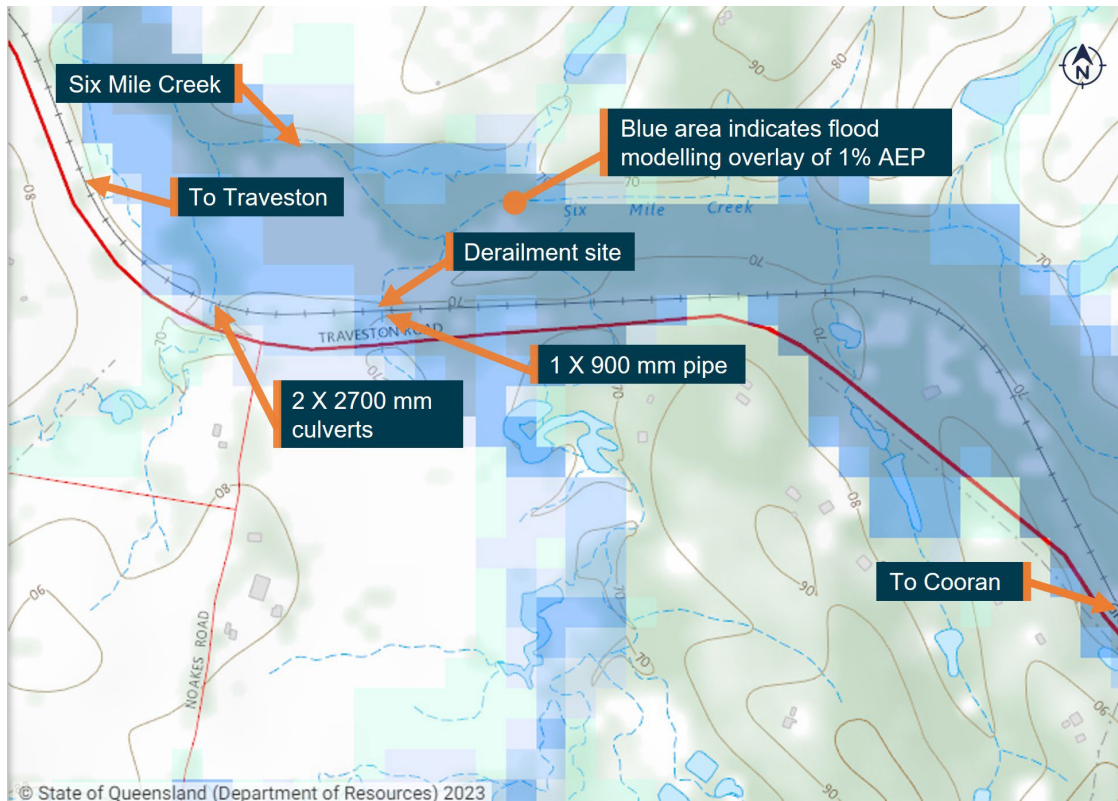
Figure 10: Excerpt from Queensland Government flood check map

The Traveston area was known to be prone to catchment flooding. Historical flood mapping was developed by the Queensland Government to provide a visual representation tool that identified catchments at risk of flooding. The flood hazard overlay map of the catchment around the derailment site identified a flood event risk equivalent to a 1% annual exceedance probability (AEP)⁹ (Figure 10).

Illustration of rainwater catchment and basing level flood modelling for 1% AEP event in the vicinity of the derailment site.
 Source: Queensland Department of Resources, annotated by the ATSB

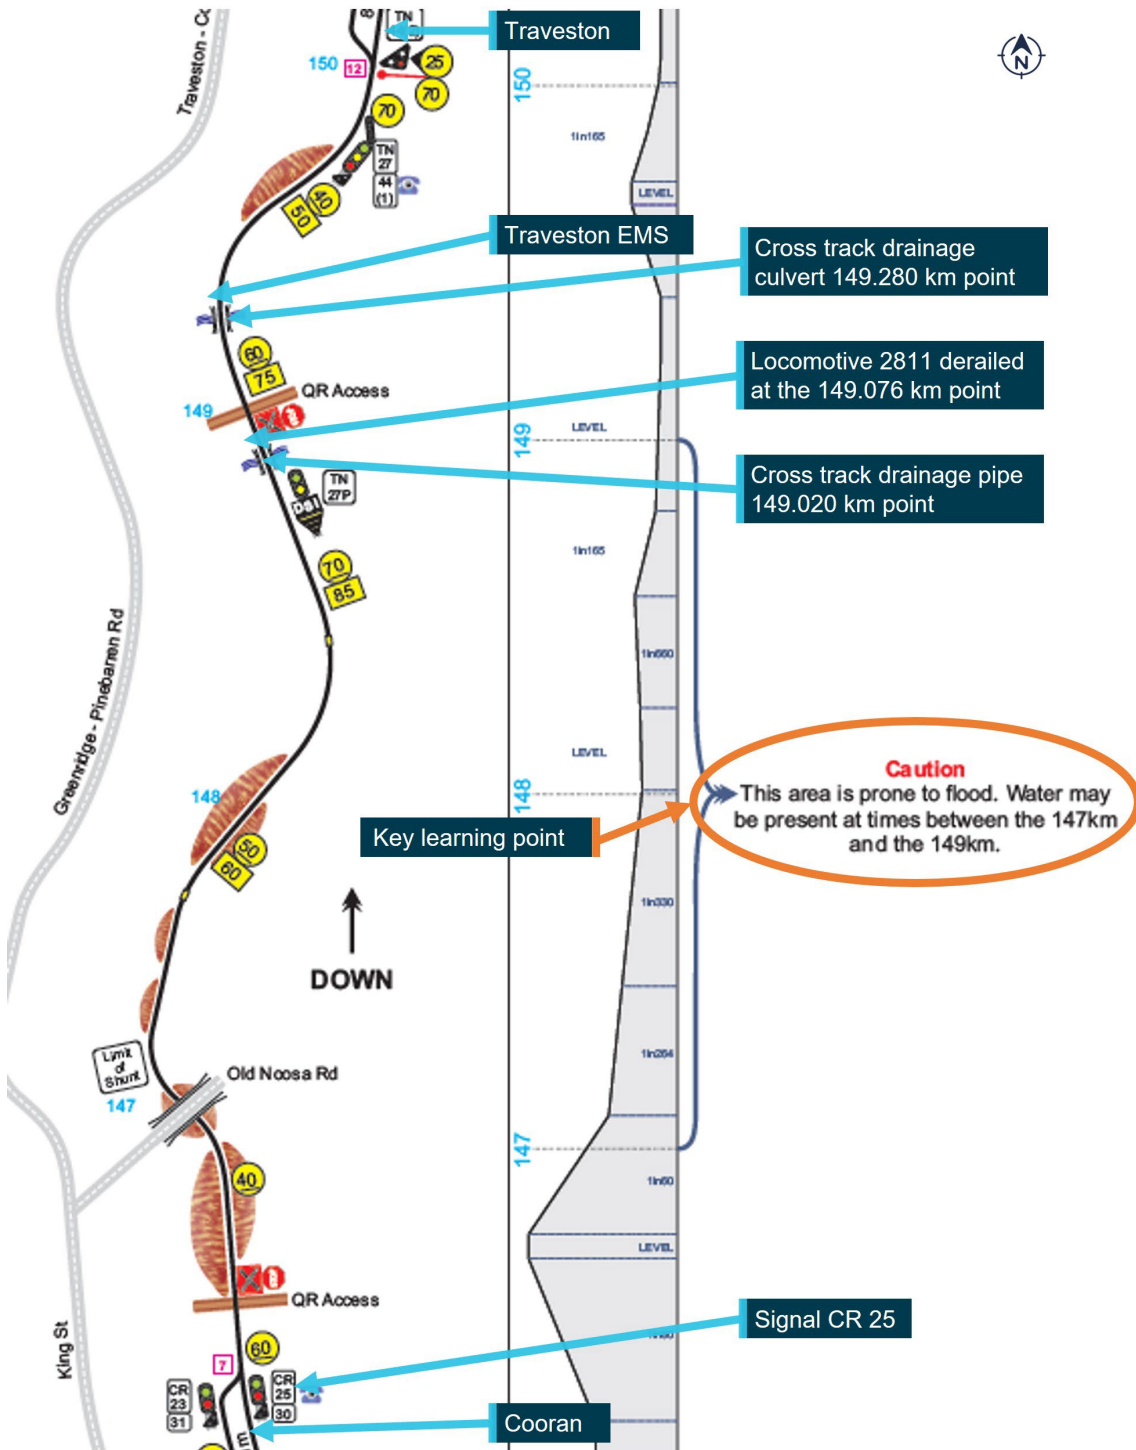
Figure 11: Route map excerpt showing features between Cooran to Traveston

The QR route map reflected the historical flood mapping and identified the track kilometres of a flood hazard area at Traveston. These route maps provided geographical operational information useful to QR personnel, including network control and infrastructure teams, and the operational staff from other rolling stock operators that use the network. Primarily, the route maps were used as a training tool to impart competency-based route knowledge to train drivers, highlighting important information as the key learning point such as the flood-prone area (Figure 11). Figure 11 also shows the position of signal CR25 and the environmental monitoring system (EMS) at Traveston.

The driver of train Y279 was aware of the flood-prone area.

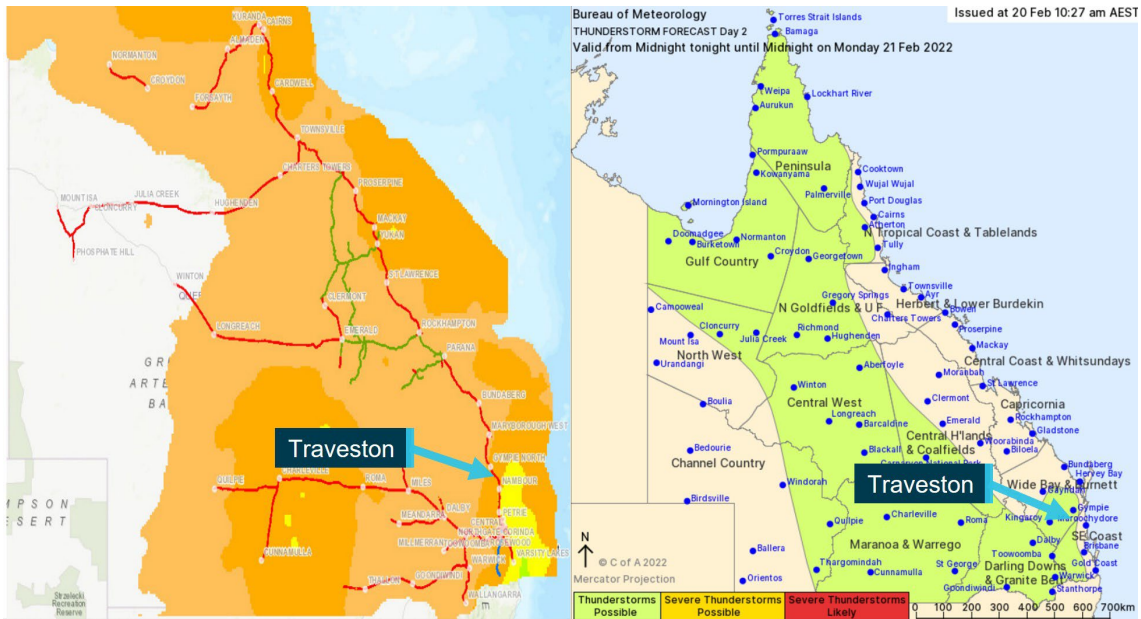
Figure 12: Excerpt from weather forecast summary

The forecast noted that thunderstorms were possible across the interior, southern and northern areas of Queensland on the Monday with a very slight chance of severe thunderstorm activity through the southern interior (Figure 12).

Excerpts from weather forecast summary. Left image shows 1 to 10 mm rainfall forecast in the Traveston area. Right image indicates thunderstorms were possible.
Source: Queensland Rail, annotated by the ATSB

The information on flooding did not relate to the area around Traveston. The summary included a caution, noting that conditions could change without warning and recipients were advised to continue monitoring the My GEO application and the BoM website.

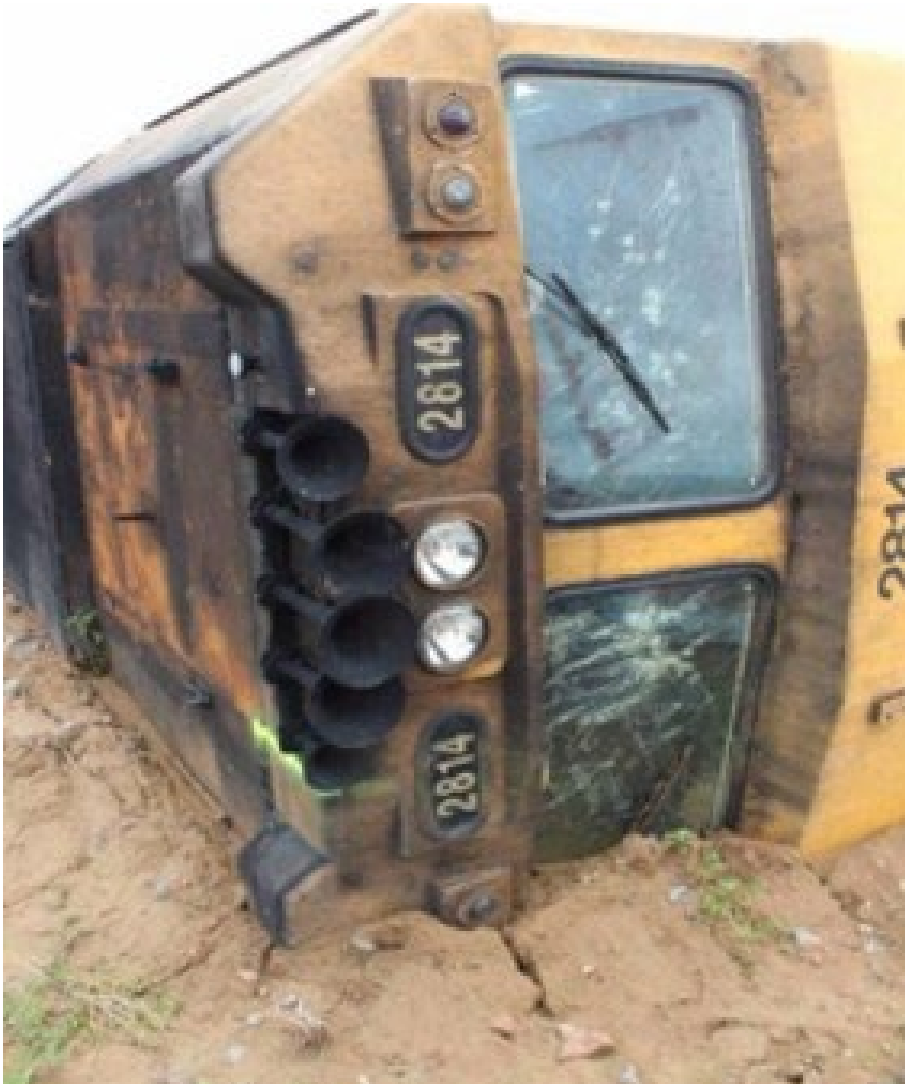
Figure 15: Excerpt from Aurizon guideline showing windscreen damage from repeated strikes from the window hammer

The following diagram (Figure 15) was included to illustrate where the windscreen was not designed as an alternative exit.
