# **Collision with terrain involving Air Tractor AT-502, VH-AQW**

17 km south-west of Bourke Airport, New South Wales, on 10 February 2024

## **ATSB Transport Safety Report**

AO-2024-005

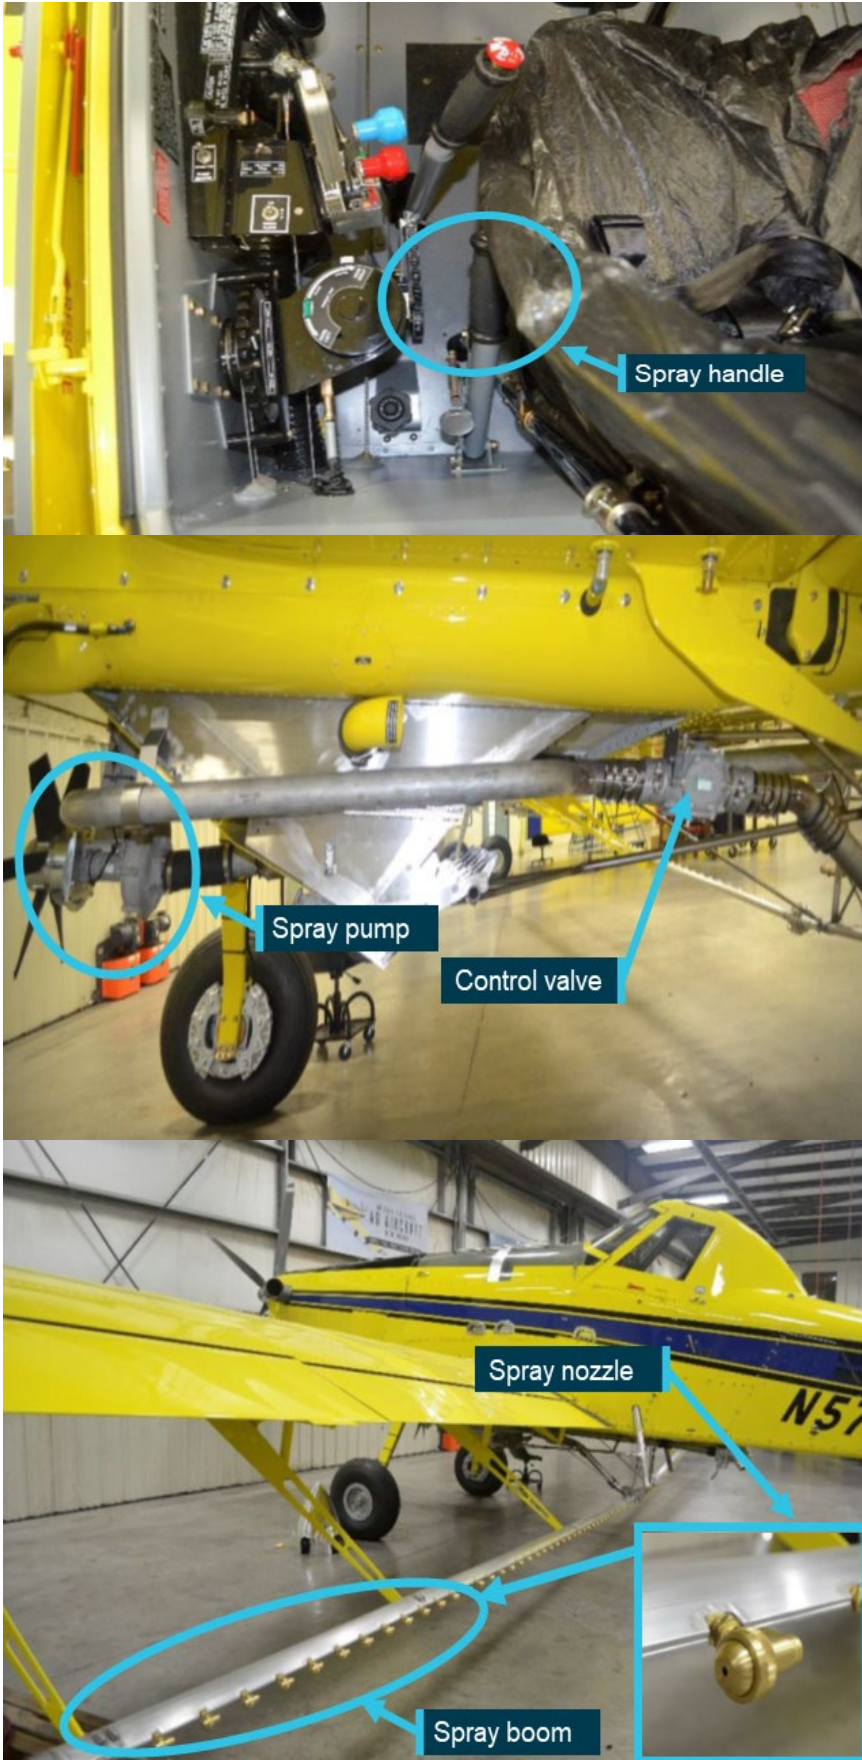
Figure 3: Spray handle (top), spray pump and control valve (middle), and spray boom (bottom) on an exemplar aircraft

All Air Tractor aircraft were fitted with a spray dispersal system at the time of production. To activate the dispersal system, the pilot switched on the spray pump from the cockpit (Figure 2) and moved the spray handle down to release the load from the hopper (Figure 3). This movement opened the control valve. The hopper contents, driven by the spray pump under the aircraft, would then be dispersed through the spray nozzles on the spray boom mounted under each wing (Figure 3). Additionally, a flow controller system, including a flow meter, was installed on the spray boom as part of the Satloc system (Figure 4). This allowed for spray flow information to be displayed in the cockpit, on the Satloc screen or light bar (refer to section titled *Recorded data*).
