# Ground strike involving British Aerospace BAe 146-300, VH-SAJ

Brisbane Airport, Queensland, on 25 June 2024

## ATSB Transport Safety Report

AO-2024-036

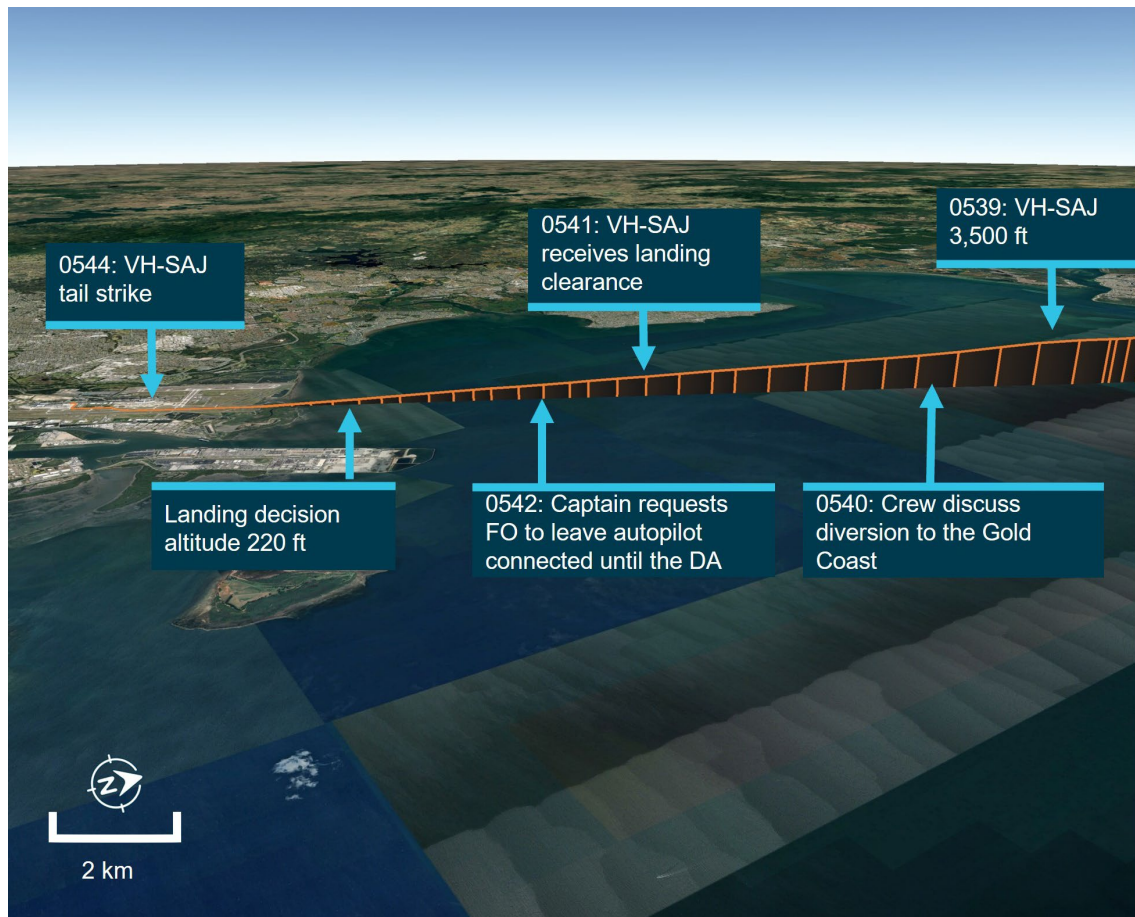
**Figure 2: VH-SAJ final approach to Brisbane Airport**

At 0541:45, the crew were provided with a landing clearance from ATC (Figure 2) and were advised that the runway visual range<sup>9</sup> was 1,200 m at the touchdown zone, 1,200 m at the runway mid-point and 1,800 m at the end point of the runway.
