# **Crew injuries during maintenance involving oil tanker, *Wisdom Venture***

About 60 km east of Sydney, New South Wales, on 6 May 2025

MO-2025-004

Final – 26 September 2025

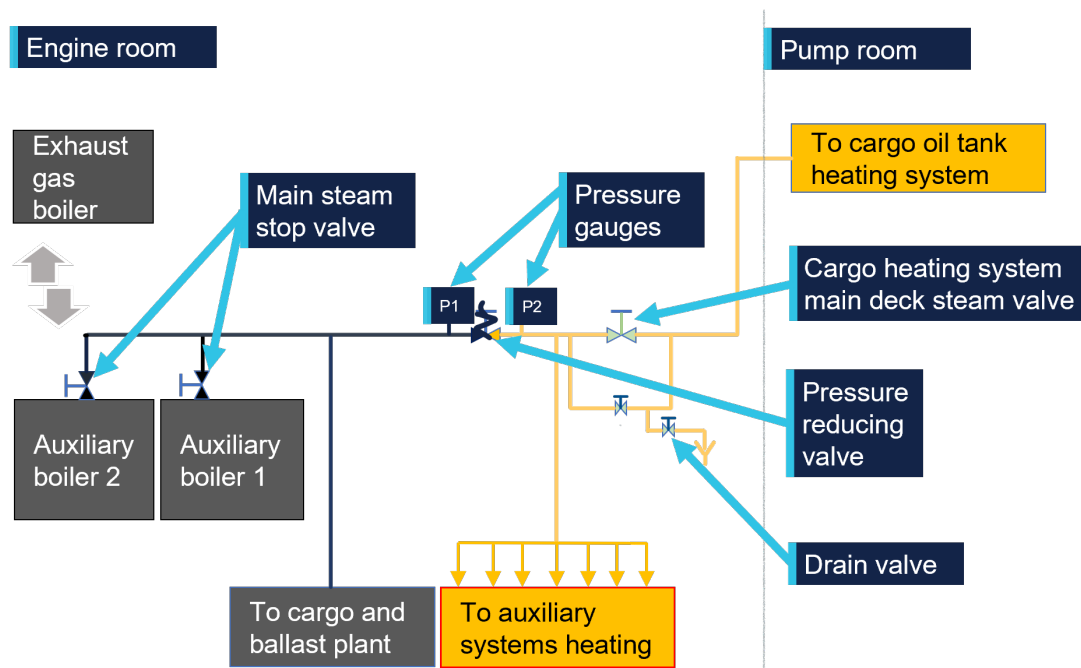
**Figure 1: Simplified diagram representing the steam system**

Low pressure steam passed through the main deck steam valve (Figure 1 and Figure 2), the last valve in the steam line in the engine room, which led to the deck and the cargo heating system. This valve was the main steam isolation valve for the cargo heating system. It was closed when cargo heating was not required and played a critical role in making sure the system could be safely shut down for maintenance and isolating the deck heating system during emergencies.
