# Loss of control and collision with terrain involving Cirrus SR22, VH-MSF

near Gundaroo, New South Wales, on 6 October 2023

Aviation Occurrence Investigation (Defined)

AO-2023-045

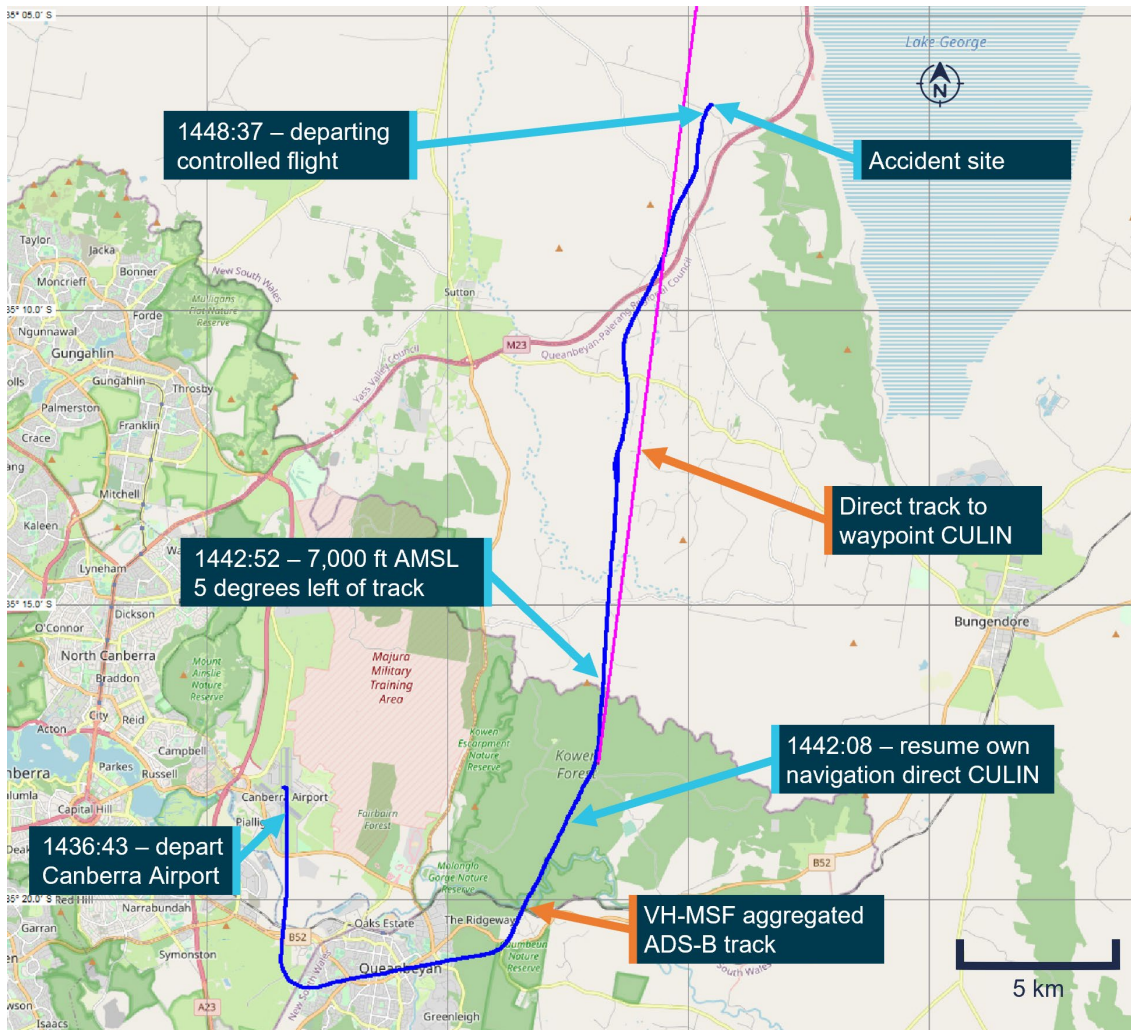
**Figure 1: Ground track of VH-MSF (in blue) from take-off to the accident site**

Figure 1 illustrates the ground track of the aircraft departing Canberra while assigned radar vectors and the direct track to CULIN.

The aircraft ground track overlaid on this map is referenced to a latitude and longitude grid aligned to true north. The headings assigned by air traffic control are referenced to magnetic north. In the Canberra region, magnetic north is about 12° less than true north. An aircraft's ground track relevant to the assigned heading can also be affected by wind.  
 Source: [OpenStreetMap](https://www.openstreetmap.org/) with ADS-B data from Airservices Australia and aggregated ADS-B data from FlyRealTraffic.com, annotated by the ATSB

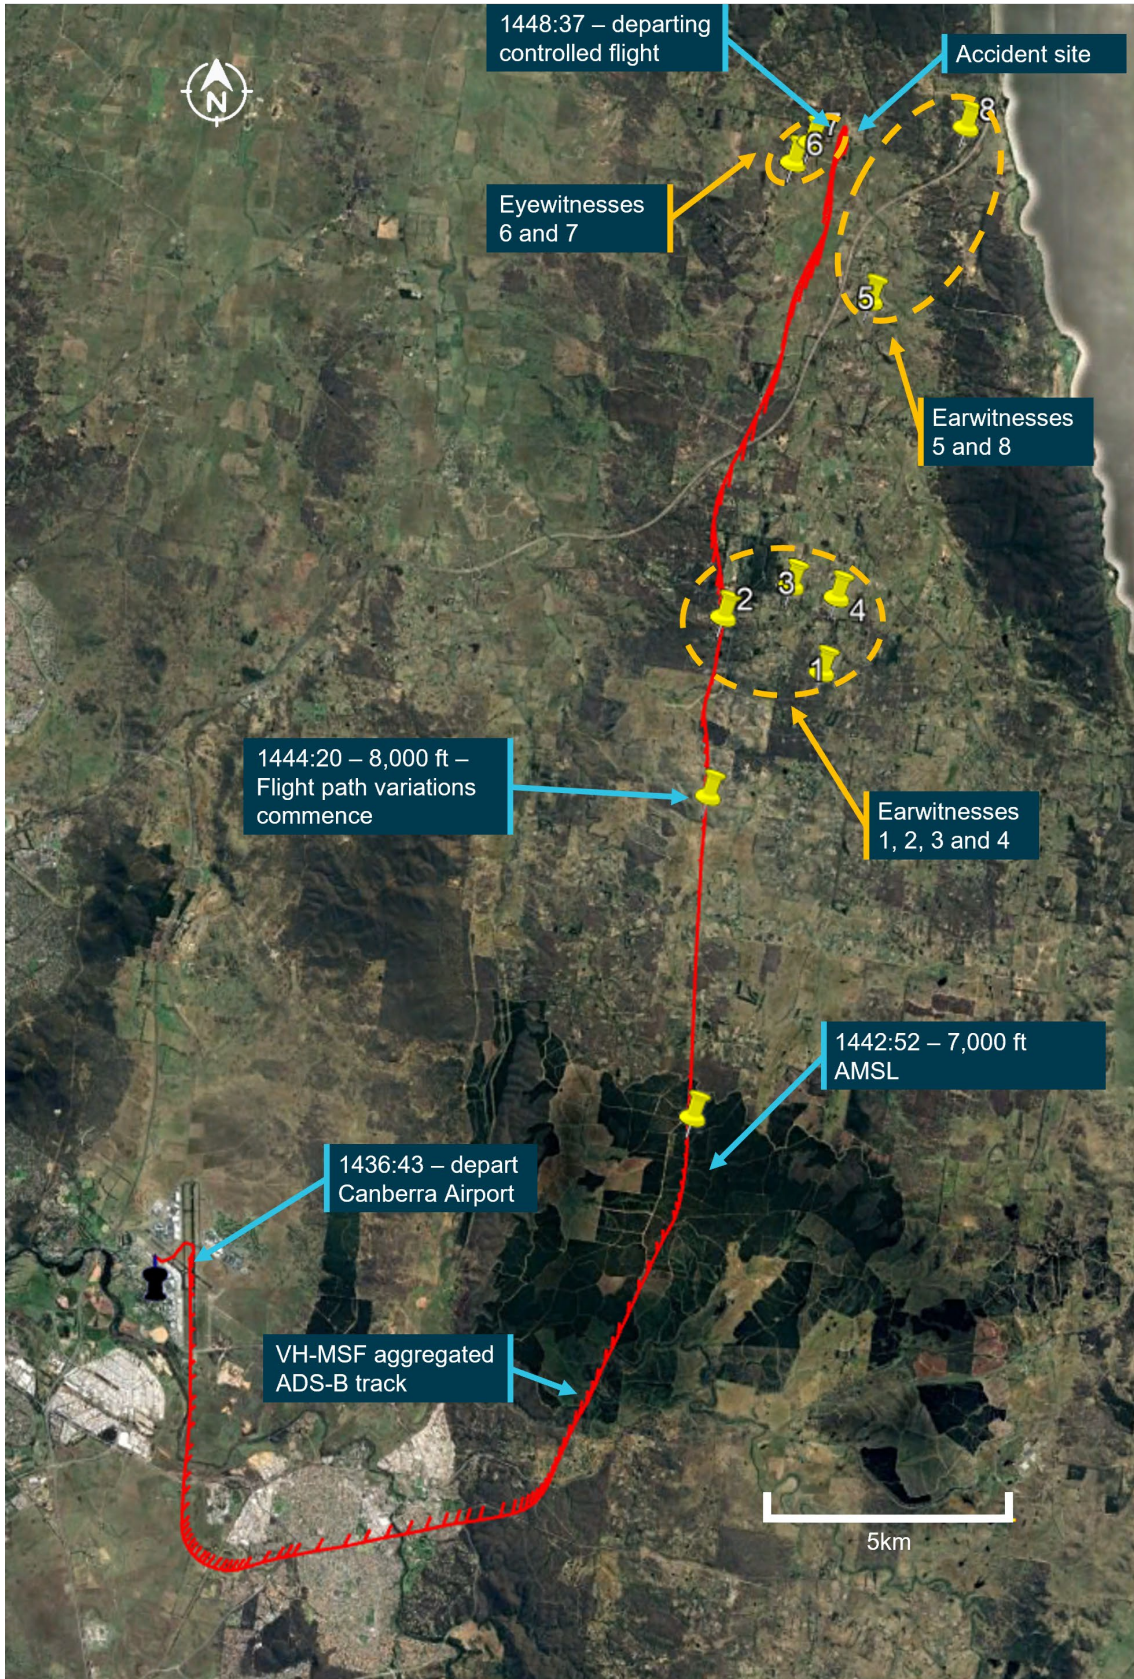
Figure 2: Aircraft flight path with ear and eyewitnesses' locations

Figure 2 and Table 1 show the witness locations and observations along the aircraft's flight path; earwitnesses reported hearing aircraft engine noises and 2 eyewitnesses reported seeing the aircraft in its final moments before the impact with terrain.

Figure 2 shows the aircraft flight track, and the location of each ear/eyewitnesses summarised in Table 1.

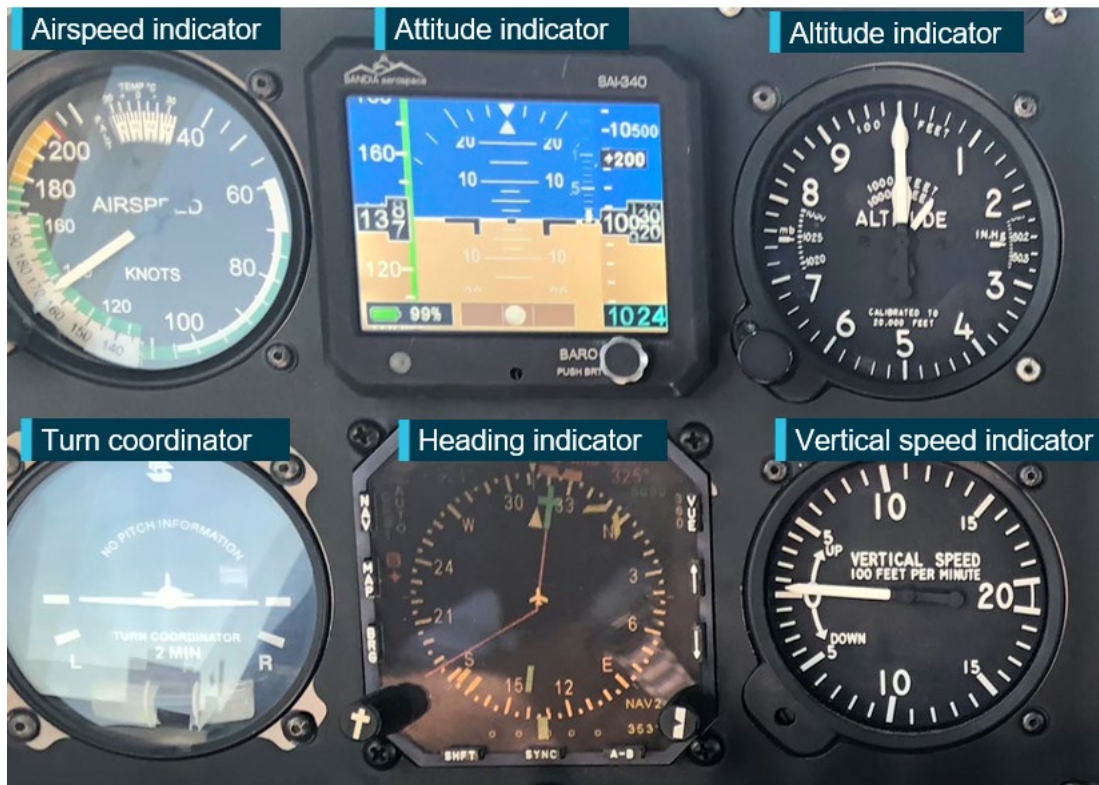
Figure 4: VH-MSF flight instruments with Sandia attitude indicator top centre

There were 6 primary flight instruments fitted to the aircraft. They were the airspeed indicator, attitude indicator, altitude indicator, turn coordinator, heading indicator, and vertical speed indicator (Figure 4). The aircraft was fitted with a Sandia SAI-340 model attitude indicator, which also incorporated airspeed, altitude and slip indicators. The unit contained a rechargeable battery capable of providing continued operation in the event of aircraft electrical failure. Maintenance documentation showed that the attitude indicator had been replaced in 2018 with a repaired model that had a software upgrade to include the addition of a vertical speed function.

The United States Federal Aviation Administration issued an emergency airworthiness directive (AD), AD-2020-18-51, for Sandia attitude indicators in 2020. That directive stated the applicability as being for Sandia attitude indicator part number 306171-10 and 306171-20. These attitude indicators may be marked as Bendix King Model KI-300 or Sandia Model SAI-340A. They may be installed on aircraft certificated in any category. It also stated that the AD was prompted by reports of 54 failed attitude indicators, which produced erroneous attitude data to the pilot and autopilot, if equipped. The FAA issued the AD to prevent aeronautical decision-making based on erroneous attitude information, which may result in loss of control of the aircraft.

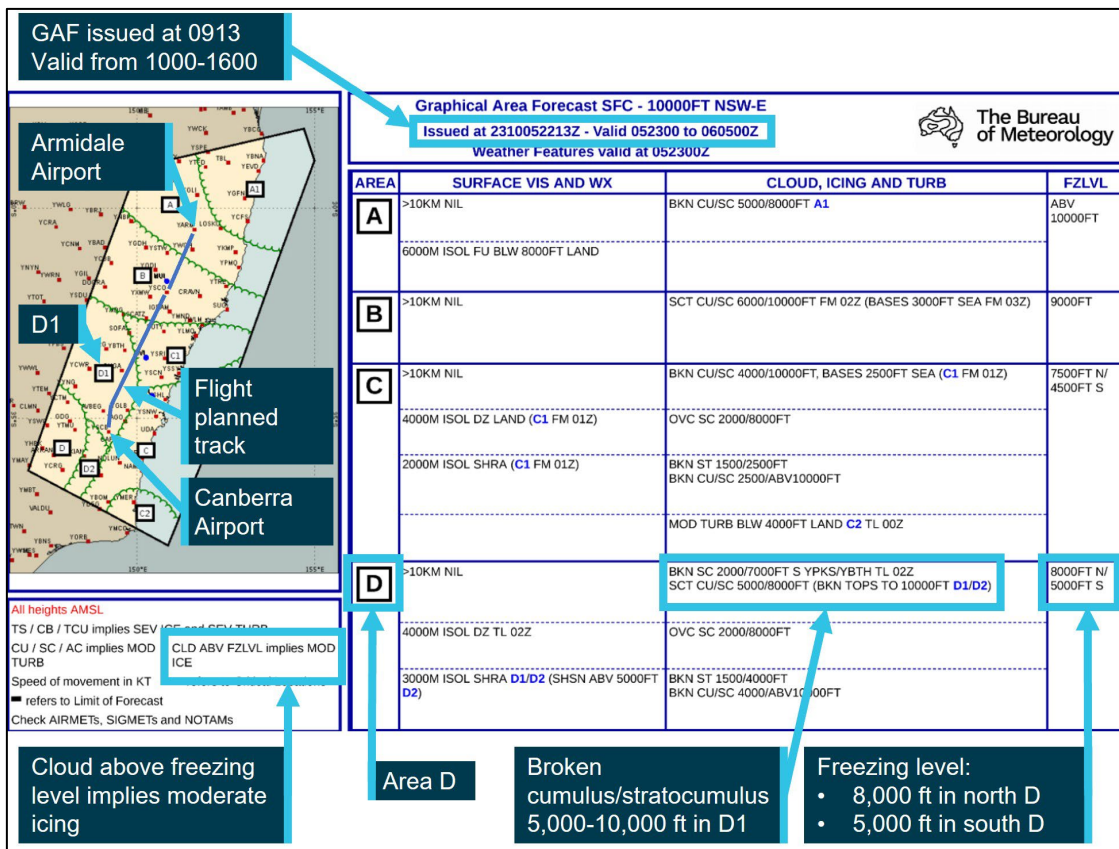
Figure 6: Graphical area forecast for New South Wales – East

The estimated freezing level of 7,000 ft at Canberra and forecast broken cumulus/stratocumulus from 5,000 ft to 10,000 ft indicated the forecast depth of the icing layer overhead Canberra had increased to 3,000 ft. Figure 6 depicts the NSW-E GAF, current at the time of the pilot’s last NAIPS area briefing request. Information relevant to the flight is labelled and highlighted. This forecast included a freezing level of 9,000 ft for the area containing Scone (area B) and a freezing level of above 10,000 ft for the area containing the destination of Armidale (area A).

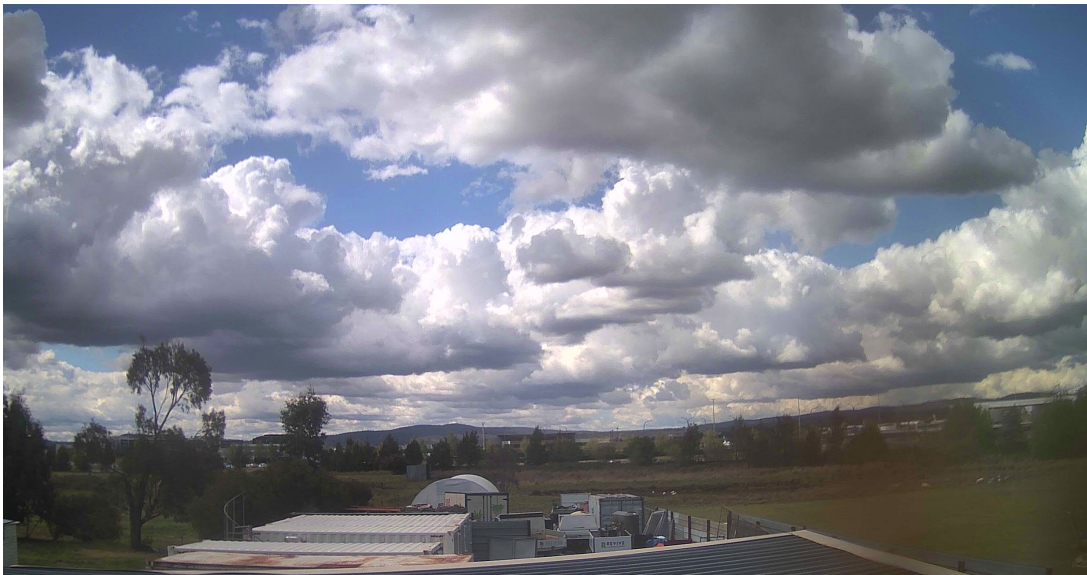
**Figure 7: Footage taken near Canberra Airport with a north-north-east aspect at 1439**

A fixed camera was located about 1.3 km to the west of Canberra Airport showing an aspect to the north-north-east. The footage, coupled with other stills taken around the time the aircraft took off to the south and then tracked to the north-north-east, showed broken cumulus/stratocumulus cloud as per the forecast (Figure 7, taken at 1439).

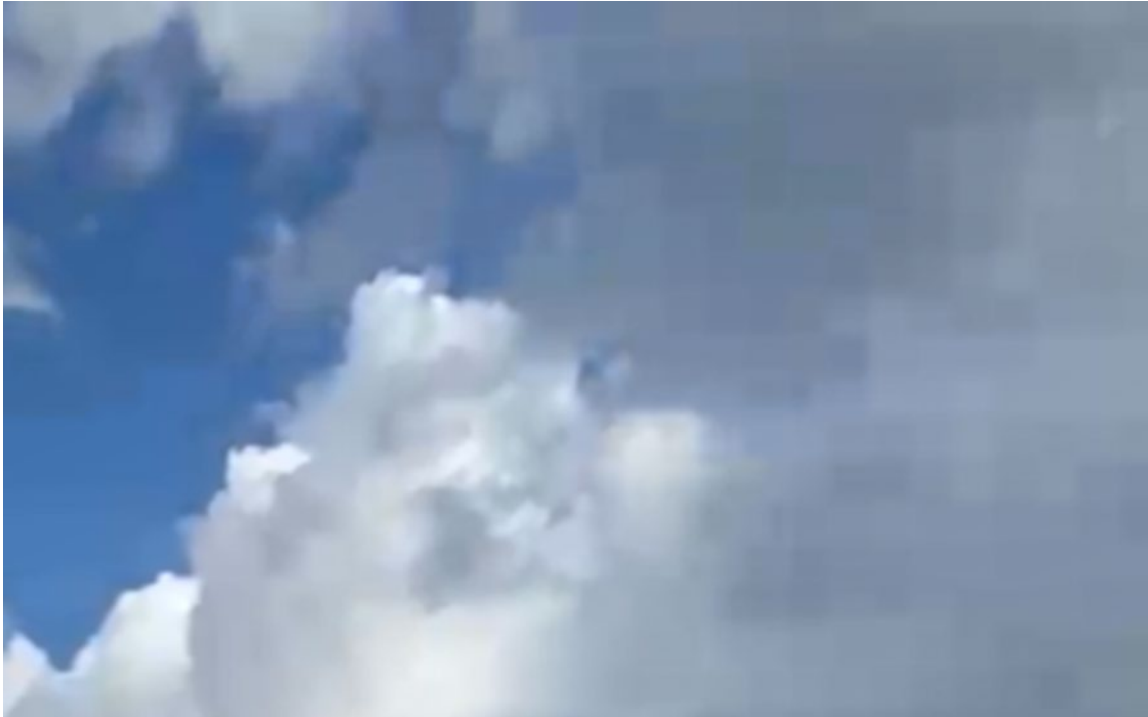
**Figure 8: Video image taken shortly after the accident viewed to the south-west**

Shortly after the accident occurred, first responders took a video around the aircraft in the hope that it could assist with the investigation into the accident. Consistent with the forecast, that video showed broken cloud overhead the accident site to the south-west, which was the direction the aircraft had come from (Figure 8).

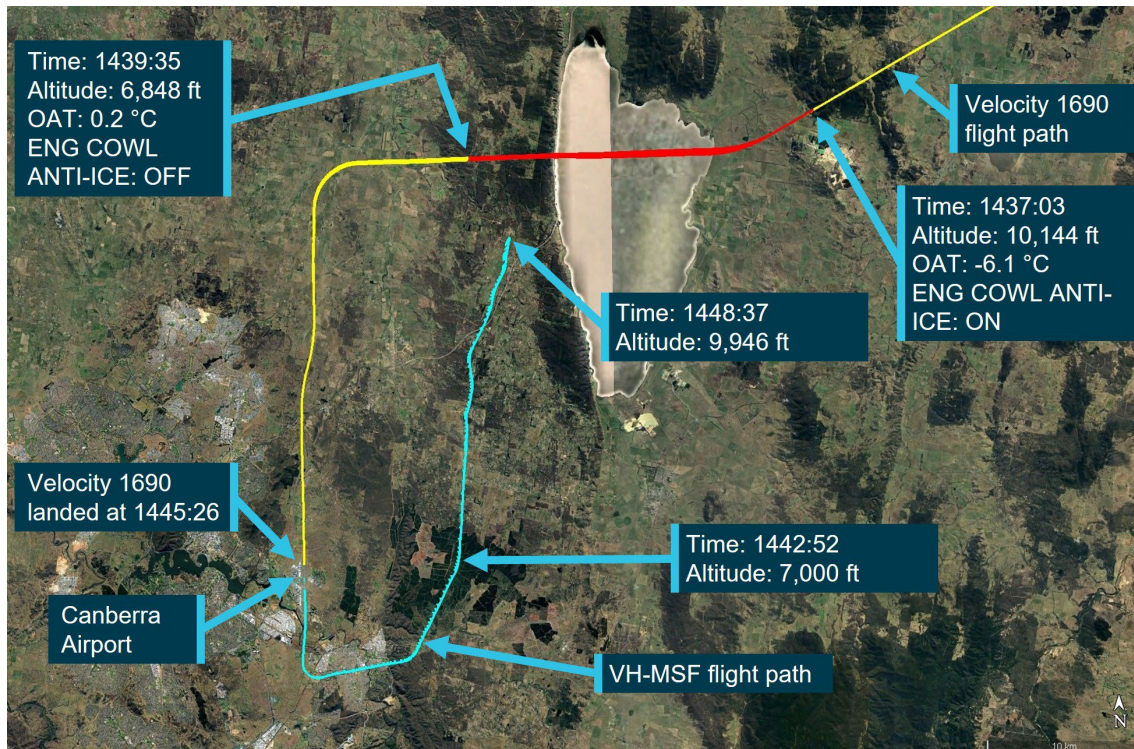
**Figure 9: Relative positions of Velocity 1690 and VH-MSF**

Velocity 1690 was being operated on a flight from the Gold Coast, Queensland, to Canberra with a landing time of 1445:26, about 4 minutes prior to the accident. Runway 17 was the active runway and Velocity 1690 approached Canberra from the north. On descent, at 1437:03, the aircraft data recorded the engine anti-icing system (ENG COWL ANTI-ICE) being turned on by the flight crew at an altitude of 10,144 ft and an outside air temperature (OAT) of  $-6.2^{\circ}\text{C}$  ( $6^{\circ}\text{C}$  total air temperature (TAT)).<sup>16</sup> The operator reported that the flight crew could not provide a detailed recollection of the approach but that the selection of the anti-ice would be consistent with the aircraft in cloud above the freezing level during the descent. At 1439:35, the flight crew turned the engine anti-icing off at 6,848 ft and an OAT of  $0.2^{\circ}\text{C}$  ( $10.5^{\circ}\text{C}$  TAT). Figure 9 depicts the approach flight path of Velocity 1690 with the times, altitudes and temperatures when the engine anti-icing was turned on and off. The flight path of VH-MSF includes the positions that corresponded with the altitude band (shown in red) in which Velocity 1690 used engine anti-icing.

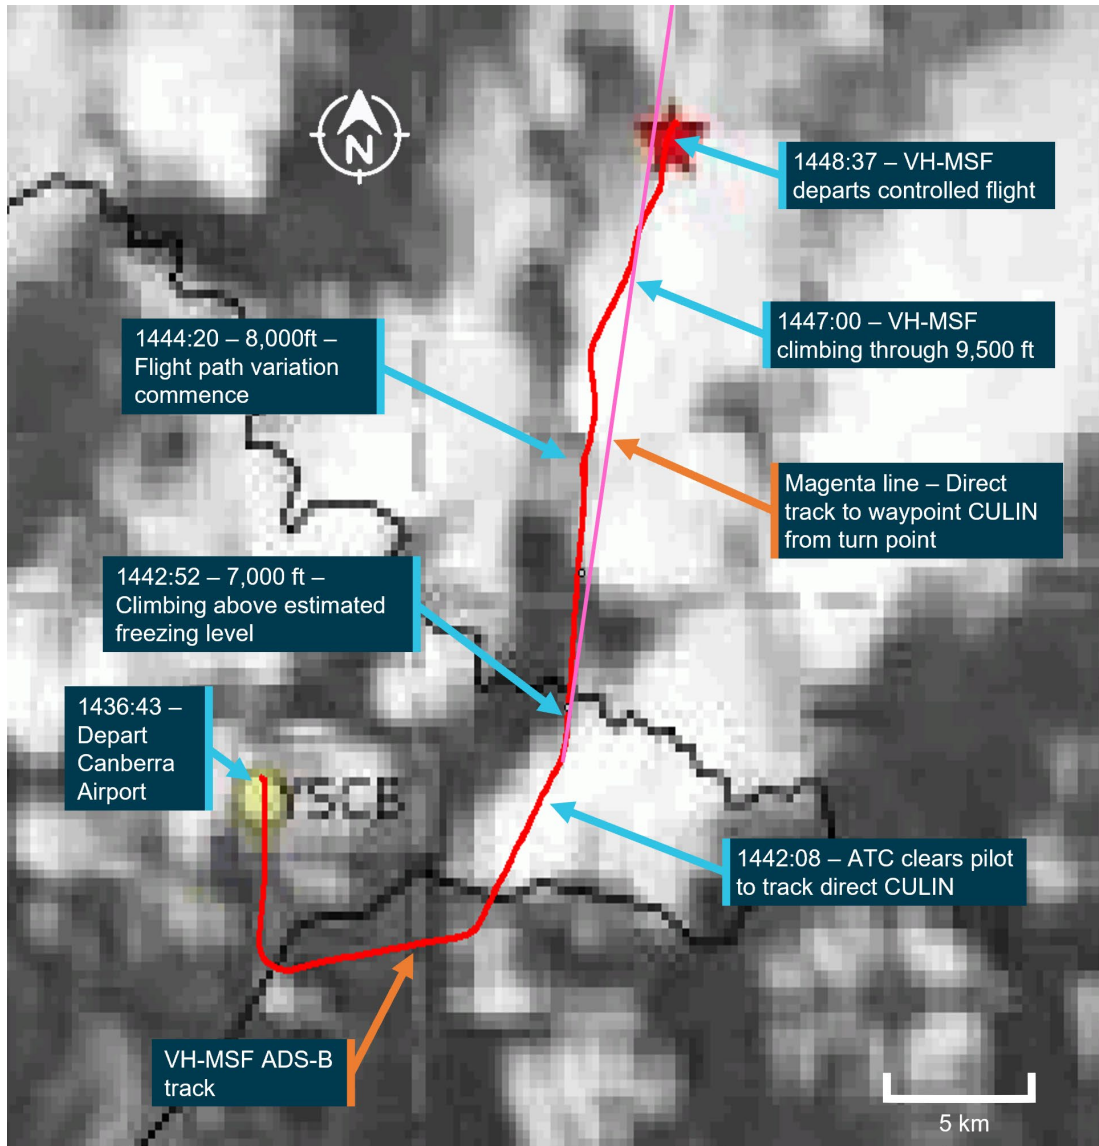
Figure 10: VH-MSF track (in red) overlaid on an enhanced visible satellite image, taken close to the time of the accident

Figure 10 is the enhanced visible satellite image showing cloud coverage for the Canberra region for the 10-minute acquisition period commencing 1440, which was the closest image relative to the time of the accident. The areas of cloud are represented by the lighter pixels, where the darker pixels are areas without (or with less) cloud coverage. This image is overlaid with VH-MSF's flight track, the direct track to waypoint CULIN, the estimated position and time the aircraft climbed through the 0°C estimated freezing level (at about 14:43 and 7,000 ft).<sup>17</sup> It also showed the aircraft's position at 8,000 ft where flight path variations commence in relation to cloud coverage.

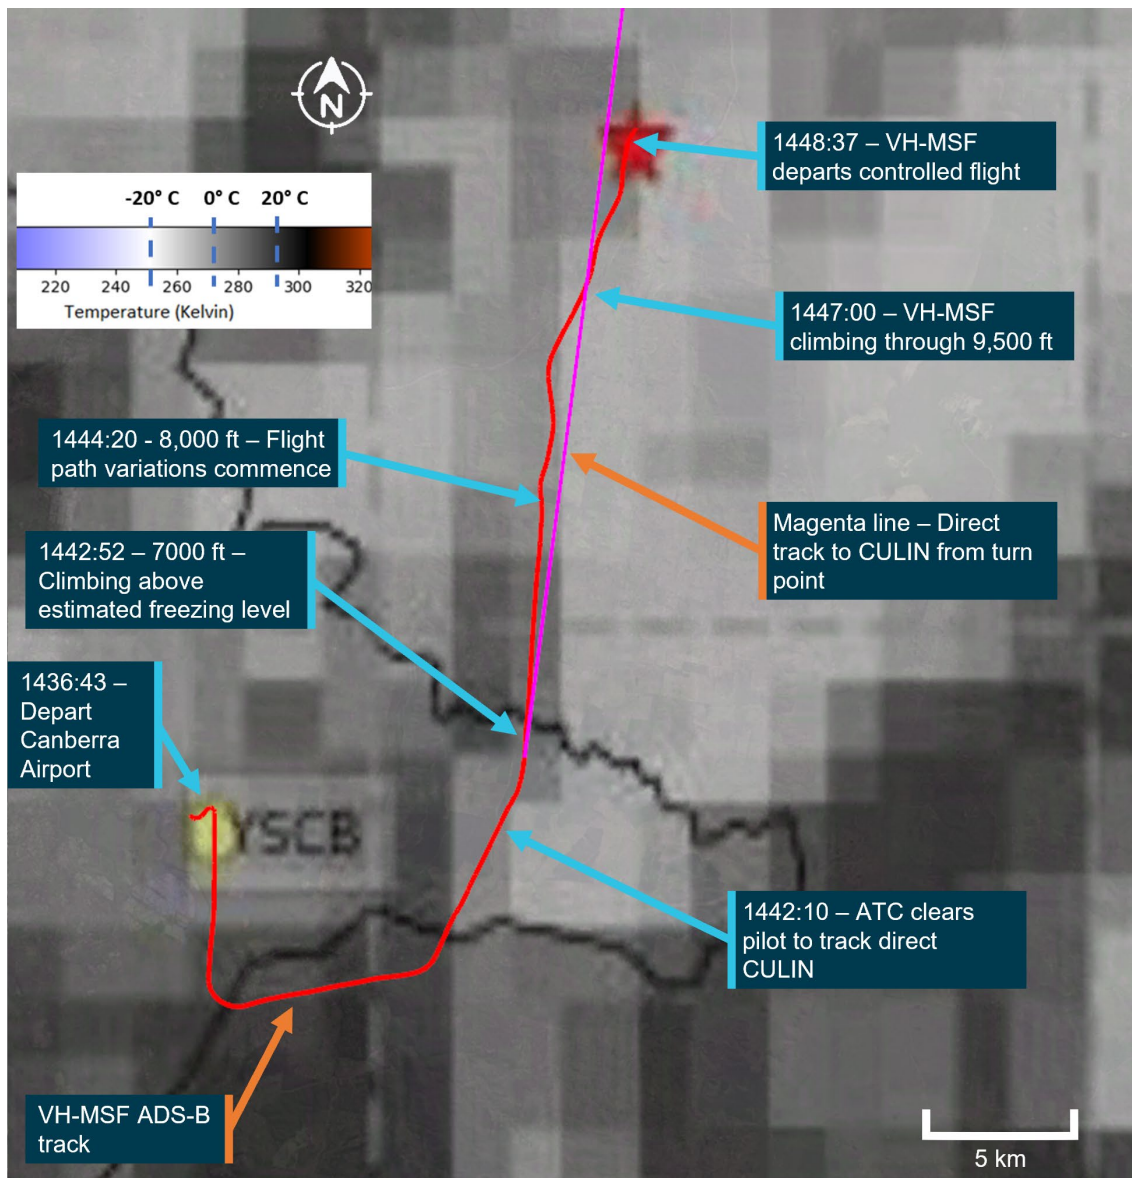
**Figure 11: VH-MSF track overlaid on RGB infrared enhancement image, taken close to the time of the accident**

Figure 11 shows a temperature scale, the flight path, times and altitudes with the position of the aircraft at an estimated freezing level of 7,000 ft. It also shows the point at which the aircraft flight path variations commence and the lighter grey areas indicating cloud tops at 10,000 ft. Based on the infrared image, it was considered likely that the aircraft entered cloud above the freezing level. However, the exact amount of time the aircraft spent in cloud could not be determined.

The infrared imagery for VH-MSF (Figure 11) was compared with the imagery applicable to the Boeing 737-800 (acquisition period commencing 1430) and the corresponding altitude and temperature data for when this aircraft likely entered cloud during descent into Canberra. This indicated that the lightest coloured pixels in the image represented

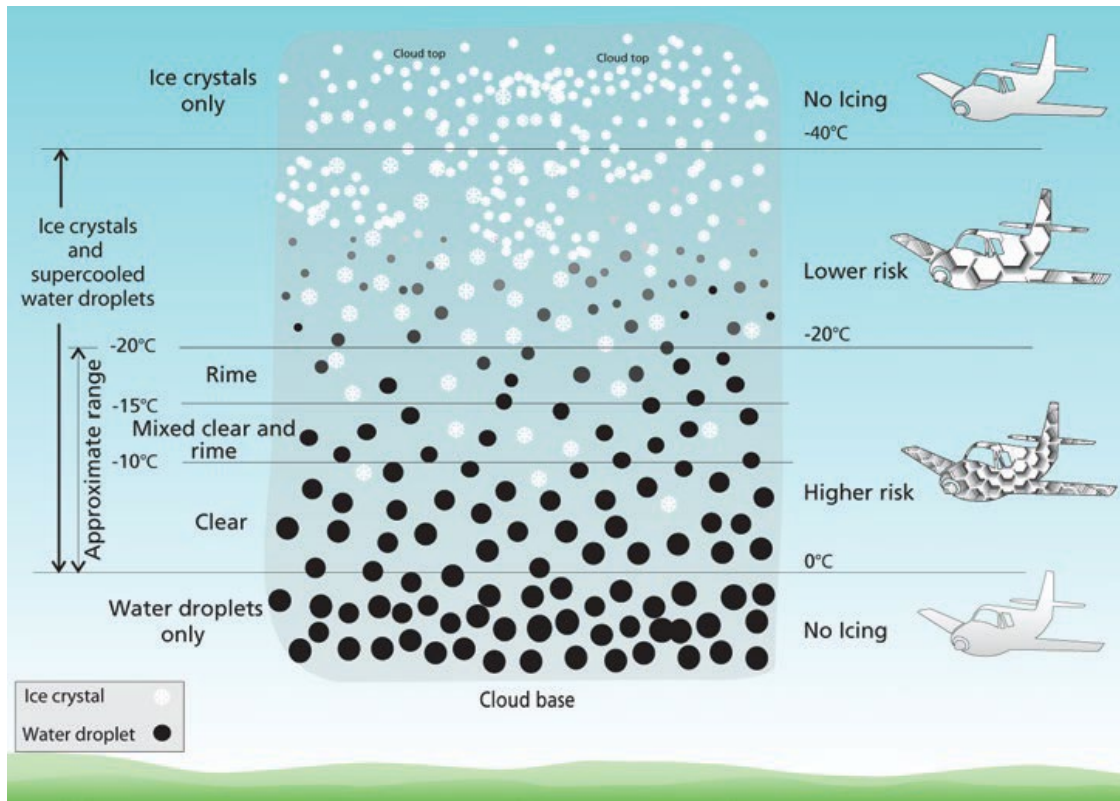
Figure 22: Icing environment depiction

The Bureau of Meteorology aviation weather services brochure titled *Hazardous Weather Phenomena – Airframe Icing* has informative content for pilots. Included in that brochure was a depiction of the icing environment and the various levels of icing risk based on temperature and water content. As shown in the icing environment depiction (Figure 22), aircraft operating within the 0 to -10°C higher risk range if/when in cloud could experience clear ice conditions.

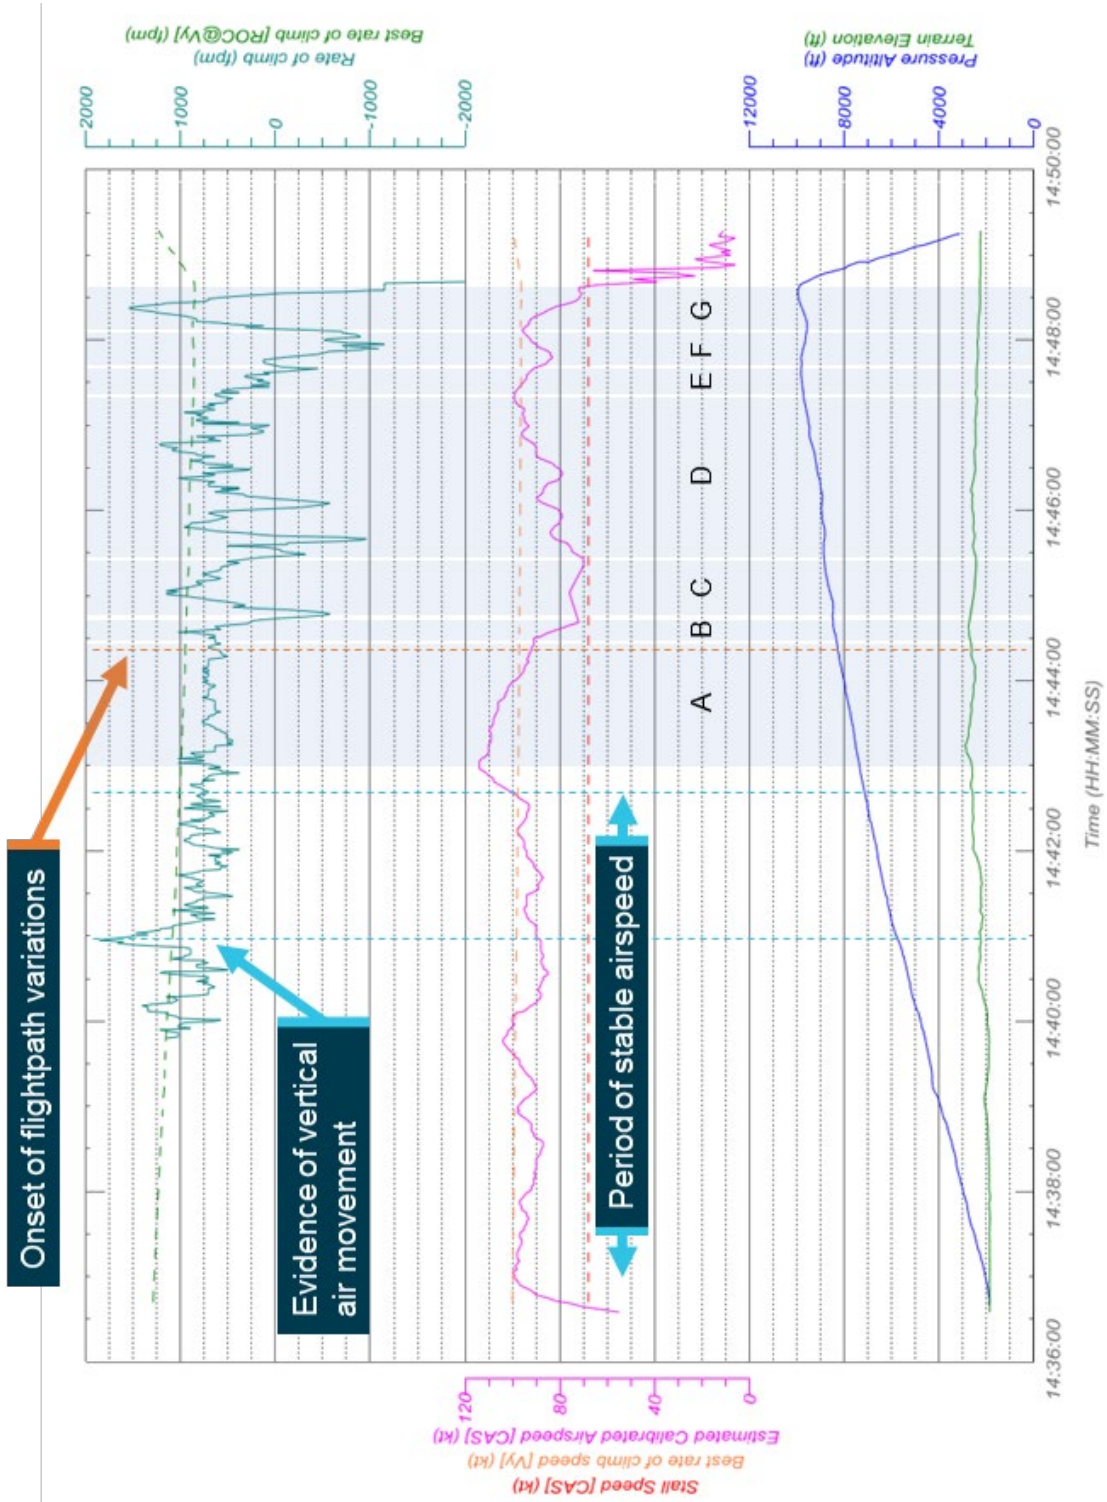
VH-MSF aggregated ADS-B altitude data for the accident flight, together with the estimated airspeed.

This image depicts selected ADS-B data and derived estimates of calibrated airspeed and altitude for VH-MSF during the accident flight. The airspeed has been estimated using data from a Boeing 737 descending into Canberra, Australian Capital Territory, a short time prior to the accident.
