# Runway excursion involving Cessna 510, VH-SQY

Bankstown Airport, New South Wales, on 11 January 2025

## **ATSB Transport Safety Report**

AO-2025-002

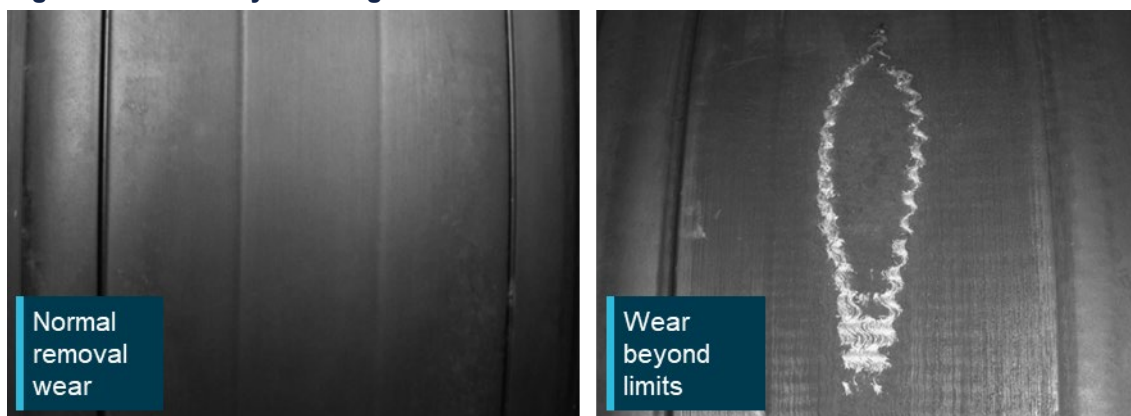
**Figure 3: Michelin tyre wear guidance**

The tyre manufacturer provided guidance on tyre removal criteria (Figure 3) which stated:

Removal criteria for normal wear is based on remaining tread rubber as determined by groove depth or exposure of textile/steel ply material...

**NORMAL REMOVAL WEAR LIMIT:** Remove the tire when the wear level reaches the bottom of any groove at one point up to a maximum 1/8 of the circumference.

**NOTE:** When the NORMAL REMOVAL limit is reached, the tire should be replaced. If it is necessary to continue the tire in service beyond the normal wear limit, the tire should be removed either at the next maintenance base or upon reaching the EXPOSED CORD LIMIT, whichever occurs first. At the EXPOSED CORD LIMIT the tire should be removed and replaced.

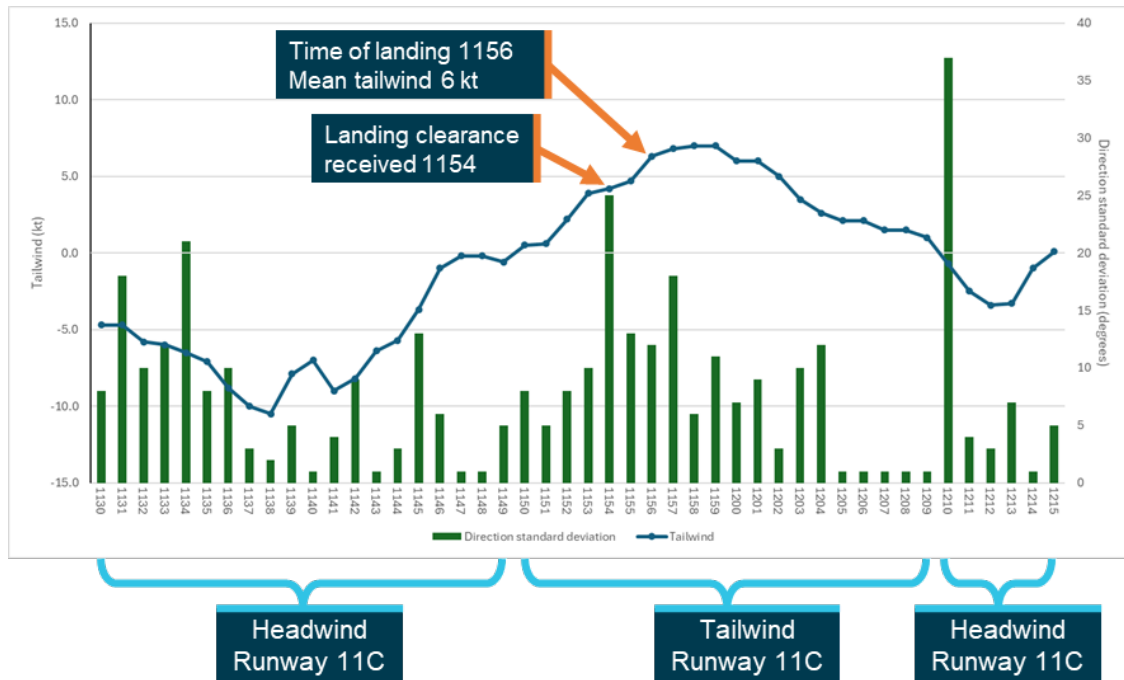
**Figure 5: Runway 11C mean tailwind and wind direction variability 1130–1215**

The mean wind direction varied significantly between 1130–1215 (Figure 5). The recorded wind changed from a headwind to a tailwind on runway 11C, 6 minutes prior to VH-SQY landing. However, at around this time, the variability of the wind direction increased. At the time of the landing, the mean wind was recorded as a 6 kt tailwind. Subsequently, the tailwind further increased slightly before decreasing again, becoming a headwind again 14 minutes after the landing.

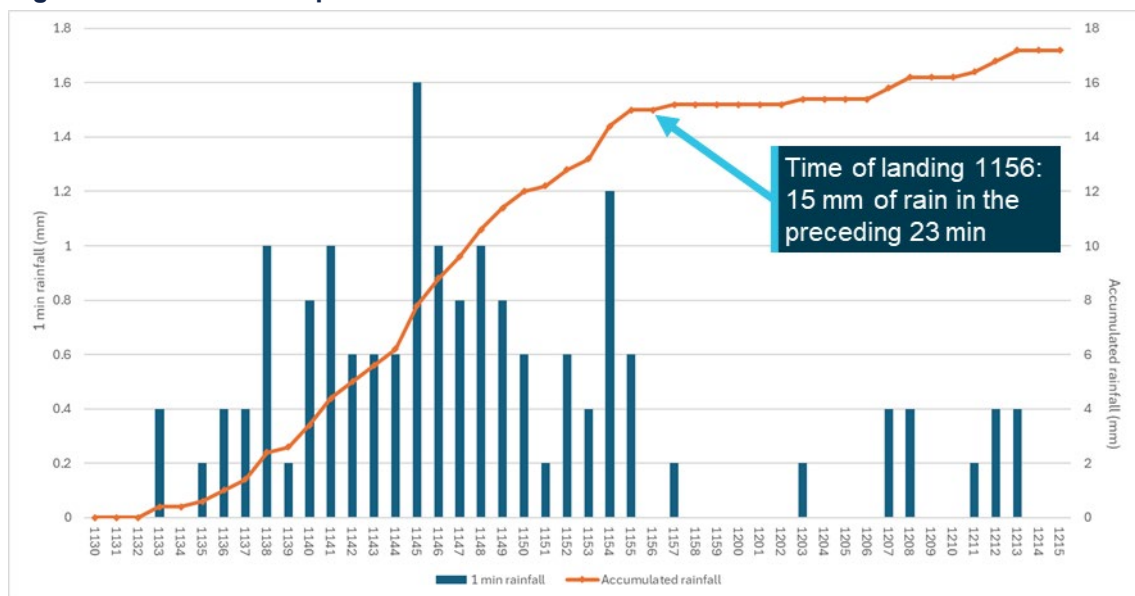
**Figure 6: Bankstown Airport recorded rainfall 1130–1215**

BoM observations recorded that Bankstown Airport received 2.8 mm of rain from 0900–1130 that morning. At 1133, heavy rain began to fall and continued to fall until 1155, 1 minute prior to the aircraft landing (Figure 6). During this 23-minute period, 15 mm of rain was recorded. This represented a rainfall rate of 39 mm/hr, significantly higher than the threshold of 10 mm/hr required to be classified as heavy rain. Satellite imagery and CCTV footage confirmed that significant rain was observed at and around the aerodrome prior to the aircraft landing.

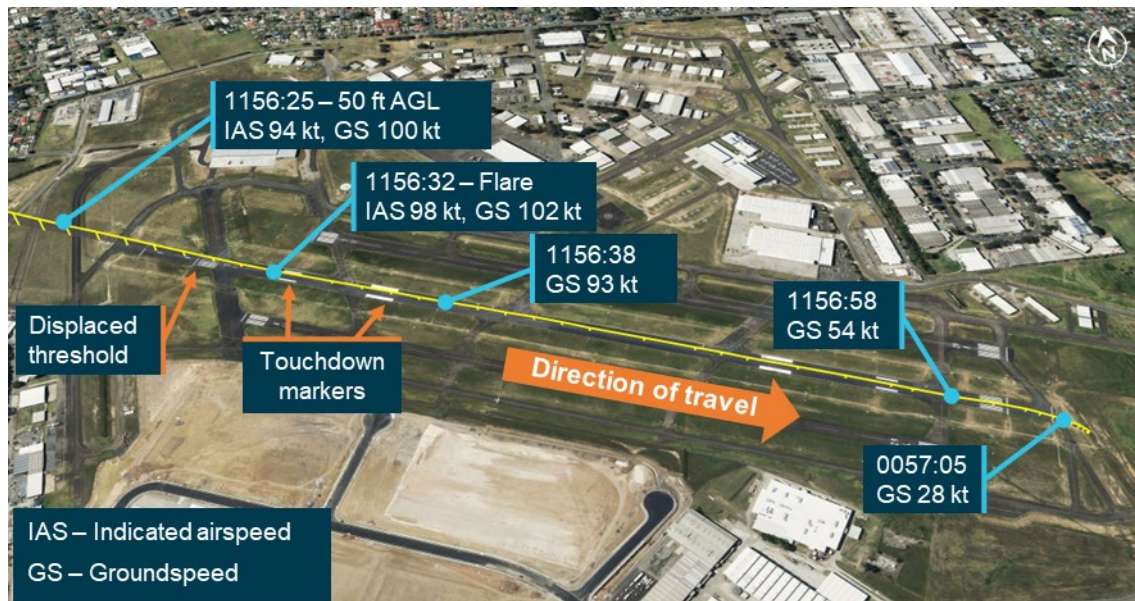
**Figure 9: VH-SQY flight path and landing**

The data from the G1000 showed that on final approach, the aircraft was at 50 ft above ground level (AGL) approximately 240 m before the displaced threshold before arriving at an aim point short of the first touchdown marker (Figure 9).

At 1156:32 the aircraft commenced the round out and flare approximately 135 m past the displaced threshold at which point the aircraft's groundspeed was 102 kt. The recorded data did not contain a specific data point to indicate when the aircraft was on the ground, however a positive G indication, consistent with a touchdown, was recorded at 1156:38, 430 m past the displaced threshold. At this time, the aircraft's groundspeed had decreased to 93 kt. The aircraft's groundspeed continued to decrease with no discernible

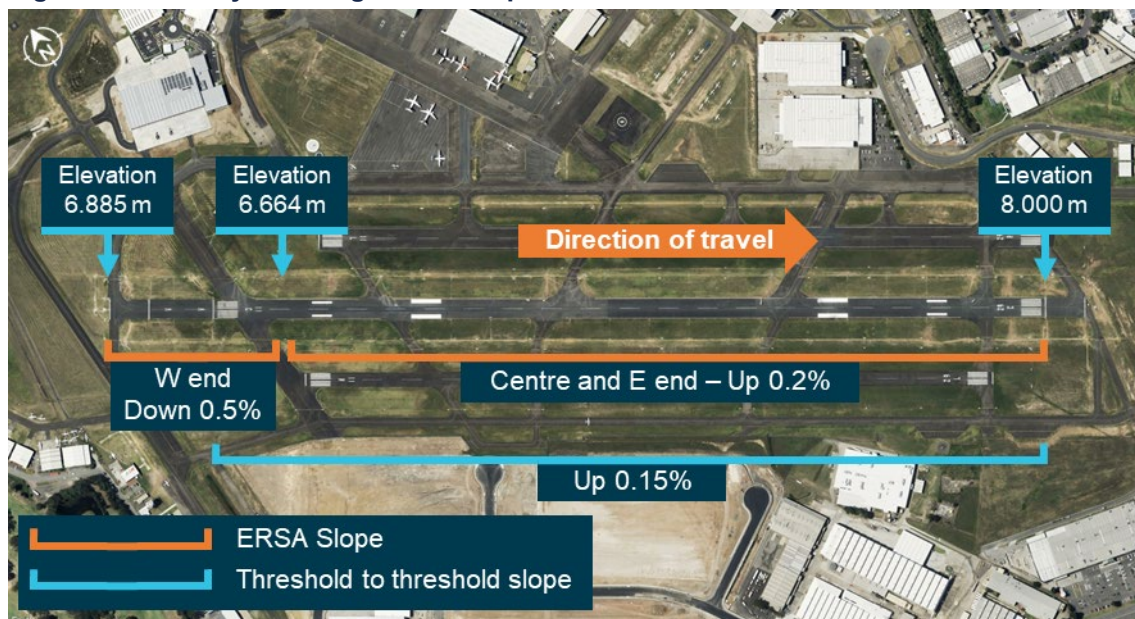
**Figure 11: Runway 11C longitudinal slope**

The ERSA did not contain information on how this description should be used to determine a runway slope value for landing and take-off performance calculations. Bankstown Airport survey information detailed how the slope described in the ERSA was constructed (Figure 11). The survey information identified that the threshold-to-threshold slope was 0.15% up to the east. This would have been the runway slope applicable to performance calculations for an aircraft landing on runway 11C.
