Collision with terrain involving Cessna 150M, VH-WWU

40 km north-west of Northampton, Western Australia, on 21 March 2025

Aviation Occurrence Investigation (Short)

AO-2025-014

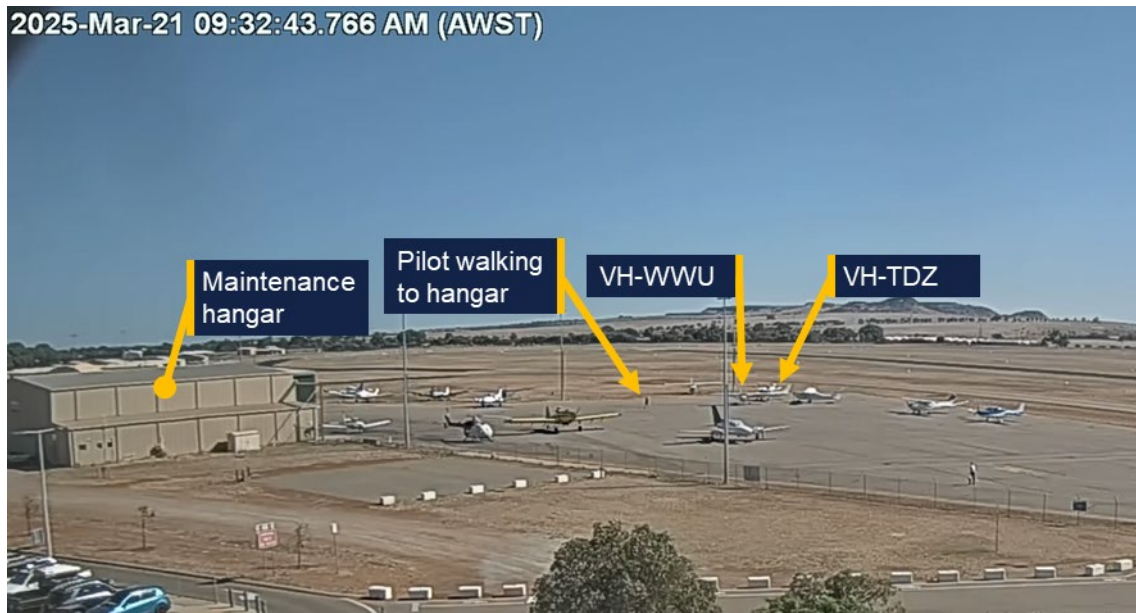
Figure 1: Aircraft changeover

Airport CCTV footage showed that between 0925 and 0931 the pilot manually manoeuvred VH-WWU out of its parking bay and moved VH-TDZ into it. Once completed, the pilot walked to the maintenance hangar (Figure 1). Witnesses at the airport reported that the pilot appeared unwell and had mentioned having had severe gastroenteritis in the preceding days. Witnesses did not report any apparent speech or physical impairment. The pilot did not appear to have any difficulty walking around or moving aircraft.

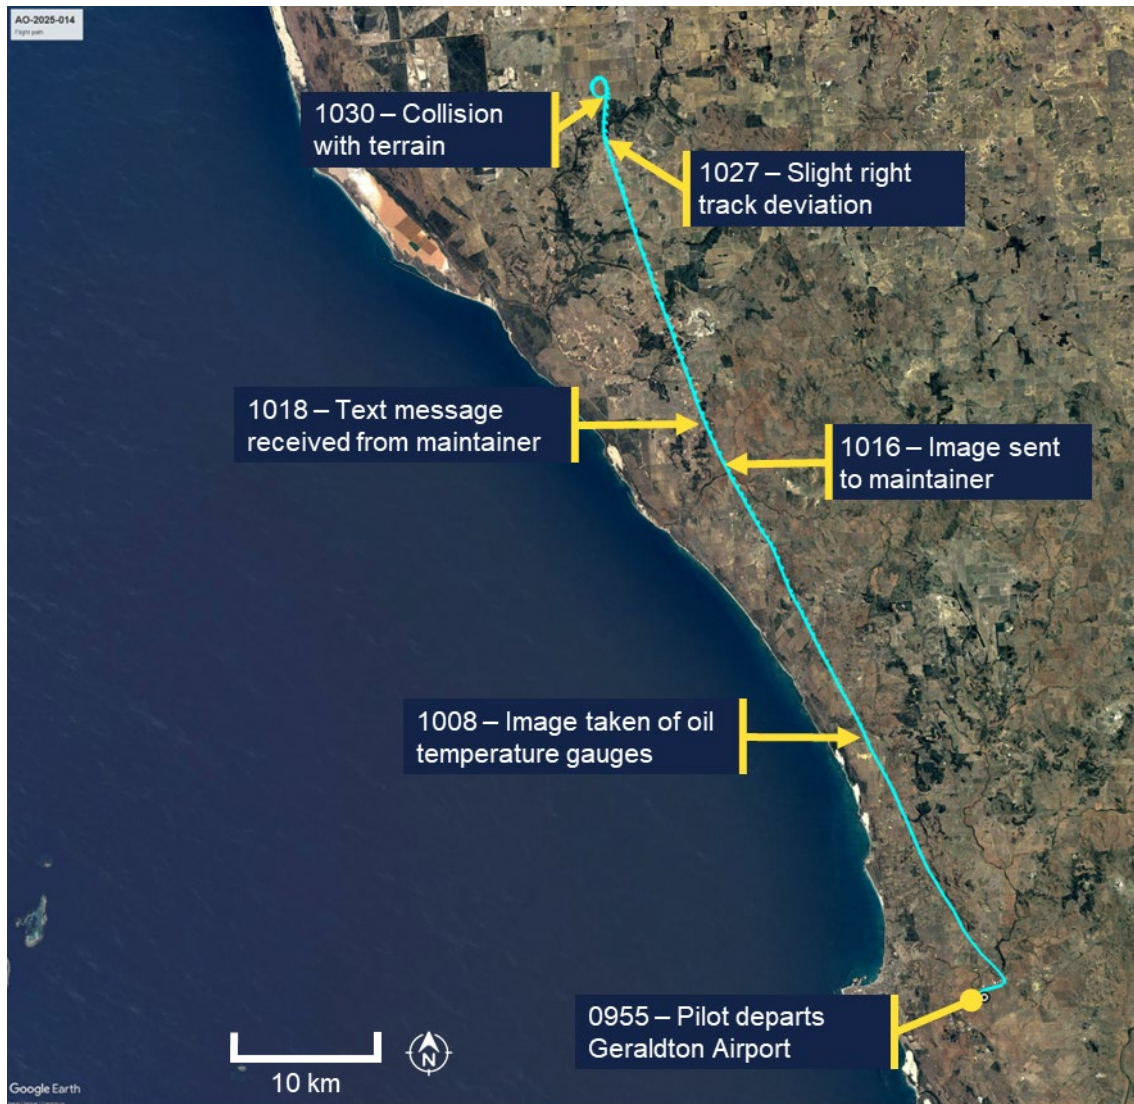
Figure 2: Flight path overview

Directly after take-off, the pilot texted the senior base pilot with the estimated arrival time at Shark Bay of 1230. The aircraft's flight path from Geraldton is shown in Figure 2.

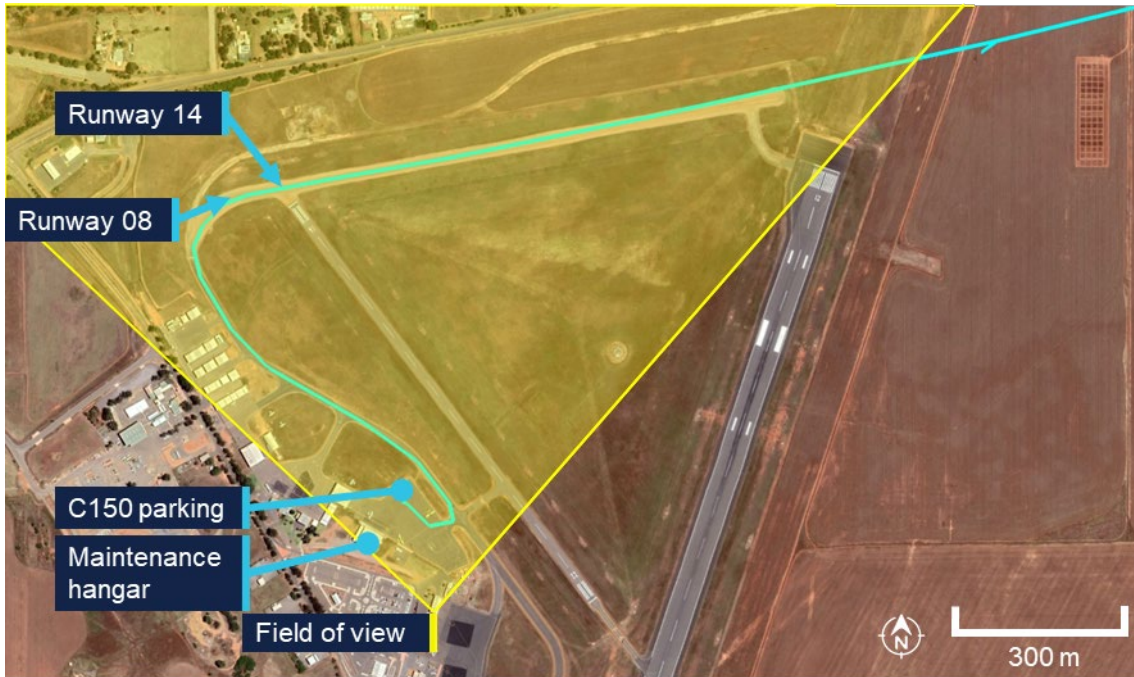
Figure 5: Geraldton Airport camera field of view

The airport camera field of view (Figure 5) covered:
