# Ditching in floodwater involving Robinson R22 Beta, VH-KNG

Adavale, Queensland, on 27 March 2025

Aviation Occurrence Investigation (Short)

AO-2025-016

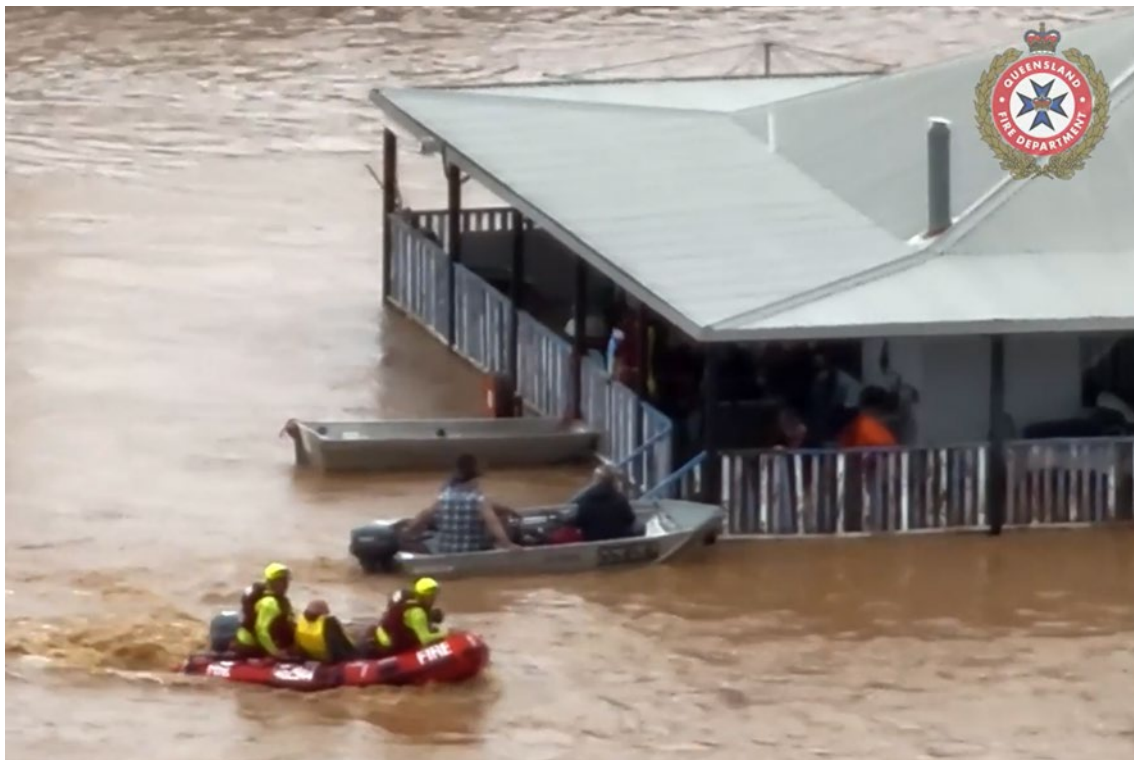
**Figure 7: QFD swift-water rescue team and volunteer boats at Adavale**

As flooding had been anticipated in the wider region due to the expected heavy rains, a swift-water rescue team (SRT)<sup>14</sup> had been pre-positioned in Charleville in anticipation of the floods. This consisted of specially trained Queensland Fire Department personnel with an inflatable rescue craft (Figure 7) being transported by a chartered heavy-lift helicopter to the site of the rescue. This helicopter was not equipped or crewed for instrument or night flying conditions and so could only be used during daylight and in visual meteorological conditions (VMC).<sup>15</sup>
