VFR into IMC and collision with trees involving Cessna 182T, VH-TSS

57 km south-east of Mount Surprise, Queensland, on 16 June 2025

Aviation Occurrence Investigation (Short)

AO-2025-028

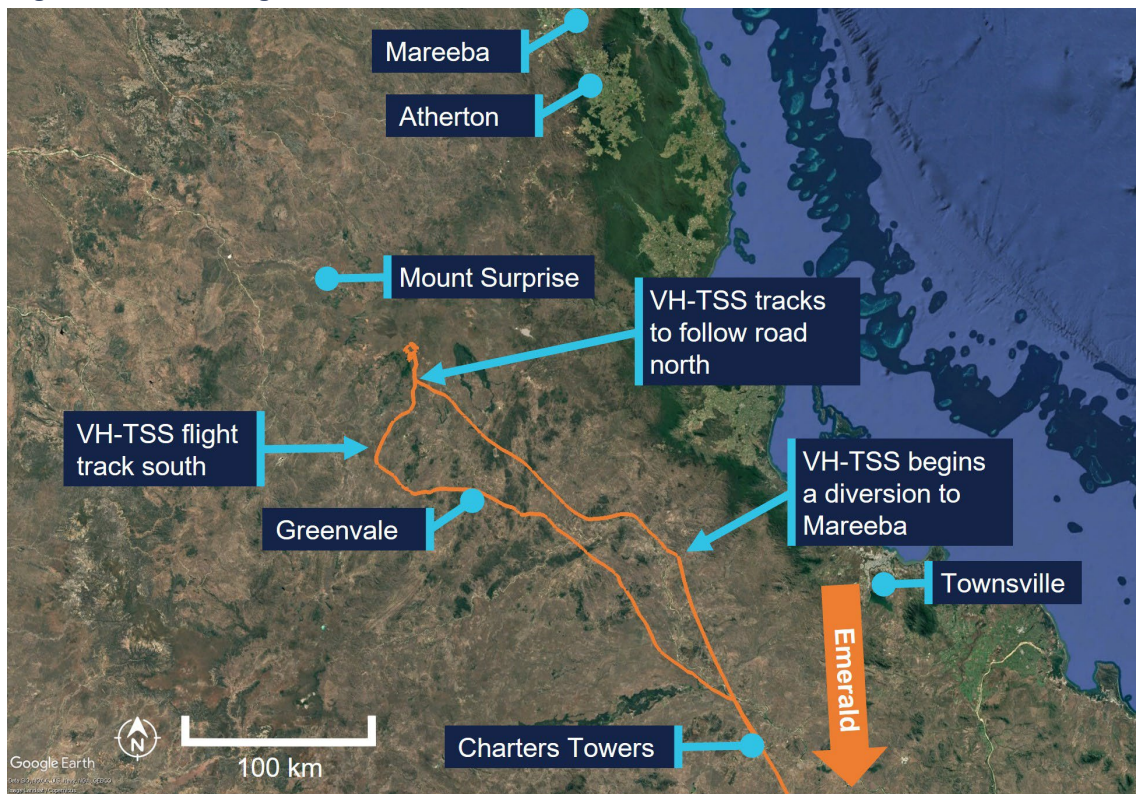
Figure 1: VH-TSS flight track between 0828 and 1115

Electronic flight data showed the aircraft departed and climbed to 4,500 ft above mean sea level (AMSL) where it initially held a steady track towards Atherton (Figure 1).

At 0848, the aircraft descended to 3,000 ft AMSL, about 35 NM north of Charters Towers. The pilot then assessed that cloud and reduced visibility would affect continued visual flight direct to Atherton. The pilot stated they elected to continue, however diverted around weather to Mareeba Airport which they had planned as an alternative destination due to the lower elevation. They stated that they were familiar with the area, having flown a similar route 7 or 8 times previously and reported that they assessed the weather for
