Australian Transport Safety Bureau

Collision with terrain involving Air Tractor AT-802, VH-ODX

17 km north of Cummins Town aerodrome, South Australia, on 8 September 2025

ATSB Transport Safety Report
Aviation Occurrence Investigation
AO-2025-053
Preliminary – 23 October 2025

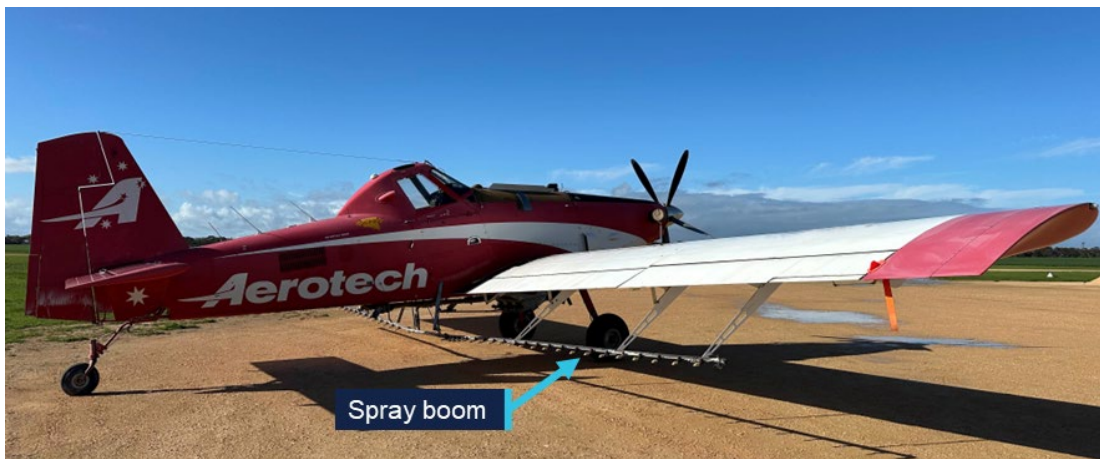
Figure 4: Exemplar AT-802 showing spray boom installation

VH-ODX was an Air Tractor Incorporated AT-802A single-seat low-wing tailwheel, fixed landing gear aircraft manufactured in the United States in 2006. It was powered by a Pratt & Whitney Canada PT6A-67AG turboprop engine. It was first registered in Australia in August 2006. The aircraft was configured for aerial spraying, with the spray boom fitted under each wing, aft of the trailing edge, and extending about three-quarters of the wingspan (exemplar shown in Figure 4).
