# Misaligned take-off occurrences on runway 06 at Perth Airport, Western Australia

involving Boeing 737, VH-IWQ, on 12 June 2023

AO-2023-027

Final – 20 November 2025

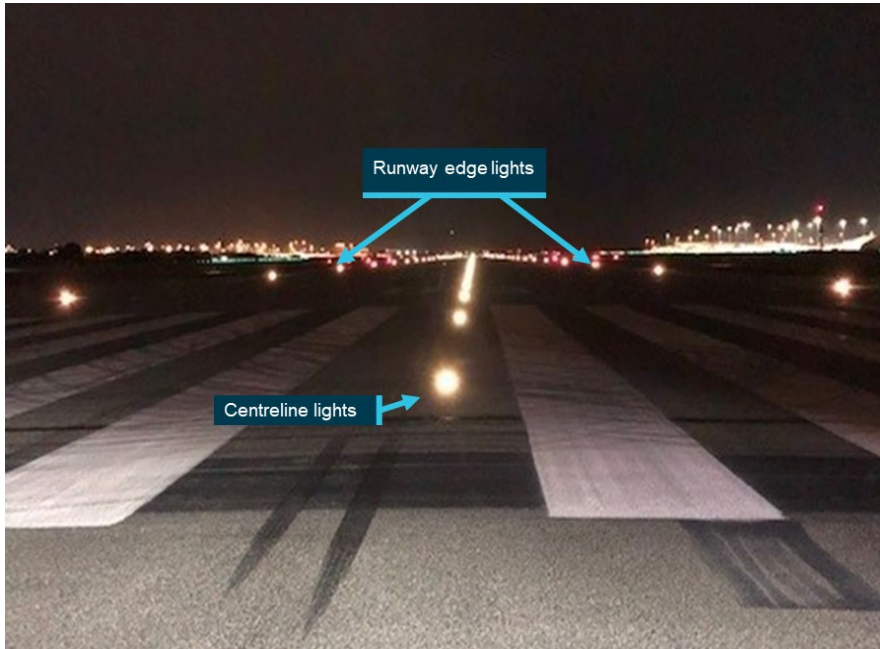
**Figure 6: Runway centreline lights and edge lights on runway 03**

Runway 03/21 was fitted with centreline lights (Figure 6). Runway 06/24 did not have centreline lights, and was not required to as per MOS 139.

edge of the runway to delineate the area available to pilots for landing and take-off at night in reduced visibility. Consistent with the MOS requirements, the runway 06/24 edge lights were white (Figure 6 shows these lights for runway 03). The first 2 edge lights on runway 06 were inset into the runway, and the remainder of the lights were elevated (Figure 7).
