# Runway excursions on take-off involving Airbus A330-323, 9M-MTL, and Boeing 787-9, VN-A819

Melbourne Airport, Victoria, on 7 and 18 September 2023

Aviation Occurrence Investigation (Systemic)

AO-2023-043

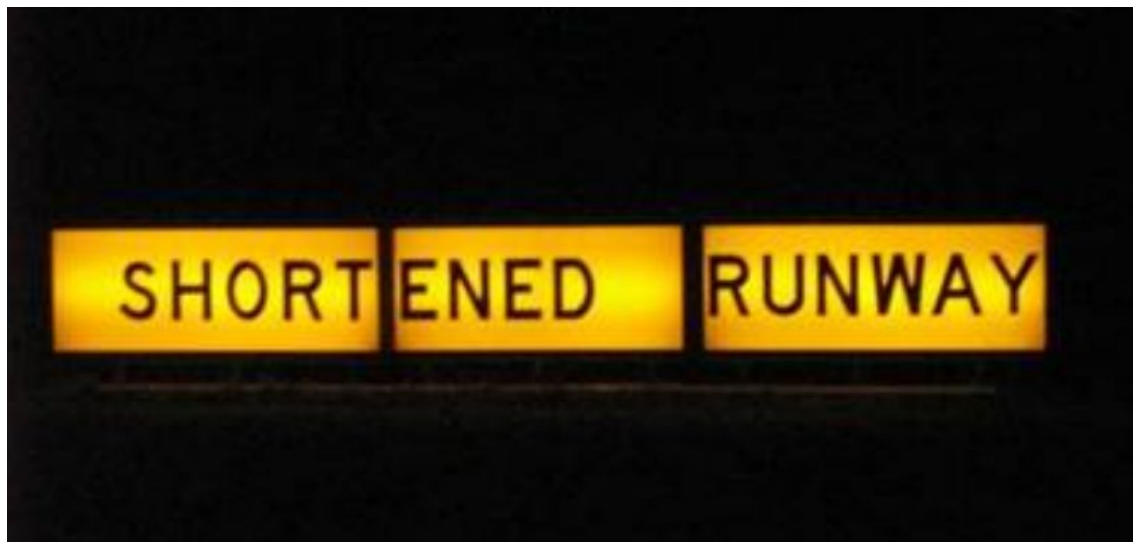
**Figure 18: Shortened runway sign used at Changi Airport during resurfacing works**

Illuminated information signs were used in an attempt to highlight the shortened runway. The existing TORA sign insert was replaced with the temporary runway length, and a yellow SHORTENED RUNWAY sign (Figure 18) was positioned on the opposite side of the runway to the taxiway entrance, where such a sign would not normally be located. The investigation report discussed that the flight crew did not recall seeing the signs,

which was probably because they were not expecting a change to the take-off length. The report also noted that the amended TORA sign was 'of the same size, font and colour indicating the shortened distance' and that the sign 'did not contain any attention-getter to draw the crew's attention to the reduced TORA'.

Among the immediate safety actions taken by Singapore ATC, was to ensure that all aircraft assigned to runway 20C were reminded of the reduced TORA by having air traffic controllers highlight the information to them during flight crew communications with both the clearance delivery and runway controllers.
