# Landing gear malfunction and collision with water involving De Havilland Aircraft of Canada DHC-2 Beaver, VH-OHU

near Whitehaven Beach, Whitsunday Island, Queensland, on 26 October 2024

**ATSB Transport Safety Report**

AO-2024-055

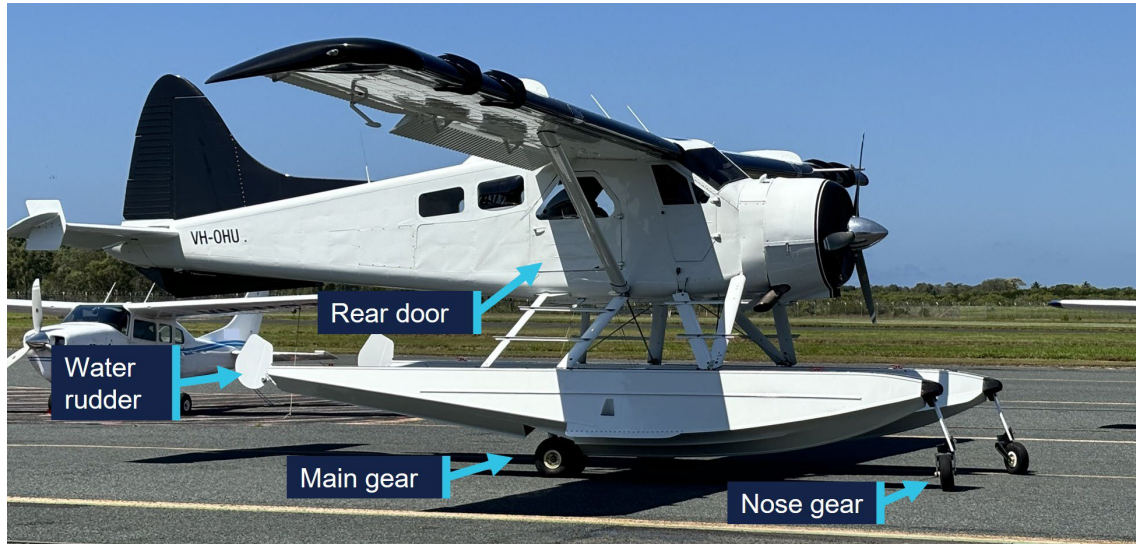
**Figure 4: VH-OHU showing the amphibious float components**

The landing gear incorporated within the amphibious floats is a retractable, quadricycle type with 2 free castoring nose (or bow) wheels and 4 (2 sets of dual) main wheels (Figure 4). Steering on the water is accomplished by a water rudder located at the rear of each float, which is cabled into the existing aircraft rudder system. Steering on land is accomplished by differential braking on the main landing gear wheels.

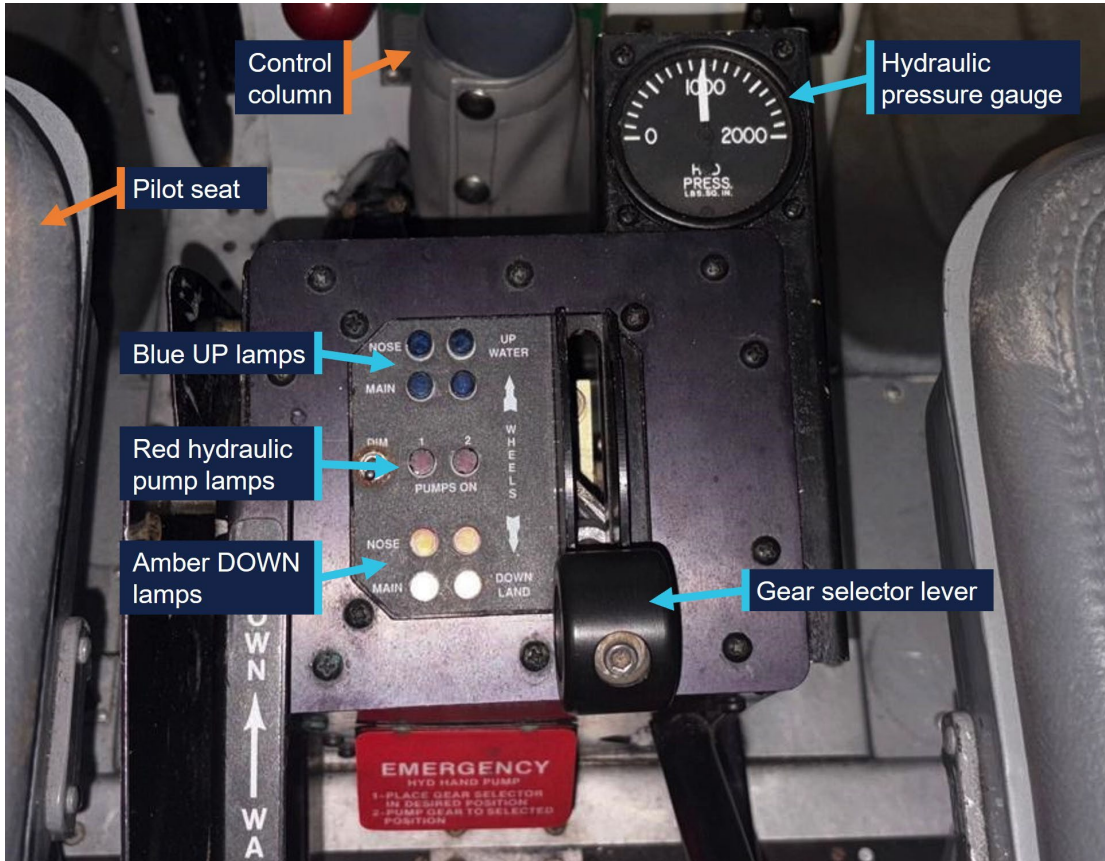
Figure 6: Typical landing gear panel

The landing gear indication panel, to the right of the pilot's seat (at the base of the control column), contained 10 lamps. Four blue to indicate the 2 nose and 2 main gear were up, 2 red to show hydraulic pump operation and 4 amber to indicate the gear was down. In addition to the standard equipment, VH-OHU was also fitted with a hydraulic pressure gauge for pilot reference (Figure 6).

The airplane flight manual supplement for the amphibian floats described 'bulb replacement during flight'. Where a lamp is not illuminated as expected, the pilot can readily remove the lamp and a known functioning lamp can be inserted into that location. This allows the pilot to determine if the non-illumination is a defective bulb, or other system issue.

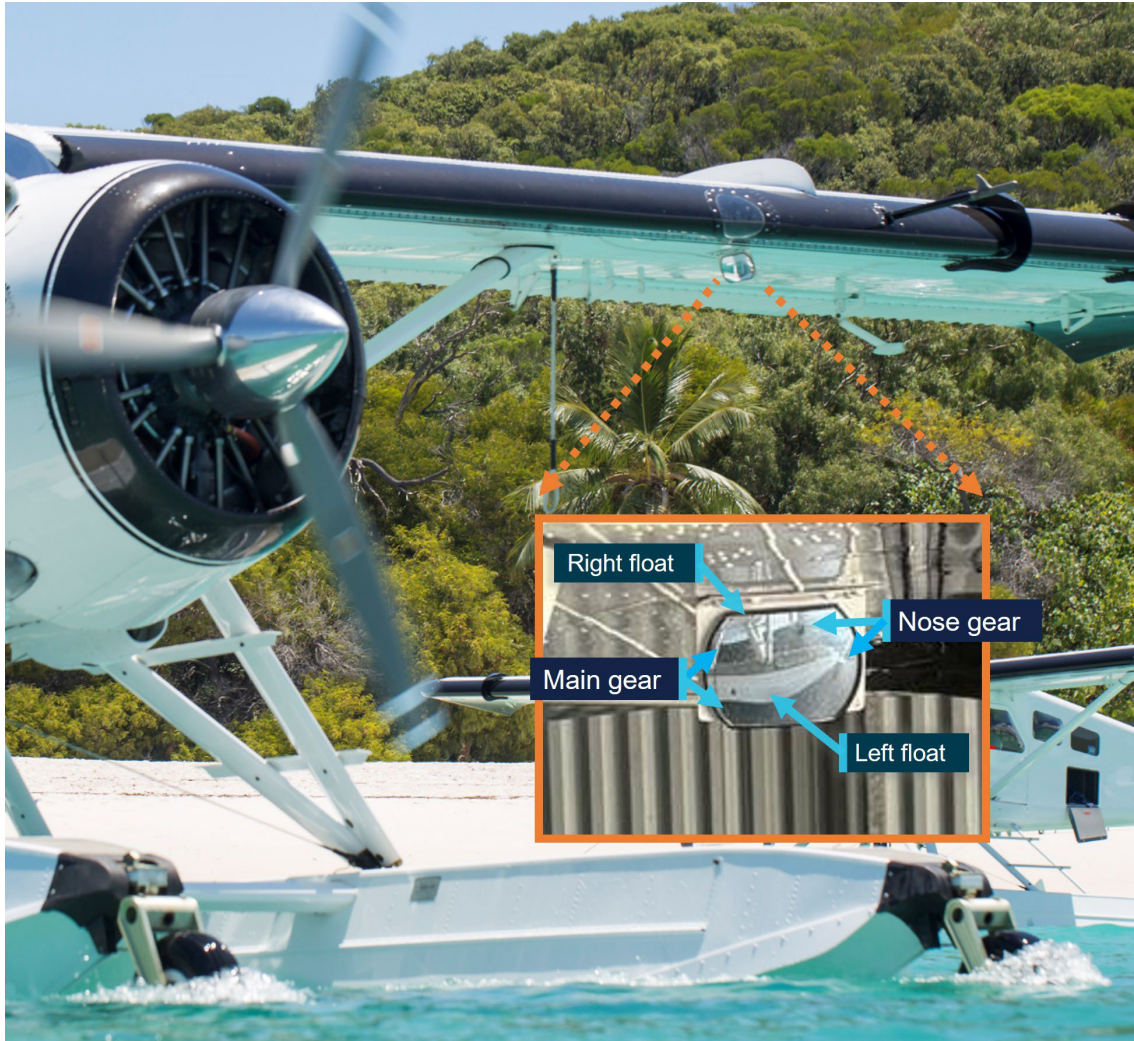
**Figure 7: Left wing mirror location, with representation of extended gear visible view**

In addition to the landing panel gear position indication, the aircraft was also fitted with an optional mirror, installed on the left wing (Figure 7). Wipaire advised the mirror was not part of its float modification, however, it was aware it was a common addition to float planes.

underside of the right float, which was not possible without the mirror. The company pilots the ATSB spoke with reported varying opinions on the effectiveness for observing the right main gear via the mirror (see *Operational information*). However, all reported the mirror on the aircraft was correctly aligned following the recent maintenance and was effective in determining gear position.

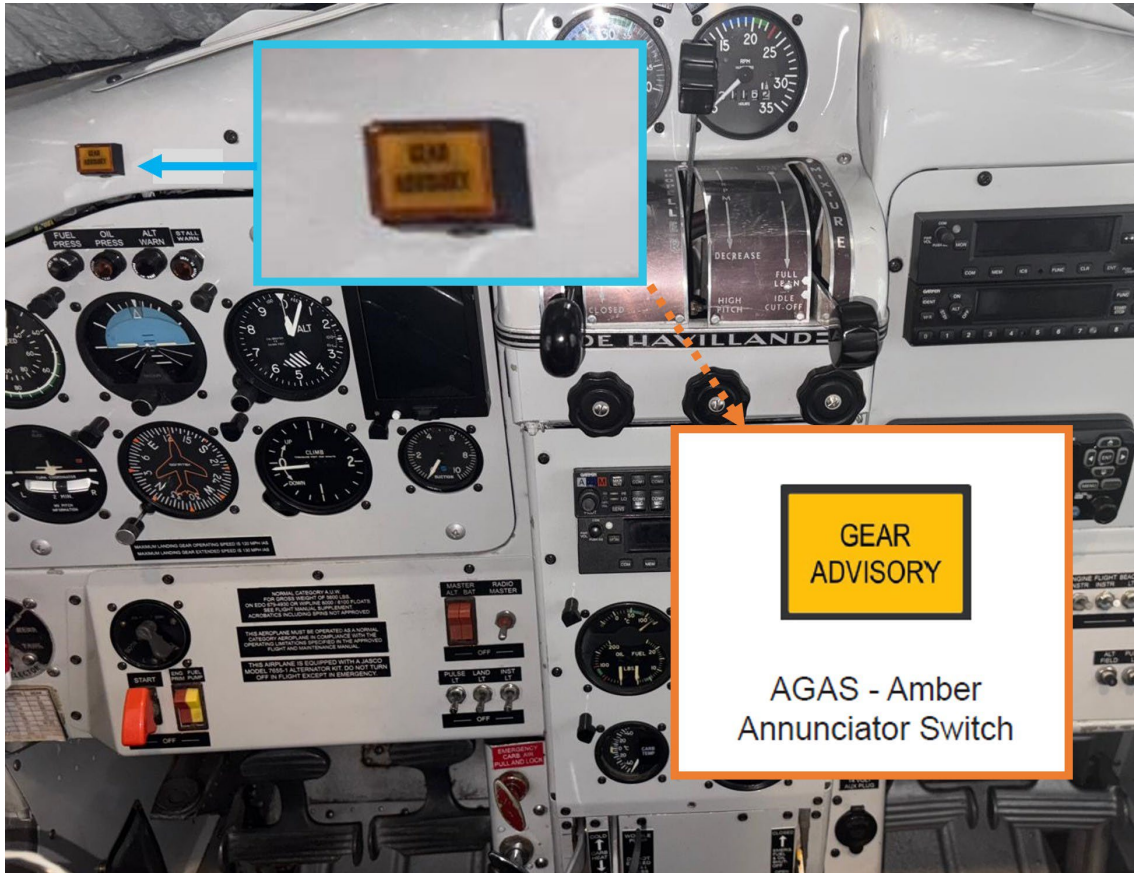
Figure 8: Example of location of gear advisory lamp in DHC-2 instrument panel

The aircraft was also fitted with a Wipaire-authorized amphibian gear advisory system (AGAS), which provided the pilot with supplementary gear position information. Following departure, once the aircraft increased through a threshold airspeed, the system was armed. Upon slowing down through the threshold airspeed, in preparation for landing, the AGAS 'Gear Advisory' amber lamp (Figure 8), positioned on the instrument panel in front of the pilot, would illuminate. In addition, an audio annunciation, heard through the front seat headset/s, would commence. Where all 4 gear were retracted, the annunciation would consist of 'gear up for water landing' (female voice). Conversely, where all 4 gear were extended, the annunciation would be 'gear down for runway landing' (male voice). The audio annunciation would repeat every few seconds, until silenced by the pilot pressing the gear advisory lamp. The annunciation was a prompt for the pilot to check their gear configuration was correct for the intended landing surface.

The AGAS also had a ‘check gear’ advisory. In this case, when the aircraft slowed through the threshold airspeed, the gear advisory amber lamp would illuminate and the annunciation of ‘check gear’ would be heard in the same female voice and similar tone as that for the ‘gear up for water landing’ advisory. There were no additional tones associated with this alert. Check gear indicated an asymmetric condition in the landing gear, where one or more proximity switches had not closed. This was designed to prompt the pilot to abort the landing and troubleshoot the discrepancy. The airplane flight manual supplement for the AGAS included the warning:
