Australian Transport Safety Bureau

Wheel brake failure involving Sling Aircraft Sling LSA, VH-PPY

Moorabbin Airport, Victoria, on 14 February 2025

AO-2025-006

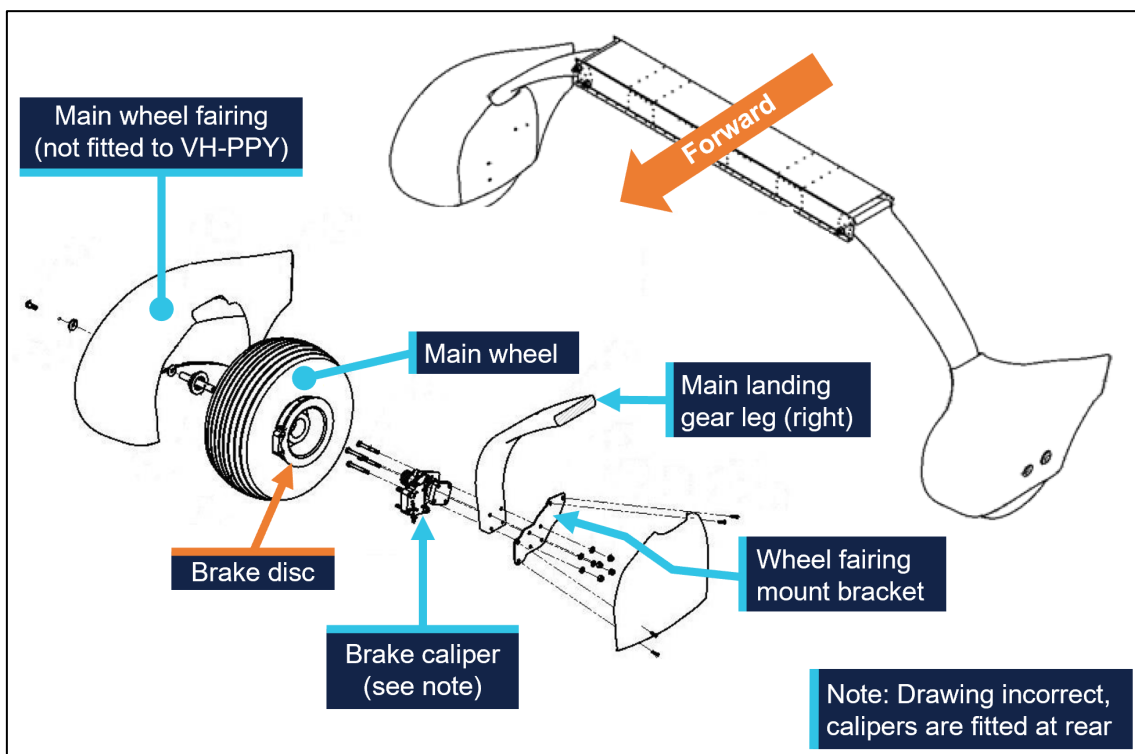
Figure 2: Sling LSA main landing gear and Matco wheel brake assembly

The Sling LSA main landing gear wheels are fitted with disc brakes (Figure 2). Braking action is achieved by the pilot's feet acting on the aircraft's rudder pedals, directing hydraulic fluid to the brake caliper piston to move the lining (pad), which in turn acts on the friction area of the brake disc.
