Loss of control and collision with terrain involving Pilatus PC-6, VH-XAA

2.5 km north of Moruya Airport, New South Wales, on 27 September 2025

ATSB Transport Safety Report
Aviation Occurrence Investigation
AO-2025-058
Preliminary – 12 November 2025

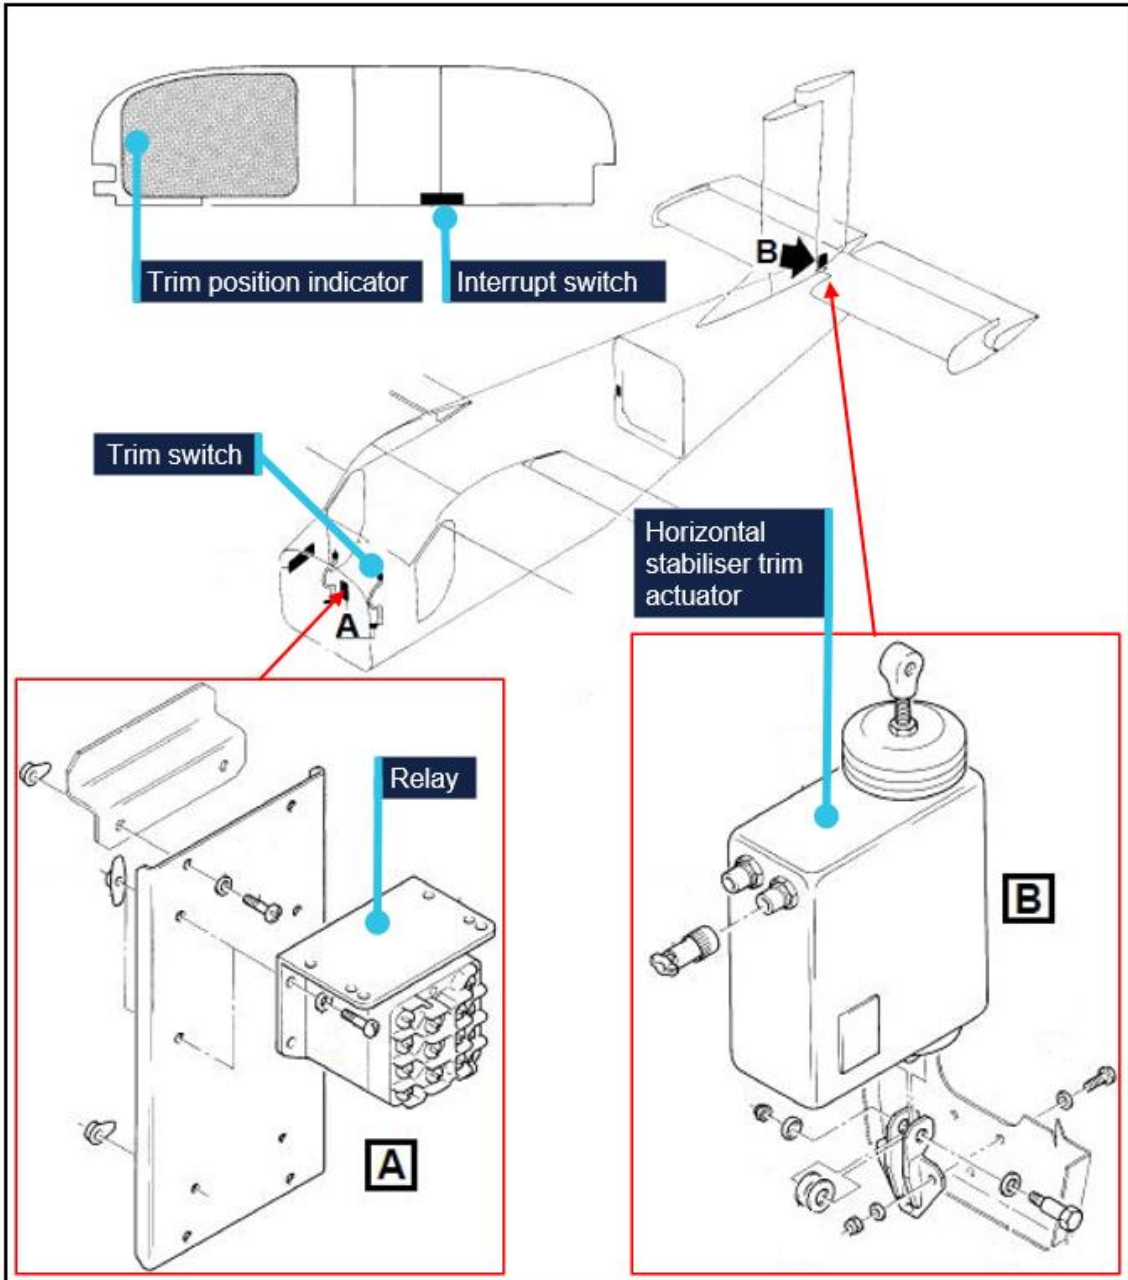
Figure 4: Schematic of horizontal stabiliser trim system

The aircraft was fitted with a horizontal stabiliser electric trim system, designed to move the entire horizontal stabiliser to adjust the pitch trim of the aircraft and balance the aerodynamic forces to reduce the pilot control forces on the elevator. The system (Figure 4), consisted of:

- a dual motor (main and alternate motors) electrically-operated linear trim actuator
- a 3-position spring-loaded trim switch, located on the control column grip
- a relay located on the firewall
- an interrupt system incorporating a guarded switch on the instrument panel shelf and an alternate trim control system with a 3-position spring-loaded trim switch (Figure 5)
- an electrically-operated trim position indicator on the upper left side of the instrument panel.
