# **Collision between container ship *Maersk Shekou* and tall ship *STS Leeuwin II***

Fremantle, Western Australia, on 30 August 2024

**ATSB Transport Safety Report**

MO-2024-001

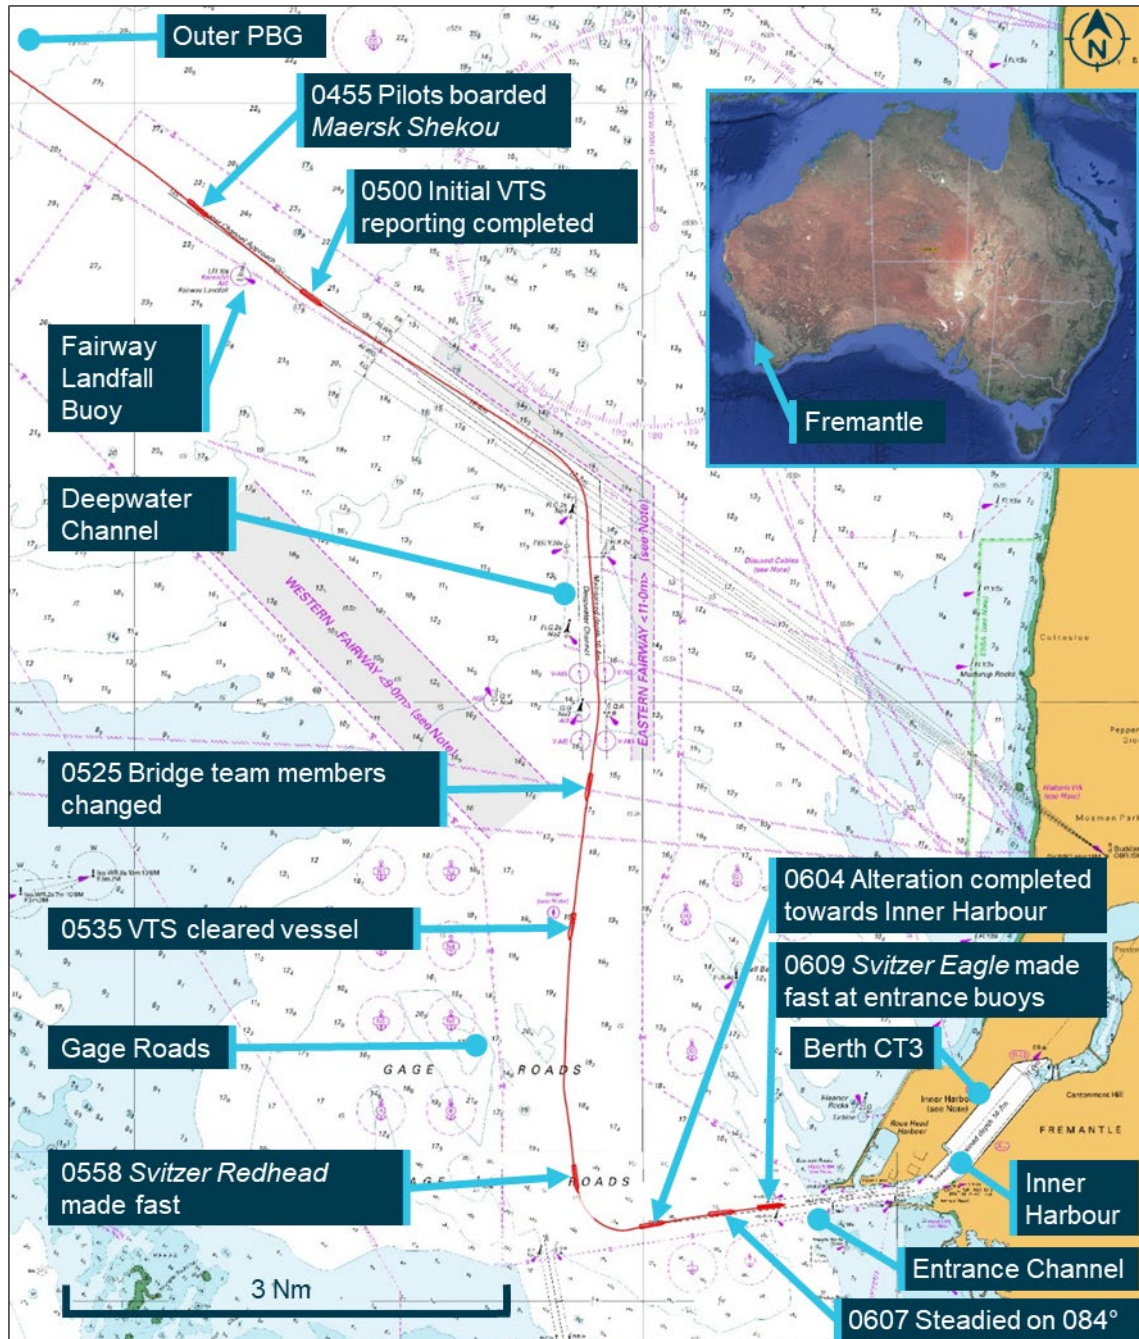
Figure 1: Section of navigational chart Aus112 showing *Maersk Shekou's* inbound track

At 1100 local time on 22 August 2024, container ship *Maersk Shekou* arrived off the Port of Fremantle, Western Australia following a voyage from Adelaide, South Australia, and commenced drifting off the coast while awaiting entry into the port. The ship was loaded with 4,164 containers and was intending to proceed to berth CT3 (Figure 1).

ship's speed unchanged at about 11.6 knots,<sup>7</sup> transit the deepwater channel (DWC)<sup>8</sup> and wait at the harbour entrance, to maintain an estimated time of arrival (ETA) of 0600 for daylight arrival into the port.

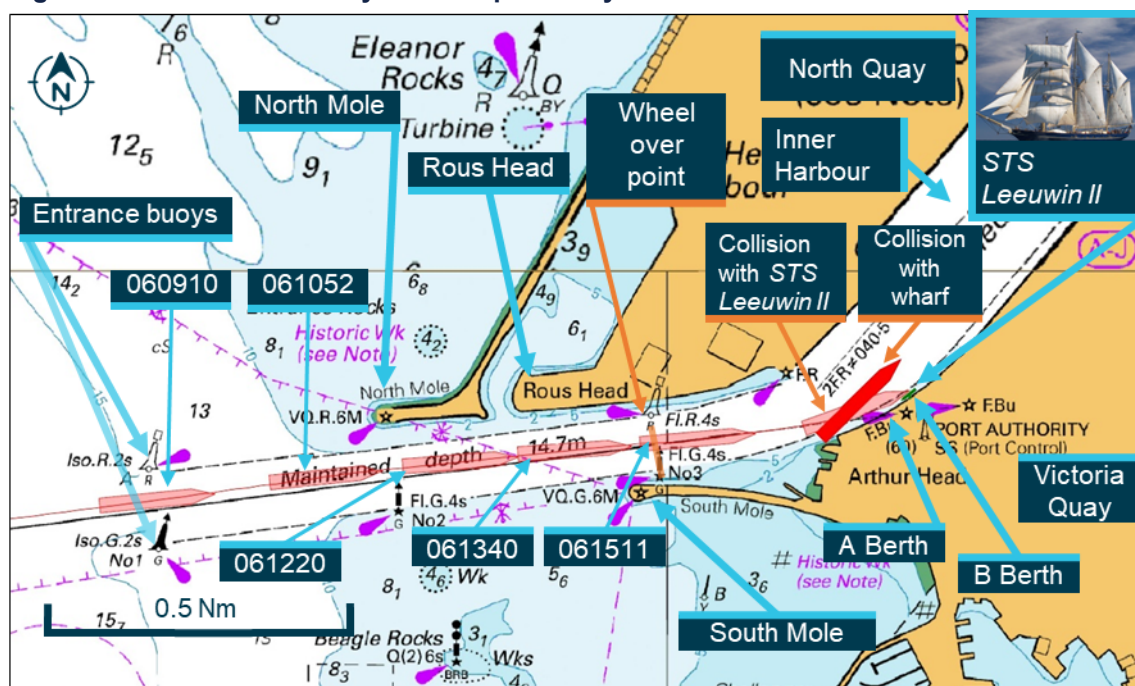
Figure 2: *Maersk Shekou* key times of port entry

At 0609, as the ship passed the IHEC entrance buoys, A and No 1, the *Svitzer Eagle* tug was made fast on the starboard quarter (Figure 2). Between helm and engine orders, the pilots continued to engage in various marine and social discussions. About a minute later, the *Svitzer Emma* tug was secured at the *Maersk Shekou*’s port shoulder. At this stage, the ship’s speed had reduced to 9.3 knots.

At around 0612:36, the ship developed a slight starboard rate of turn. To maintain the 085° heading ordered by the pilot, the helmsman put the helm<sup>17</sup> over to port 25° and then port 30°. The wind speed was steadily increasing and by 0612:50, the ship was

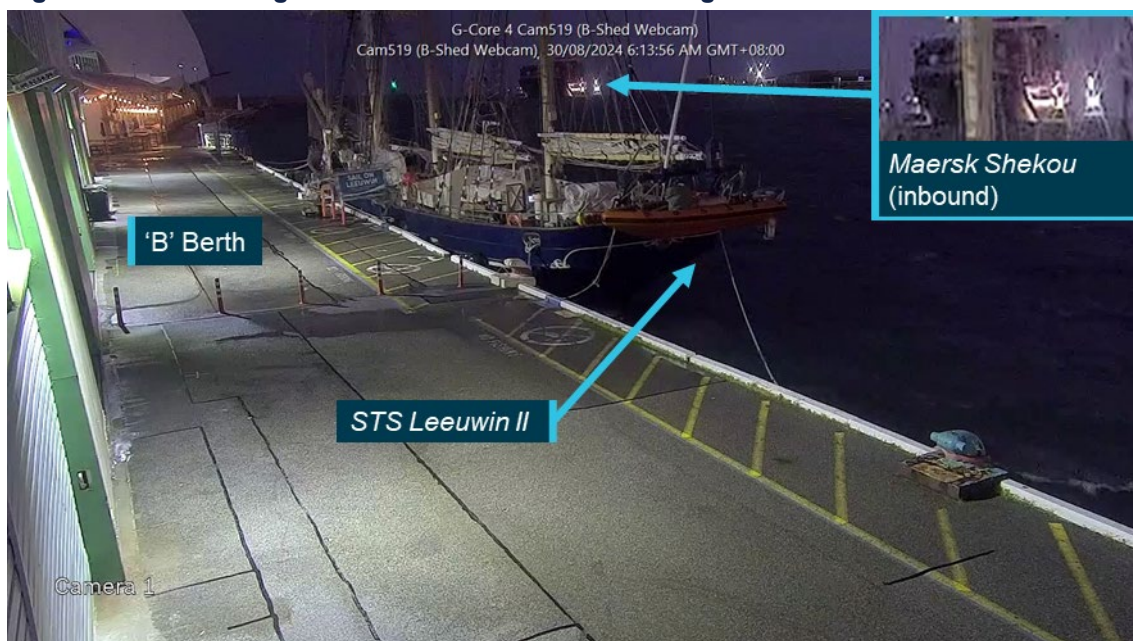
**Figure 3: CCTV footage of *STS Leeuwin II* at its mooring with *Maersk Shekou* inbound**

At 0615:47, the *Maersk Shekou*’s engine achieved its full ahead potential of 76 RPM, and the helmsman maintained the rudder in the midship position. The ship was proceeding at 7.2 knots on a steady 083.5° heading, into the path of *STS Leeuwin II*, which was less than a ship’s length away, and moored port side alongside B berth at Victoria Quay (Figure 3).

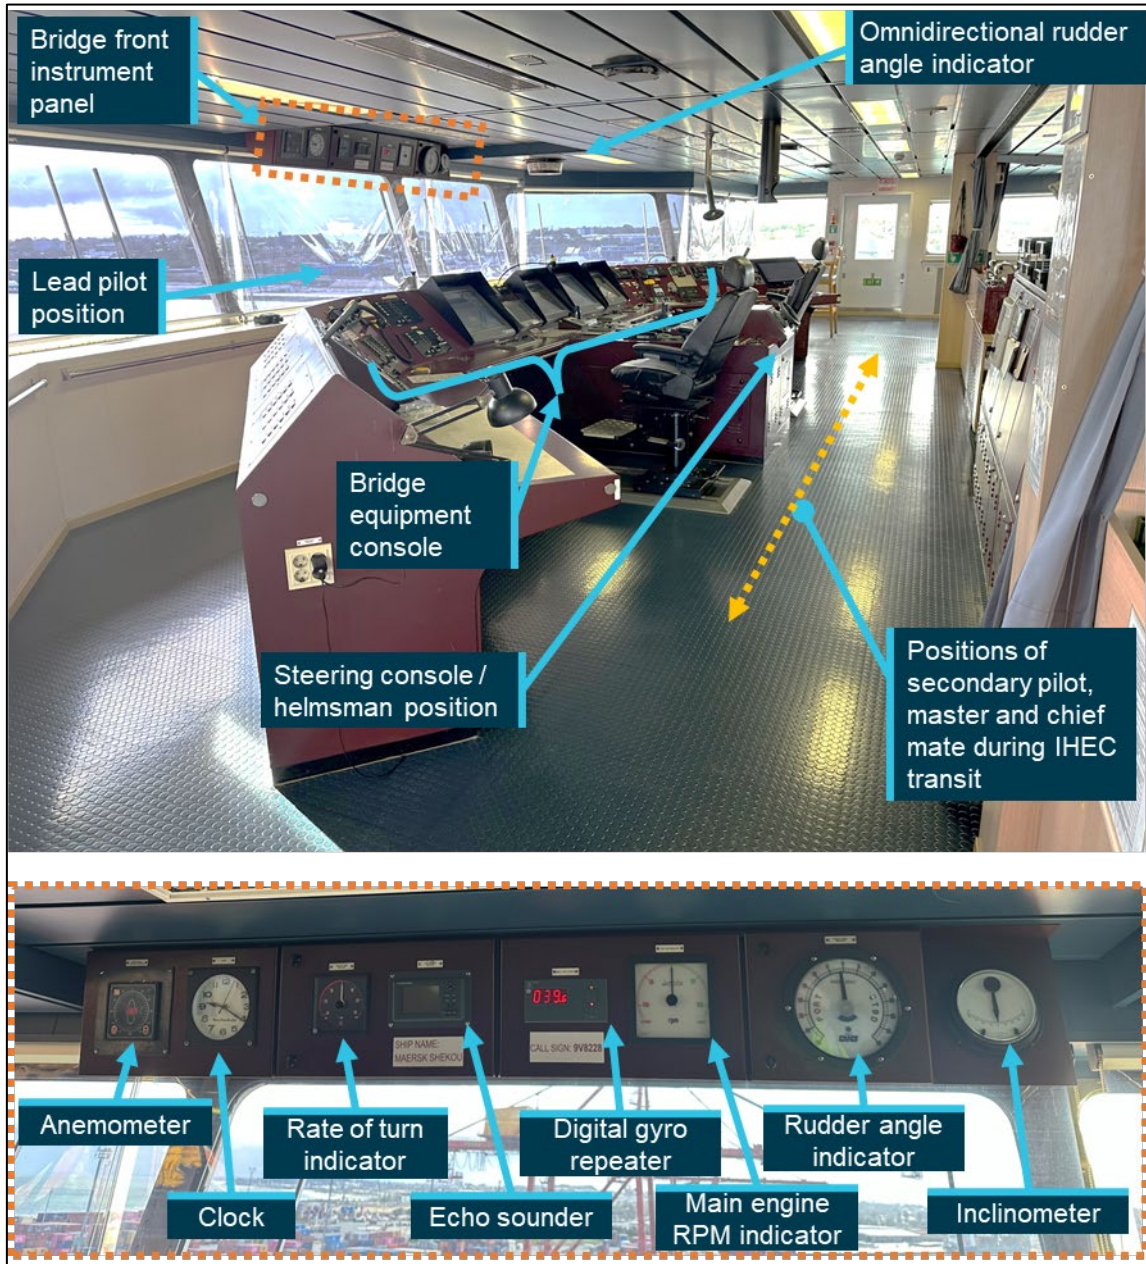
Figure 7: View of *Maersk Shekou's* wheelhouse and bridge front indicator panel (inset)

An omni-directional indicator was also fitted on the wheelhouse deckhead above the manoeuvring console. Based on their reported positioning inside the wheelhouse during the accident transit, the bridge front instrument display panel would have been visible to both pilots and the ship's bridge team members (Figure 7).

There were no equipment defects reported prior to the ship's arrival in Fremantle on 30 August 2024. On the day of the accident, the second mate recorded that the steering gear was tested at 0300 as part of the pre-arrival checks. On review of the VDR data, there was no evidence of the steering gear being operated at that time. Notwithstanding, no operational deficiencies were identified with the ship's bridge equipment or steering gear in relation to the accident.

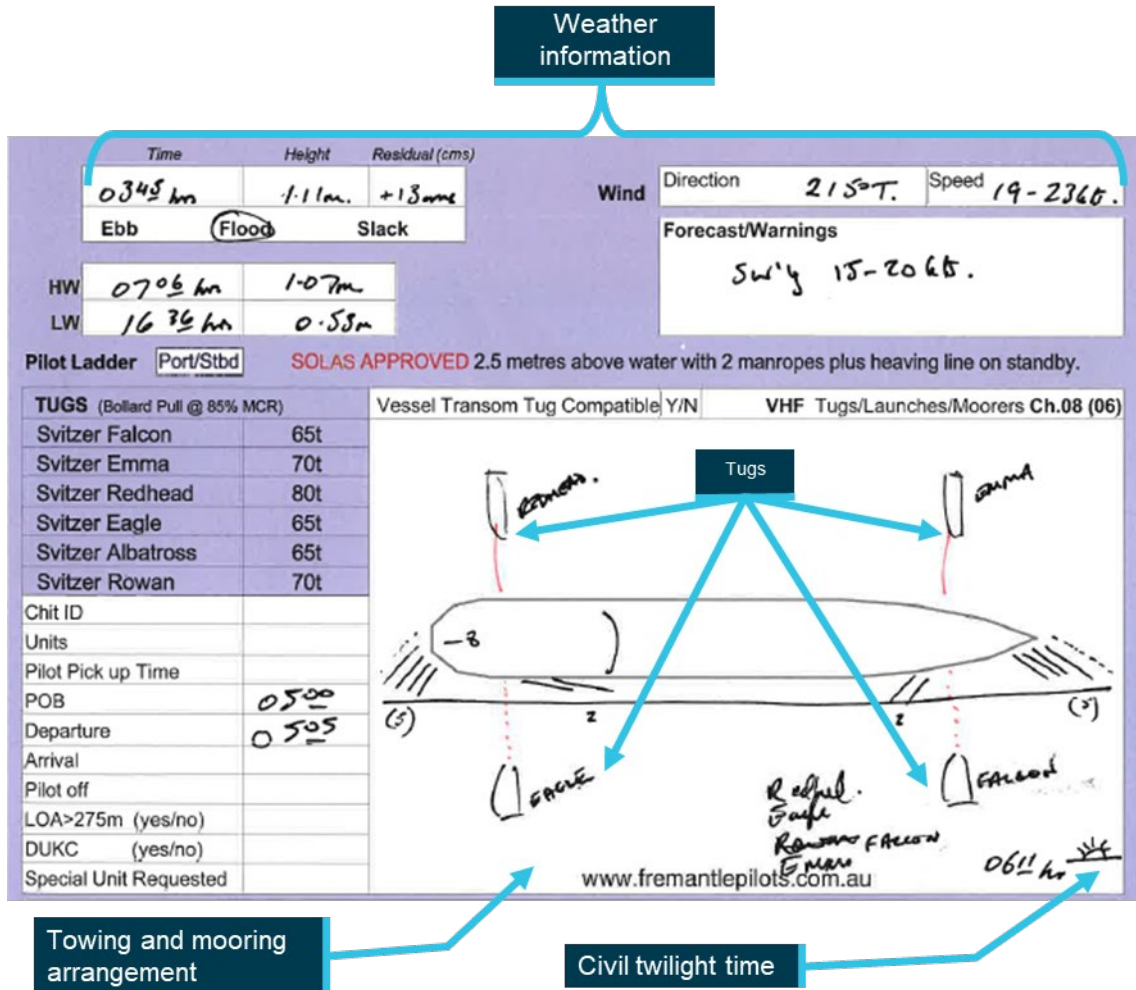
Figure 8: Master-pilot exchange plan

The MPX form that was completed by the pilot, contained the passage plan from the outer pilot boarding ground up to CT3 berth, with the charted courses and speeds, mooring and towing arrangements, weather information and confirmation of the ship's equipment status. The plan also included a symbolic representation of the 0611 civil twilight time (Figure 8).

During the initial southbound segment of the transit, the plan noted 'speed adjusted for daylight entry', with the pilot verbally advising the master of a 0600 daylight time. The plan also included wheel over points, the turn radii and the locations where the tugs were to be made fast. The plan detailed that the tugs were to be made fast prior to the IHEC entrance buoys. However, the plan was not marked with the abort point, as per industry requirements.<sup>37</sup> It was later reported that the abort point was about one mile before the IHEC.

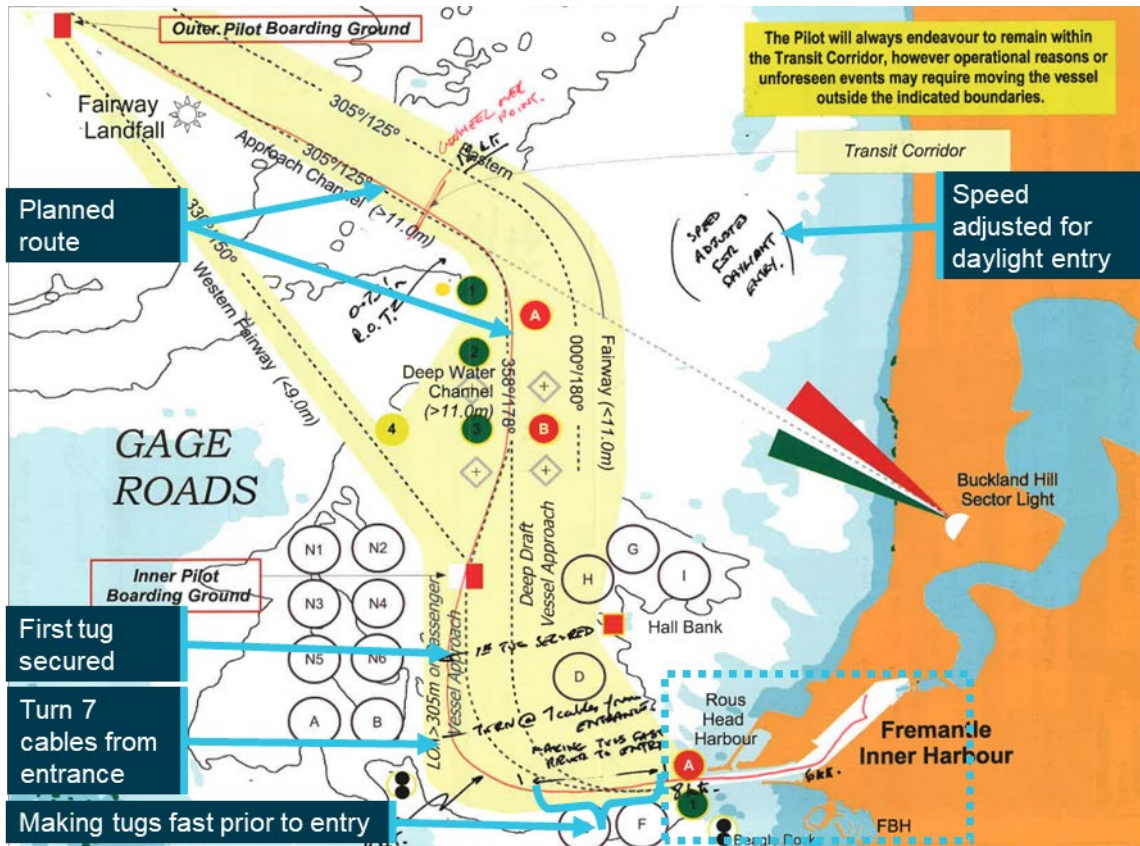
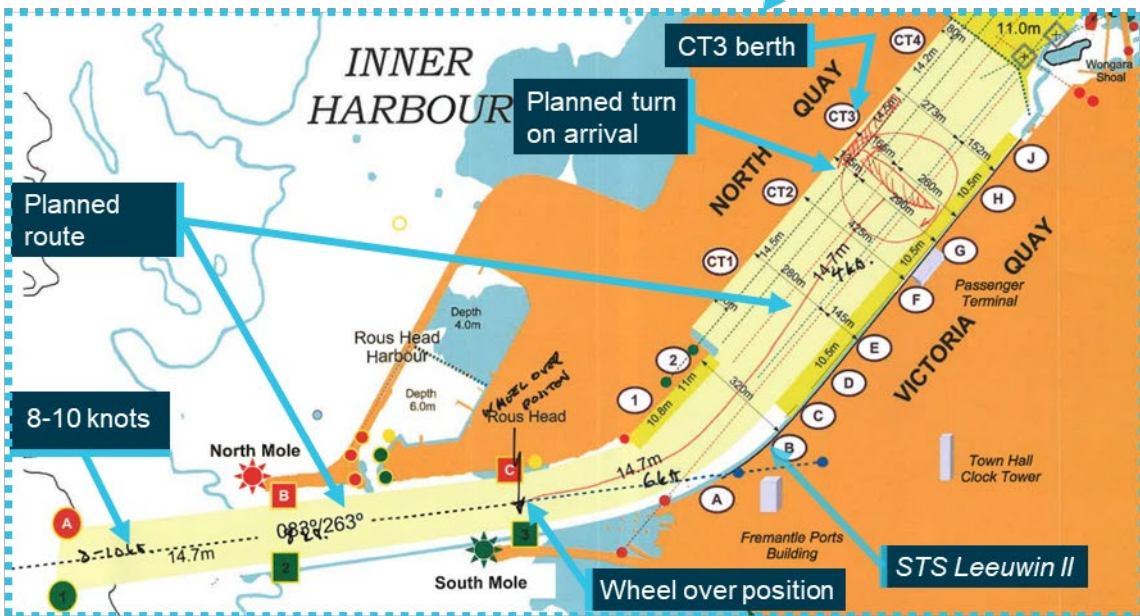
Figure 9: Master-pilot exchange plan

The pilot and master continued discussing pertinent information provided on Fremantle Pilots' MPX form (Figure 8). This included the route to be followed and an inner harbour manoeuvre involving a 180° turn, so that the ship could be berthed heading outwards with starboard side alongside at berth CT3 (Figure 9).<sup>11</sup> In the pilotage passage plan, the wheel over point<sup>12</sup> for the turn into the inner harbour entrance channel (IHEC) was marked abeam<sup>13</sup> buoys No 3 and C, near South Mole (Figure 2).
