Midair collision involving Robinson R22 Beta II, VH-HQH, and Robinson R22 Beta II, VH-HYQ

51 km south-south-east of Curtin Airport, Western Australia, on 25 July 2024

ATSB Transport Safety Report

AO-2024-044

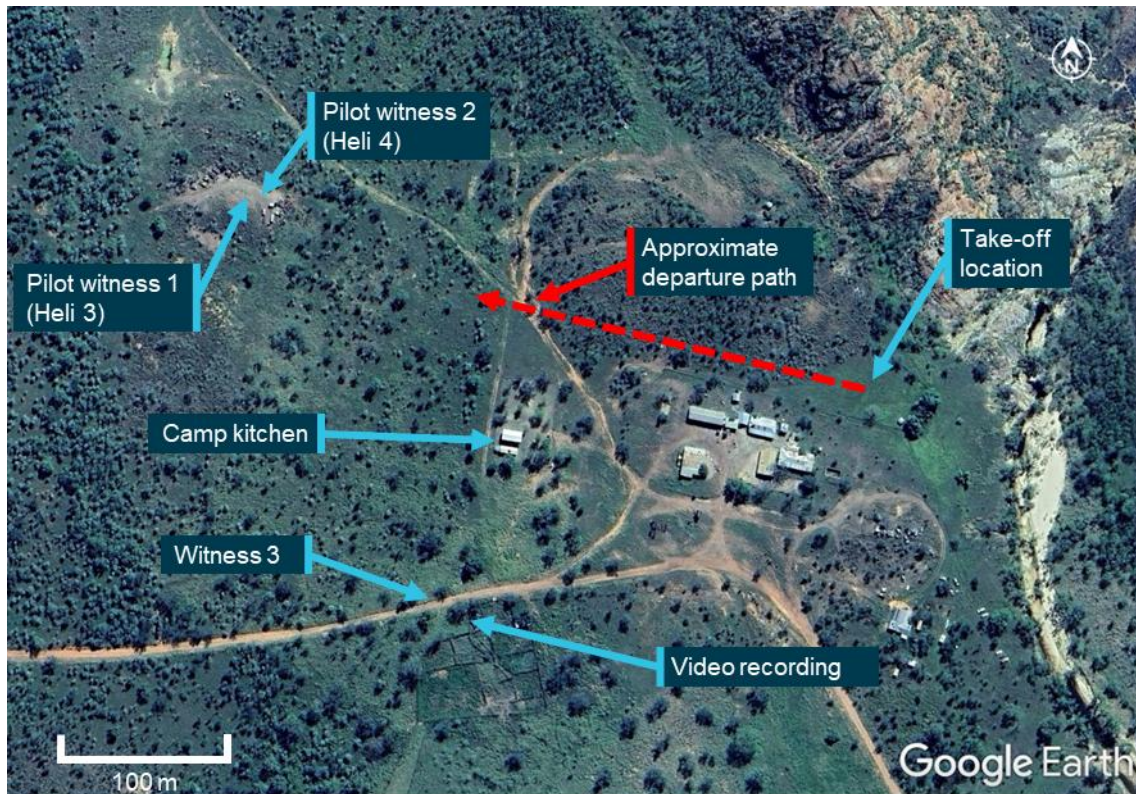
Figure 3: Witness locations

At 0603, Heli 1 (lead helicopter) and Heli 2 (following helicopter) departed the overnight parking area and flew west. The track to the planned muster took them past the location where the other helicopters were parked (Figure 3). The intention was for the remaining helicopters to join them as they flew past and the group would fly together to the muster.

A witness (witness 3) located near the stockyards about 200 m to the south of the homestead watched the 2 helicopters depart, climbing above the buildings with the following helicopter slightly lower and off to one side. They recalled that the helicopters were already established on the departure track, travelling about the same speed, and appeared to be close to one another when they first saw them.

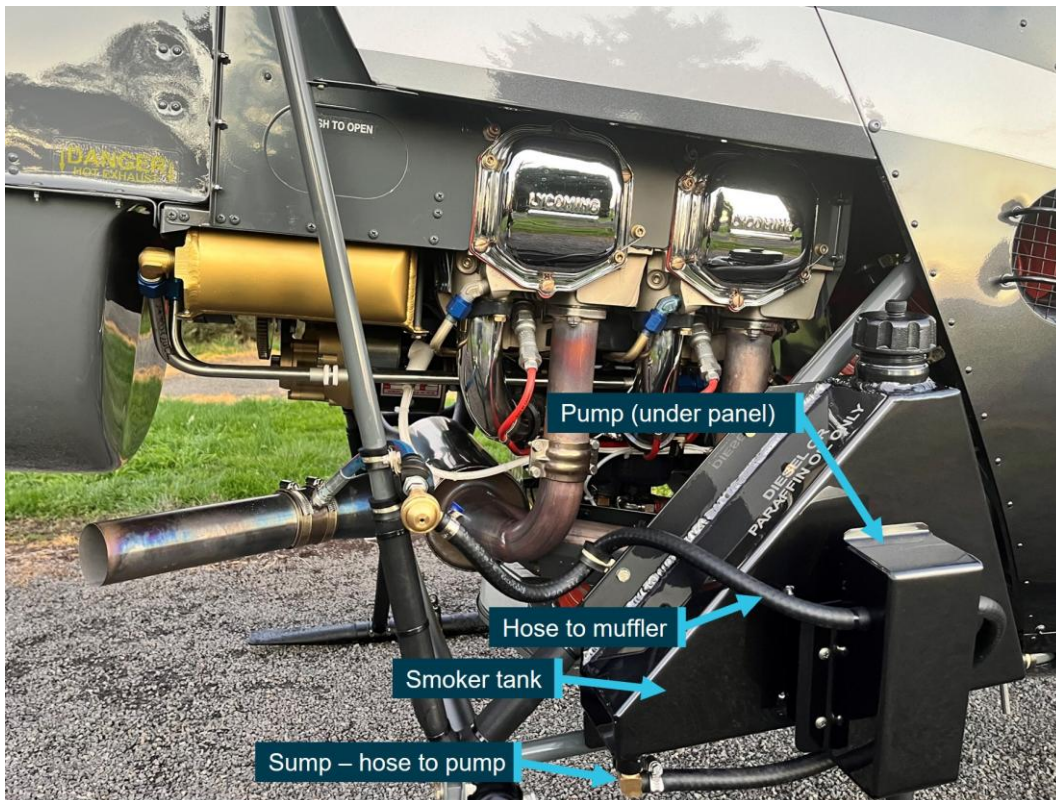
Figure 7: VH-HQH smoker unit installation

During this recent overhaul, HQH was fitted with several optional items including a carbon fibre console cover, carbon fibre battery box, and a smoker unit to aid in aerial mustering operations (Figure 7).¹ The smoker consisted of a small tank (about 5 L capacity), that was filled with either diesel or paraffin oil and mounted on the right-side lower frame.

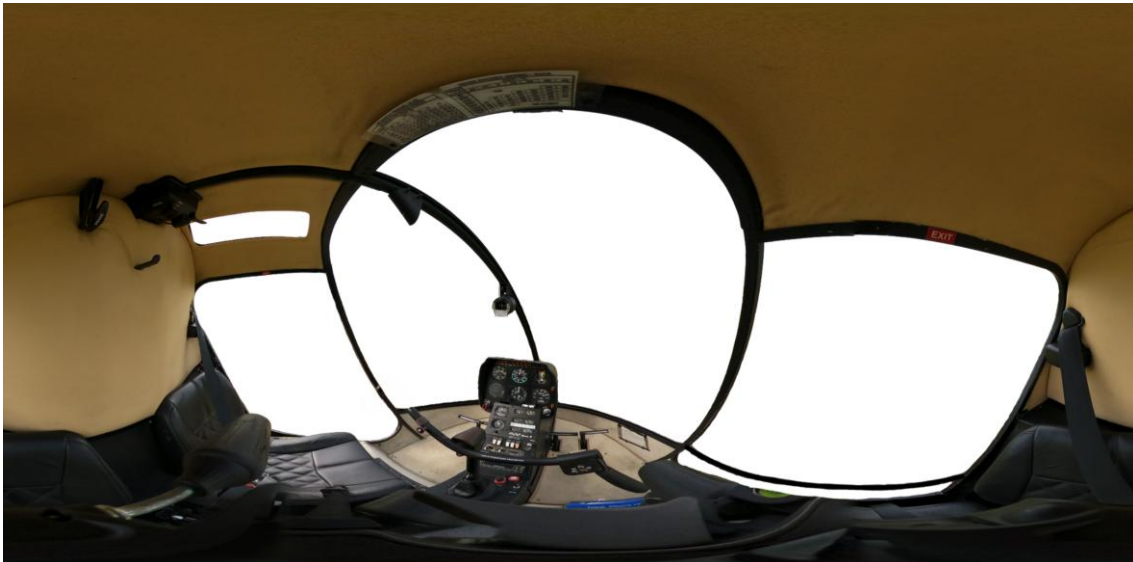
Figure 16: Equirectangular cockpit image of exemplar R22

Due to the lack of available flight path and aircraft body angle information it was not possible to complete a full visibility analysis from both aircraft. However, it was possible to demonstrate the limitations to visibility presented by the R22's cockpit by using a cockpit mask from the pilot's perspective (Figure 16). Refer to *Appendix A – Visibility and R22 exemplar cockpit mask* for more detail.

The cockpit mask in Figure 16 was developed from a 360° equirectangular image taken from a location approximating the eye position of a person seated in the pilot's seat. This position was determined from medical records and an exemplar pilot of similar height.

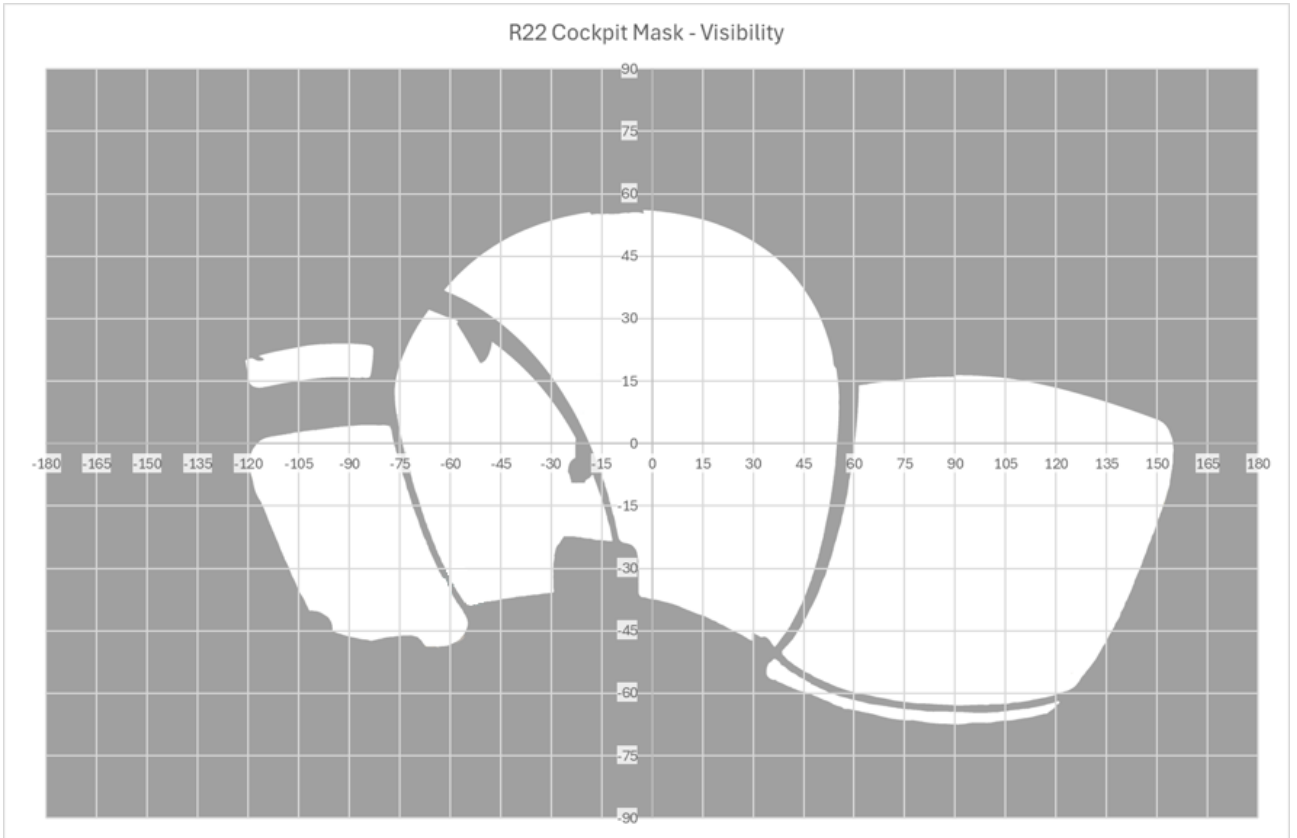
Figure 18: R22 generic mask with grid overlay

Figure 18 shows the mask overlain with a 15° marked grid in both azimuth and elevation angles.

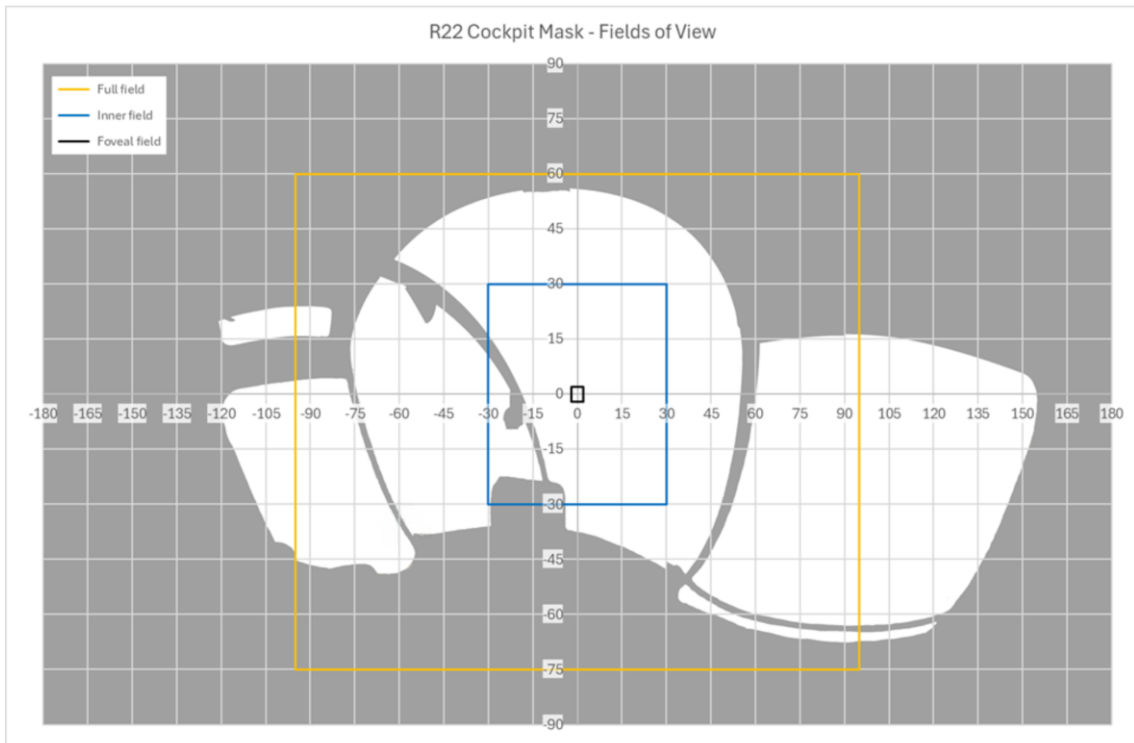
Figure 19: R22 generic cockpit mask showing fields of view

Figure 19 shows approximate areas of the visual field overlain on the R22 generic cockpit mask as developed earlier. In this case the field of view has been positioned as if the eyes are directed straight ahead to demonstrate the size of the field. Rotation of the eyes will change where in the FOV parts of the structure appear, which may impact visual acquisition of the target. It is important to note that movement of the head may also impact FOV but it will impact the relative location of the structure so modelling rotation of the head would require a different cockpit mask.
