Midair collision involving Jabiru UL 450, 19-4079, and Cessna 182, VH-APN

2.7 km west of The Oaks, New South Wales, on 26 October 2024

ATSB Transport Safety Report
Aviation Occurrence Investigation
AO-2024-054
Interim – 4 December 2025

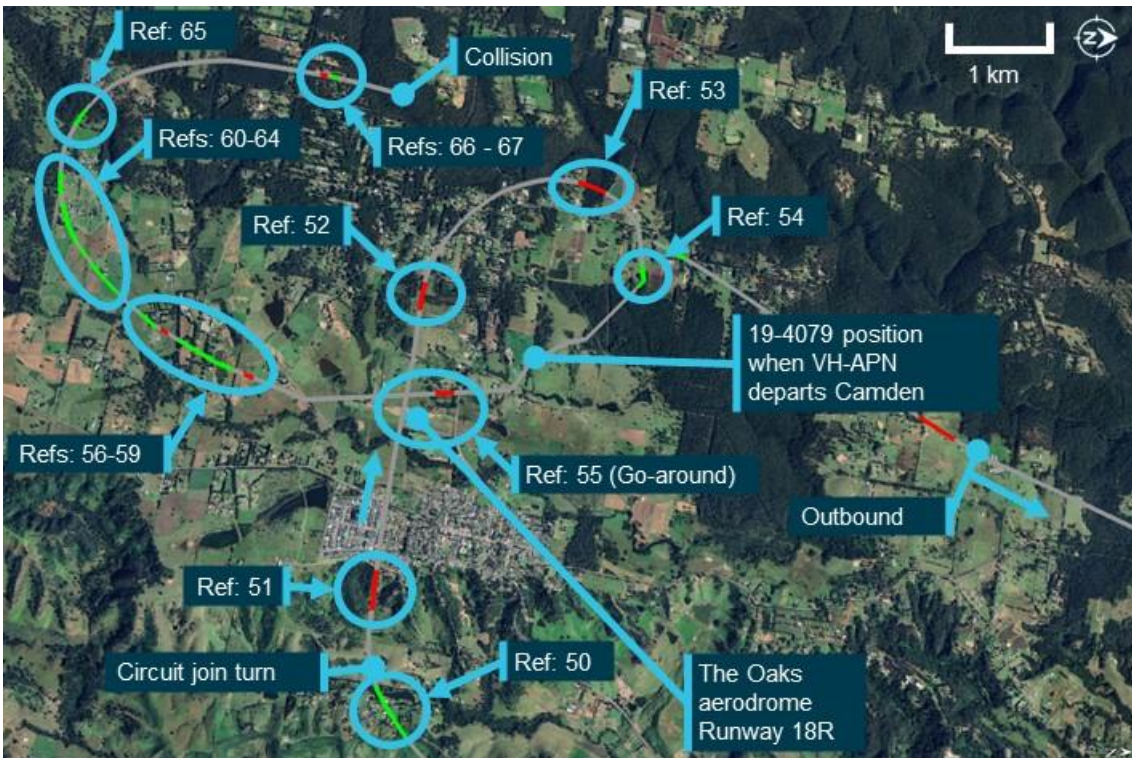
Figure 11: Flight track showing the position of 19-4079 with no transmission was detected (grey lines), and when radio calls were transmitted (red lines) and received (green lines) by 19-4079 after returning to The Oaks to the collision

As 4079 was on the upwind and crosswind legs, 3 groups of transmissions occurred, with references 56–59, 60–64 and 65 in Table 2 and Table A2, and aircraft positions circled in Figure 11, Figure 12 and Figure 13. Around this time, the 2 pilot witnesses both recalled 3 communications exchanges, specifically:

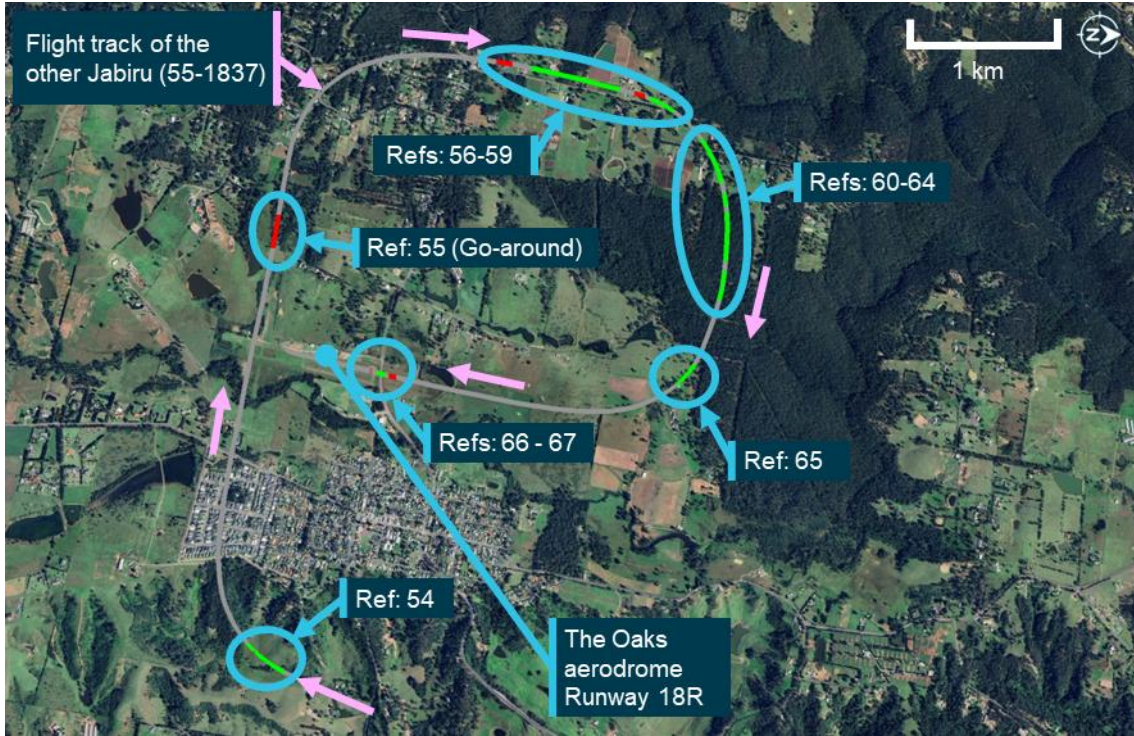
Figure 12: Flight track of the other Jabiru, showing positions with no transmissions detected (grey lines), and when signals were transmitted (red lines) and received (green lines) by 19-4079 after returning to The Oaks to the collision

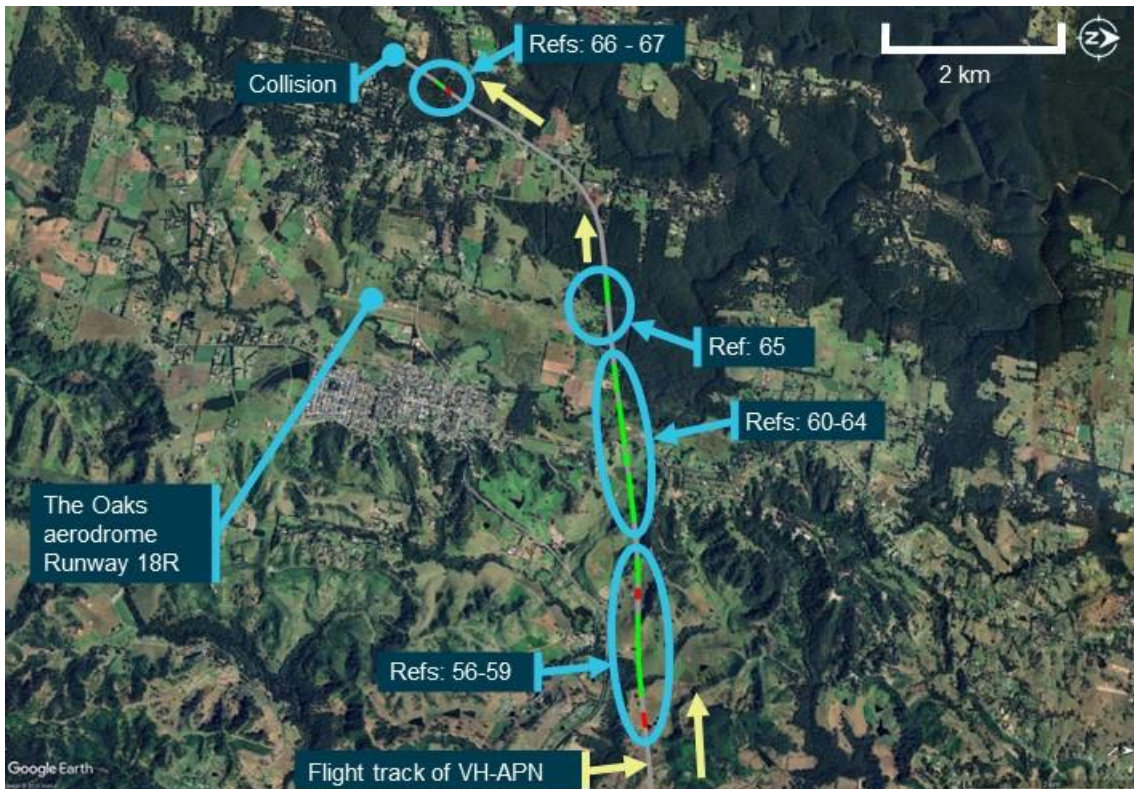
Figure 13: Flight tracks of VH-APN and the other Jabiru, showing where no transmissions were detected (grey lines), and when signals were transmitted (red lines) and received (green lines) by 19-4079 after returning to The Oaks to the collision

The ATSB identified that terrain shielding was possible between the Sonex and APN after APN departed Camden airspace. A notable period for potential shielding was around the time that APN turned left and started to climb, after radio call with reference 65 (Figure 13 and Table 2). The line of sight between the Sonex and APN has not been fully assessed. However, at the time of the radio calls with reference 60–64 (Figure 13 and Table 2), APN was likely in line of sight of the Sonex.
