Loss of control and collision with water involving Cessna 208 Caravan amphibian, VH-WTY

Rottneest Island, Western Australia, on 7 January 2025

ATSB Transport Safety Report
Aviation Occurrence Investigation
AO-2025-001
Interim – 19 December 2025

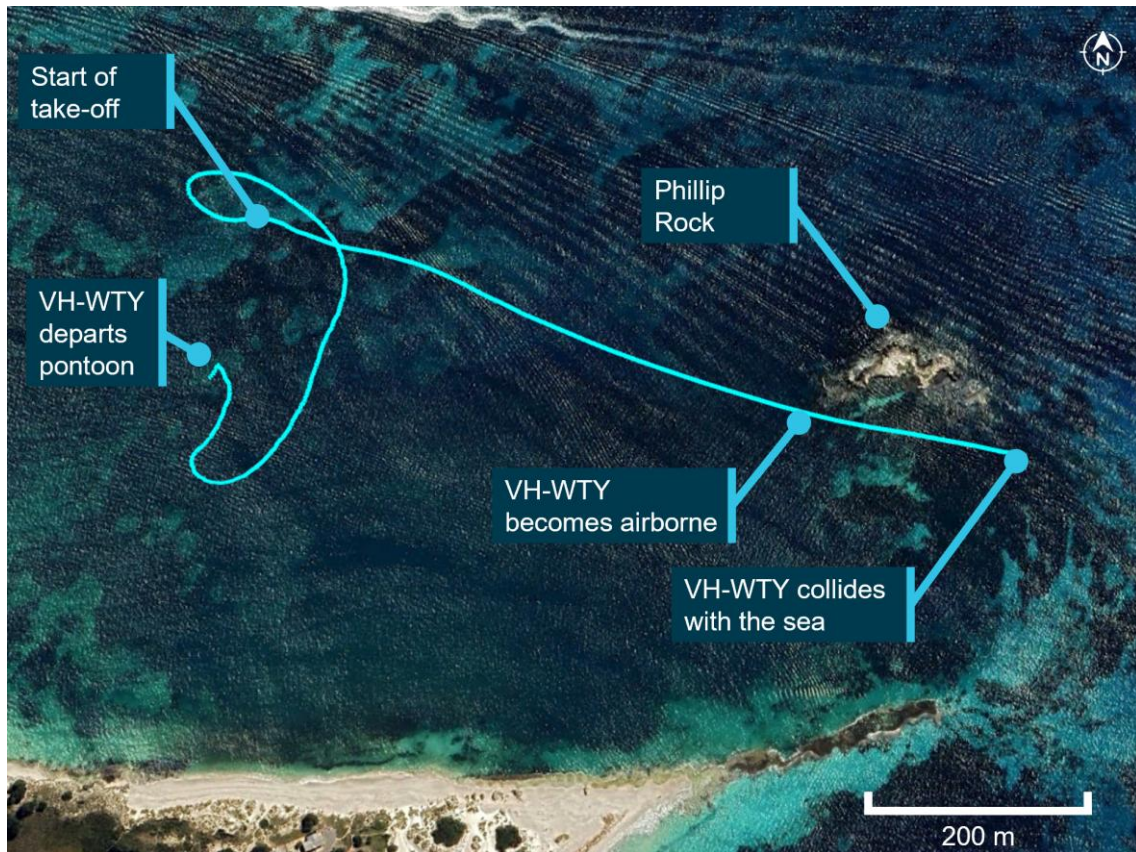
Figure 3: VH-WTY take-off track with approximate location of key events

Figure 3 shows the track of the aircraft during its take-off from Thomson Bay. Recorded data showed that engine power was applied for take-off at about 1600:20. The aircraft accelerated in the plowing position⁴ to about 31 kt groundspeed and 21 kt indicated airspeed (IAS)⁵ by 1600:30, and yawed slightly left, on course towards Philip Rock.

At about 1600:38, as the aircraft accelerated to about 43 kt IAS, the pilot manoeuvred the aircraft onto the step.⁶

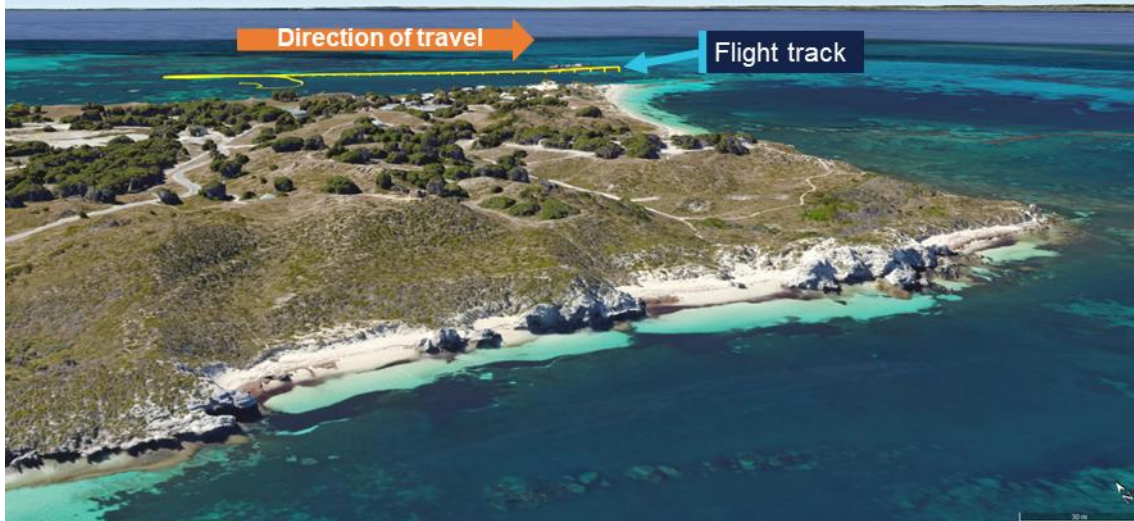
Figure 7: Overhead photograph of Thomson Bay near Phillip Point, with accident flight track of VH-WTY highlighted

The terrain surrounding the bay near Phillip Point includes coastal dunes, some small hills and buildings, with elevation to about 16 m above sea level (Figure 7). Maritime charts showed that the sea in Thomson Bay was around 3–4 m deep, whereas past Phillip Point the depth increased significantly (Figure 8).

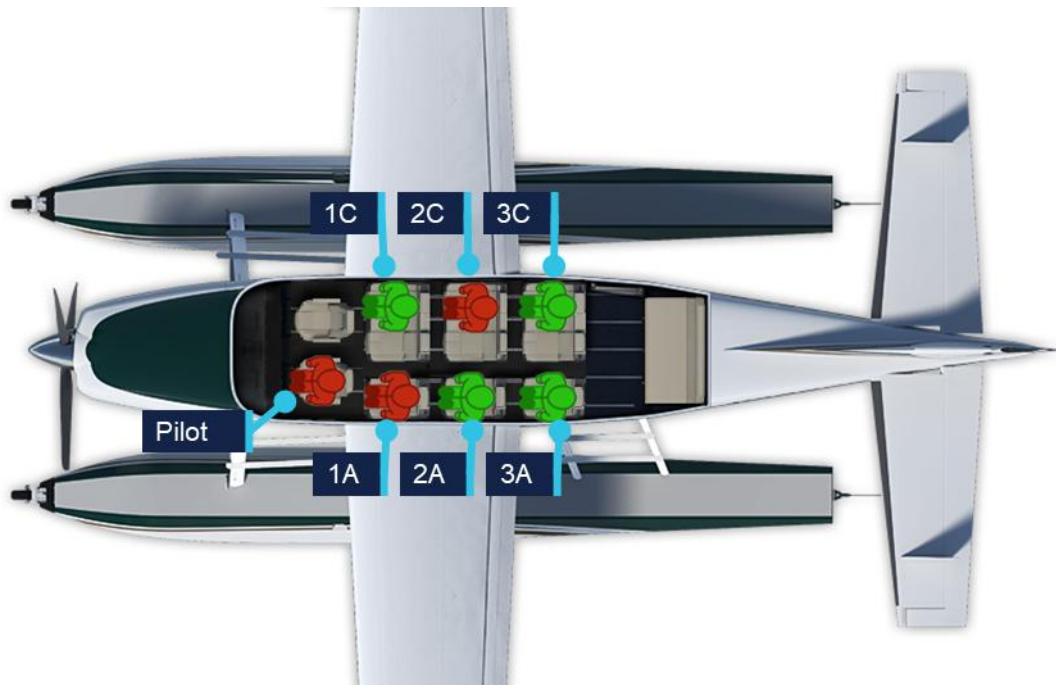
Figure 15: Cessna 208 seating plan showing the occupant location of those who survived (green) and those who sustained fatal injuries (red)

Surviving passengers recalled that the seating positions for the accident flight were as follows (illustrated in Figure 15):

- The pilot was seated in the normal position in the front left seat, and was fatally injured in the accident. There was no passenger seated in the front right seat.
- Two passengers were seated in the first passenger row (seats 1A and 1C), with the central seat vacant. The passenger seated in the left seat was fatally injured in the accident.
- Two passengers were seated in the second passenger row (2A and 2C), with the central seat vacant. The passenger seated in the right seat was fatally injured in the accident.
- Two passengers were seated in the third passenger row (3A and 3C), with the central seat vacant. Both passengers in the third row survived the accident.

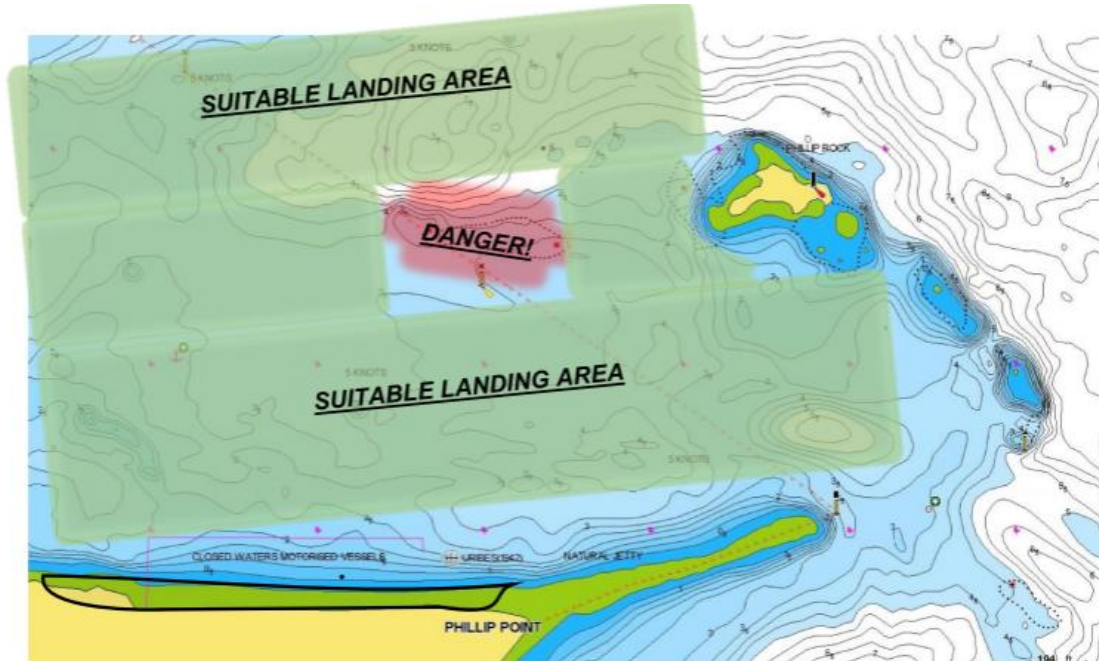
Figure 22: Swan River Seaplanes water alighting area diagram for Thomson Bay

The procedures for the Thomson Bay water alighting area provided a water alighting area diagram, which showed a defined 'suitable landing area' (Figure 22). The procedures did not describe the dimensions of the suitable landing area, and nor did they indicate the tracks which should be utilised for take-offs and landings in the area.

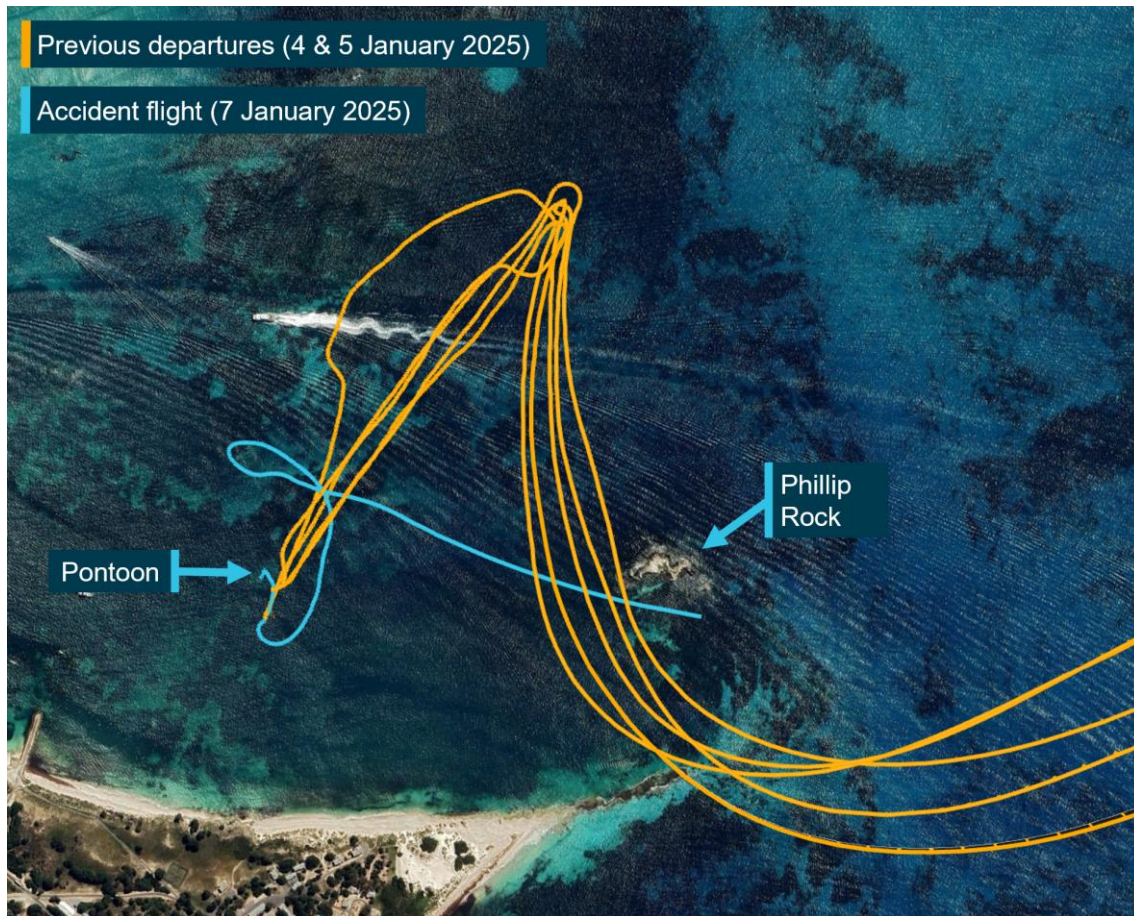
Figure 25: Recorded departure (including taxiing phase) tracks for VH-WTY within Thomson Bay displaying the difference between the accident flight and the previous flights

Flight tracking information from the accident aircraft, VH-WTY, recorded the flights conducted from Thomson Bay on 4 and 5 January under the command of the Swan River Seaplanes HOFO. All of these flights were conducted on a south-easterly track (Figure 25). The pilot of the accident flight had not conducted a take-off from Thomson Bay using VH-WTY prior to the day of the accident.

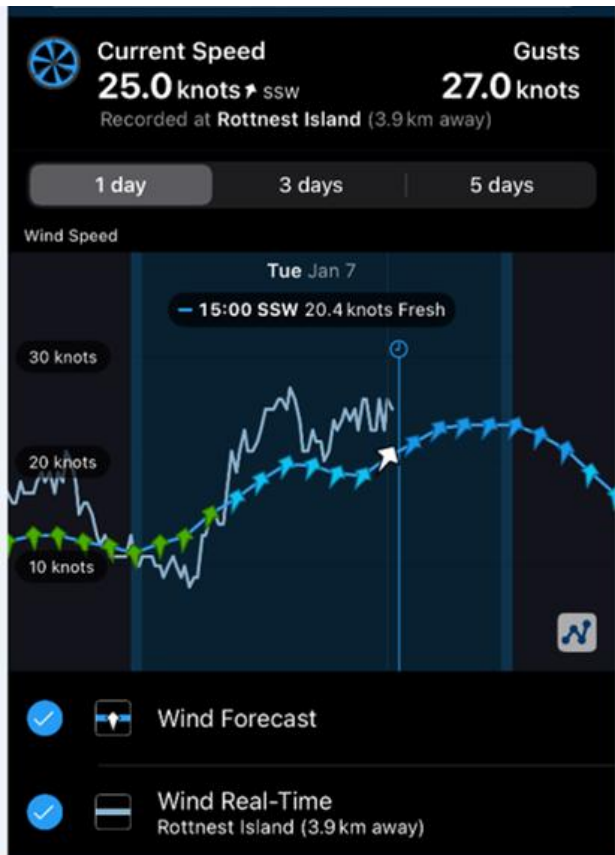
Figure 26: Rottnest Island wind measurement and prediction obtained by pilot of VH-WTY at about 1525 on 7 January 2025

- The HOF0 messaged the pilot at 1116, providing an image from a weather website showing that winds at Rottnest Island were 25 kt with gusts to 34 kt.
- At 1316, the pilot accessed and saved weather observation and forecast information for Rottnest Island. The image showed that winds had been recorded at 25 kt, gusting to 34 kt, and that actual winds were much stronger than predicted.
- At 1525, the pilot accessed the same forecast and saved another image. This showed that winds were still recorded at 25 kt south-south-west, however the gusts had reduced to 27 kt. The image showed forecast winds increasing (Figure 26).

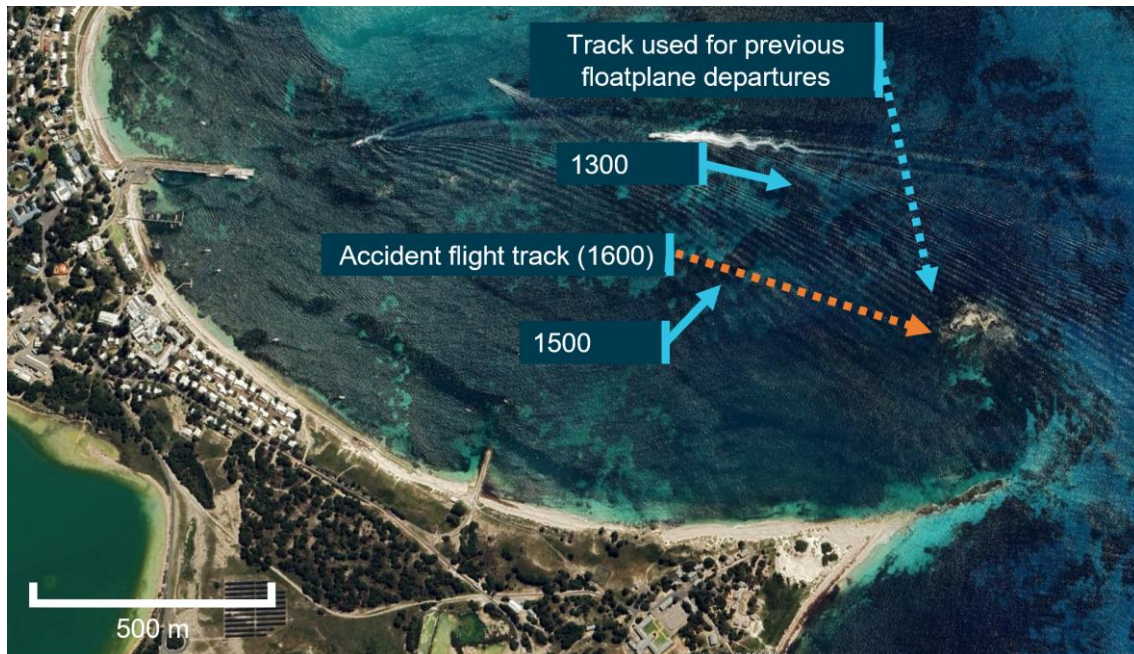
Figure 27: Thomson Bay showing farthest (most easterly) recorded positions of the tender vessel during inspection journeys at 1300 and 1500, 7 January 2025

The tracking data and CCTV showed that the pilot operated the tender vessel solo at about 1300, with the tracking data showing the tender vessel operated to about 400 m north-west of Philip Rock. The vessel was recorded at this location at about 1310 on a heading of 55° at 22 kt. The vessel returned to the jetty at about 1320.

CCTV recorded the coxswain arrive at the jetty and board the tender vessel with the pilot at about 1450. The tracking data showed the tender vessel was then operated to about 450 m west of Philip Rock, before returning to the fuel jetty. Regarding this journey, the coxswain recalled that:
