# **Collision with terrain involving Reims Aviation F406, VH-EYQ**

3 km from Oakey Airport, Queensland, on 20 July 2025

**ATSB Transport Safety Report**  
Aviation Occurrence Investigation  
AO-2025-042  
Preliminary – 10 December 2025

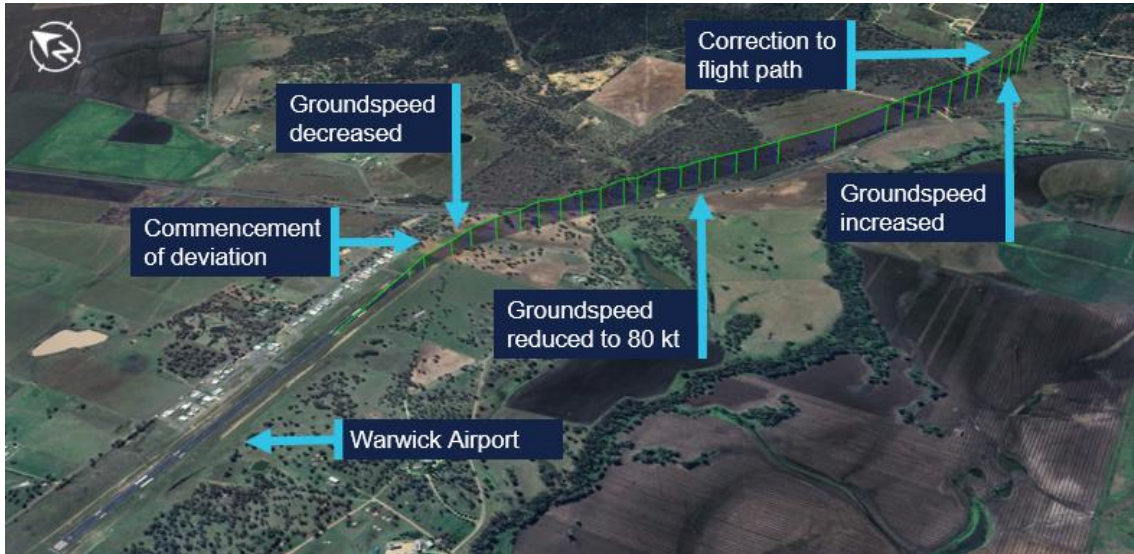
Figure 1: VH-EYQ departure from Warwick Airport

The pilot arrived at Warwick Airport at 1345 where they met the flight examiner. At 1426, the aircraft departed Warwick Airport. About 16 seconds after departure, the aircraft's groundspeed began to decrease from 109 kt, and the aircraft stopped climbing and commenced a slow turn to the right (Figure 1). This turn was not consistent with the submitted flight plan. The aircraft's groundspeed continued to reduce over a period of about one minute to 80 kt (see *Recorded flight data*). The aircraft then began to accelerate before turning left and commencing a climb to an altitude of 6,100 ft above mean sea level.

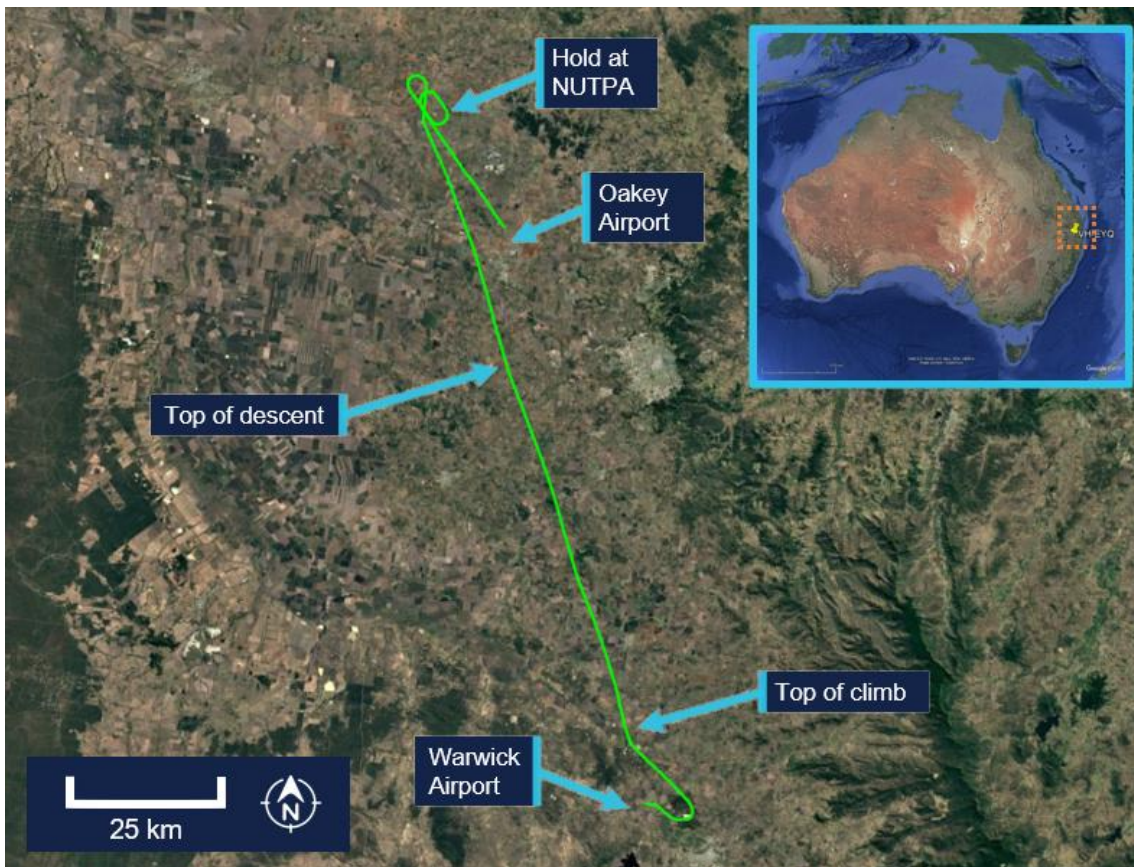
Figure 2: VH-EYQ flight overview

At 1433, Brisbane Centre air traffic control (ATC) issued the pilot with a clearance to track directly to reporting point<sup>3</sup> NUTPA, which was the commencement point for the Oakey Airport runway 14 instrument landing system (ILS)<sup>4</sup> approach (Figure 2).

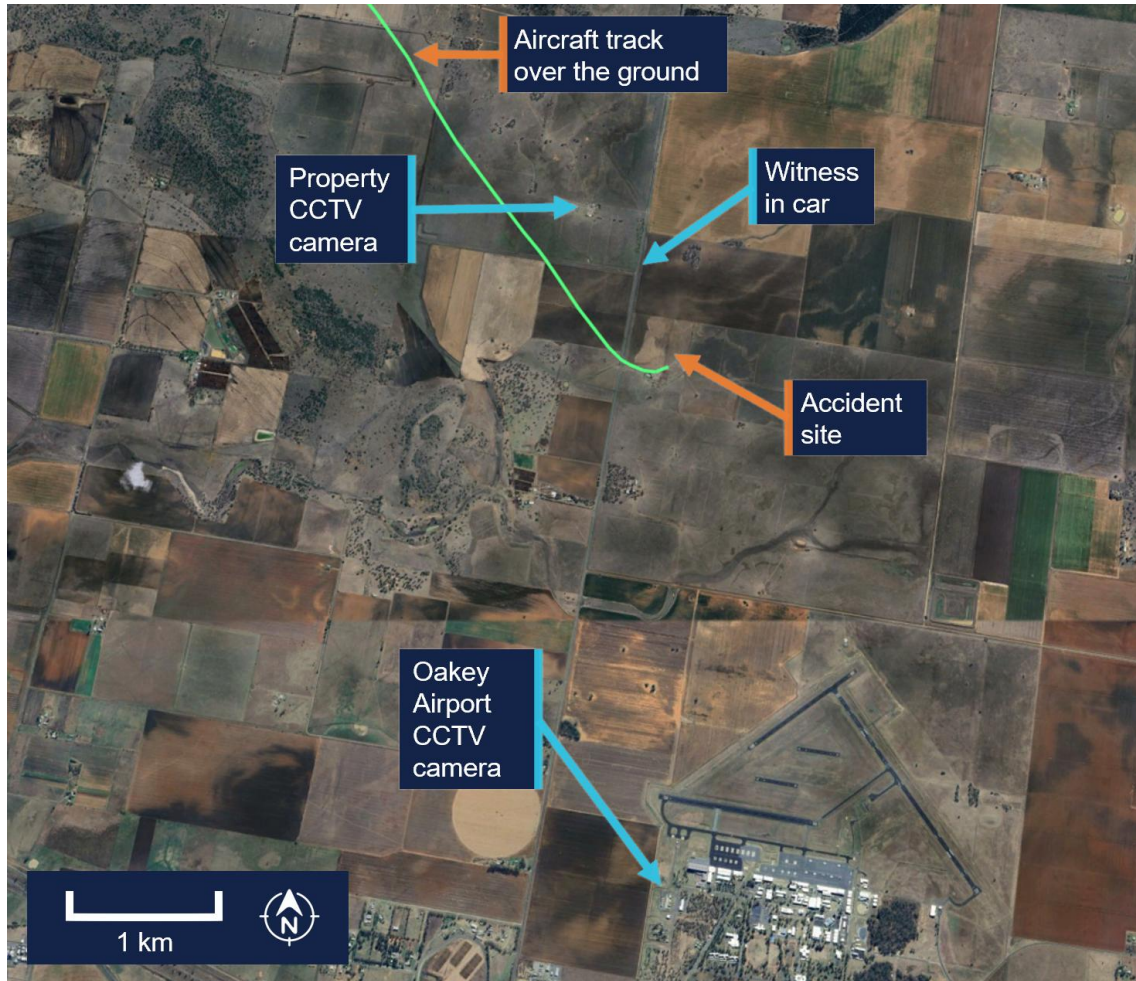
**Figure 4: Witness and closed-circuit television camera locations**

A motorist travelling south observed the aircraft on approach and maintained visual contact with it for about 3 km (Figure 4). They observed the aircraft commence a flat turn and yaw<sup>7</sup> to the left at a height of about 300 ft AGL and pass above the road ahead of them. They recalled seeing the aircraft then roll to the left, pitch down, and impact the terrain.

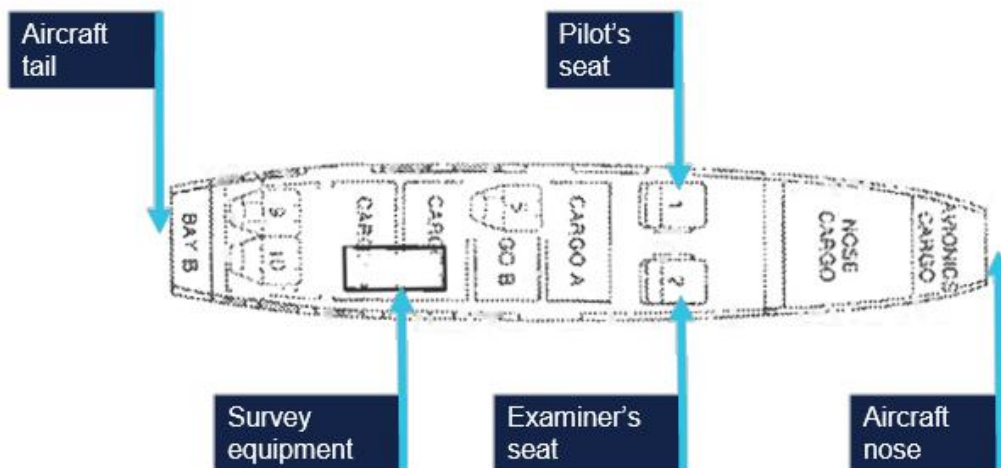
Figure 7: VH-EYQ cabin configuration

VH-EYQ was configured in a 5-seat survey layout. This comprised the pilot (left) and copilot (right) seats in the front row, followed by 1 passenger seat in row 3, and 2 passenger seats in row 5. The remaining passenger seats were removed from the cabin to accommodate the installation of aerial survey equipment (Figure 7). An electronic loading system had been generated for this configuration by an approved load controller, and records show that this was utilised by the pilot for previous flights.

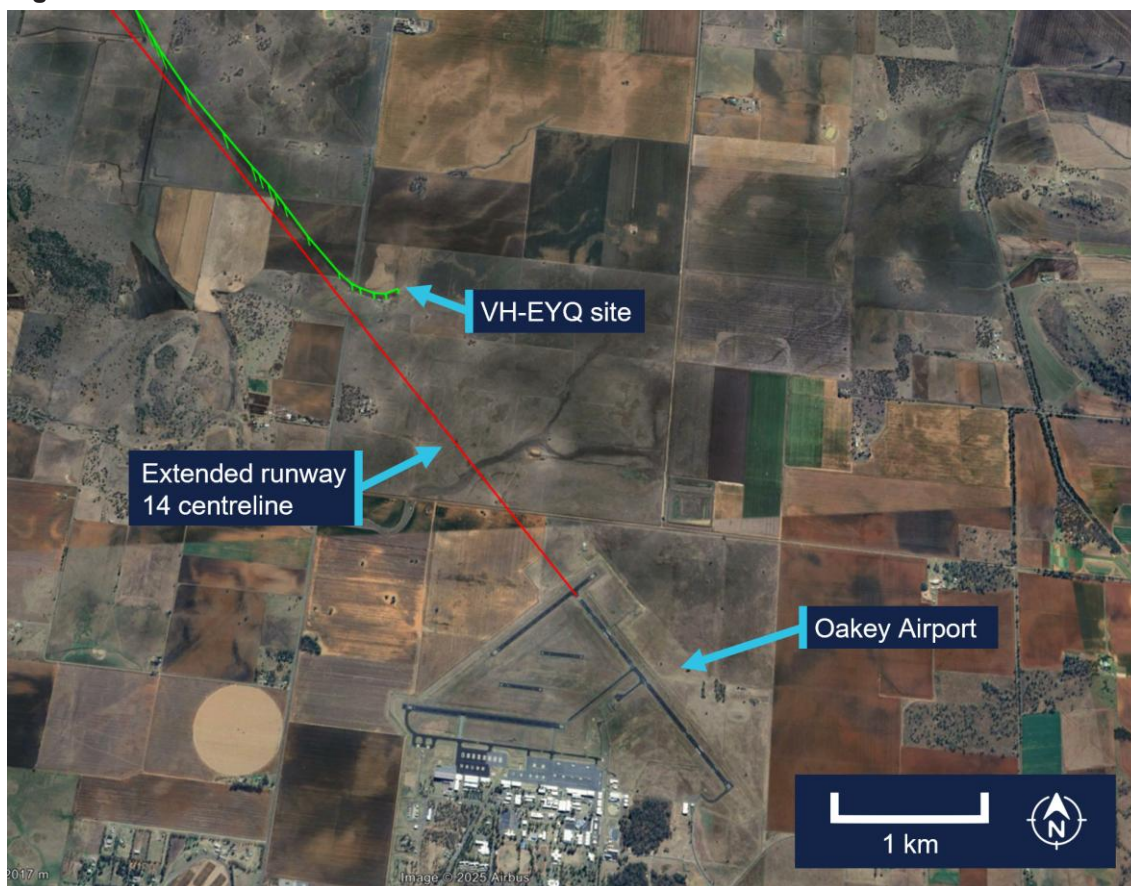
**Figure 8: Location of accident**

The ATSB conducted an onsite examination of the aircraft wreckage, which was located in an open paddock about 2.6 km from the threshold of runway 14 at Oakey Airport (Figure 8).

The wreckage was confined to a 30 m radius of the accident site. The impact marks and wreckage position indicated the aircraft impacted terrain left wing low with little forward momentum. Ground scars indicated the aircraft moved about 6 m after the initial impact. All components were upright.

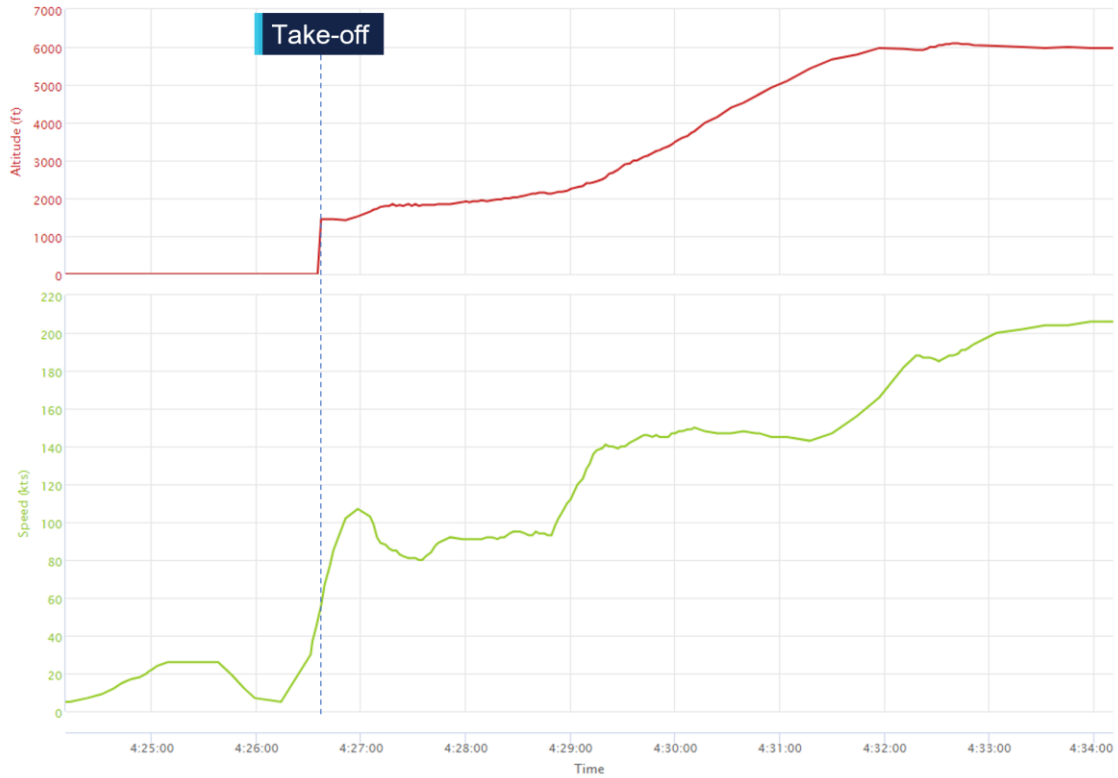
**Figure 11: VH-EYQ altitude and groundspeed during the Warwick Airport departure**

The ADS-B altitude and groundspeed data for the aircraft's departure from Warwick Airport is depicted in Figure 11.
