# In-flight fire involving Boeing 737, VH-YFY

56 km north-north-east of Hobart Airport, Tasmania, on 21 July 2025

Aviation Occurrence Investigation (Short)

AO-2025-043

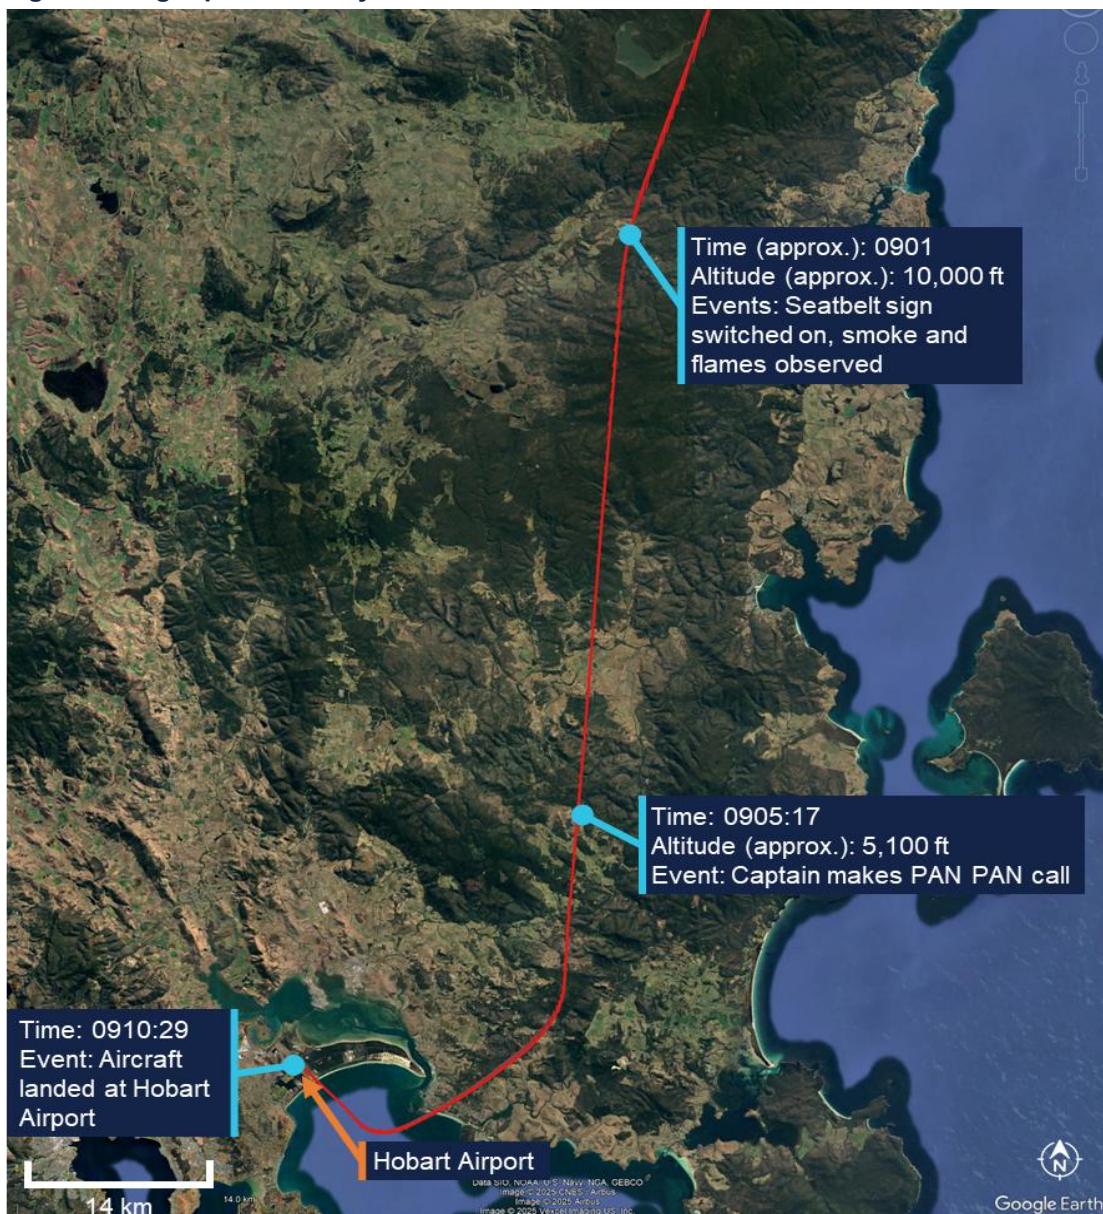
**Figure 2: Flight path with key events**

Flight data provided by Virgin Australia showed that the aircraft touched down at Hobart at 0910:29 (**Error! Reference source not found.**).

The captain stopped the aircraft on the taxiway and exited the flight deck to speak to 1L and observed the cabin to determine whether an evacuation was required. As the fire appeared to be contained, the captain taxied the aircraft to the parking bay. At 0919, the aviation rescue and firefighting personnel boarded the aircraft and removed the backpack from the overhead locker. They confirmed the origin of the fire was a lithium power bank, stored in one of the backpack's front pockets (Figure 3).

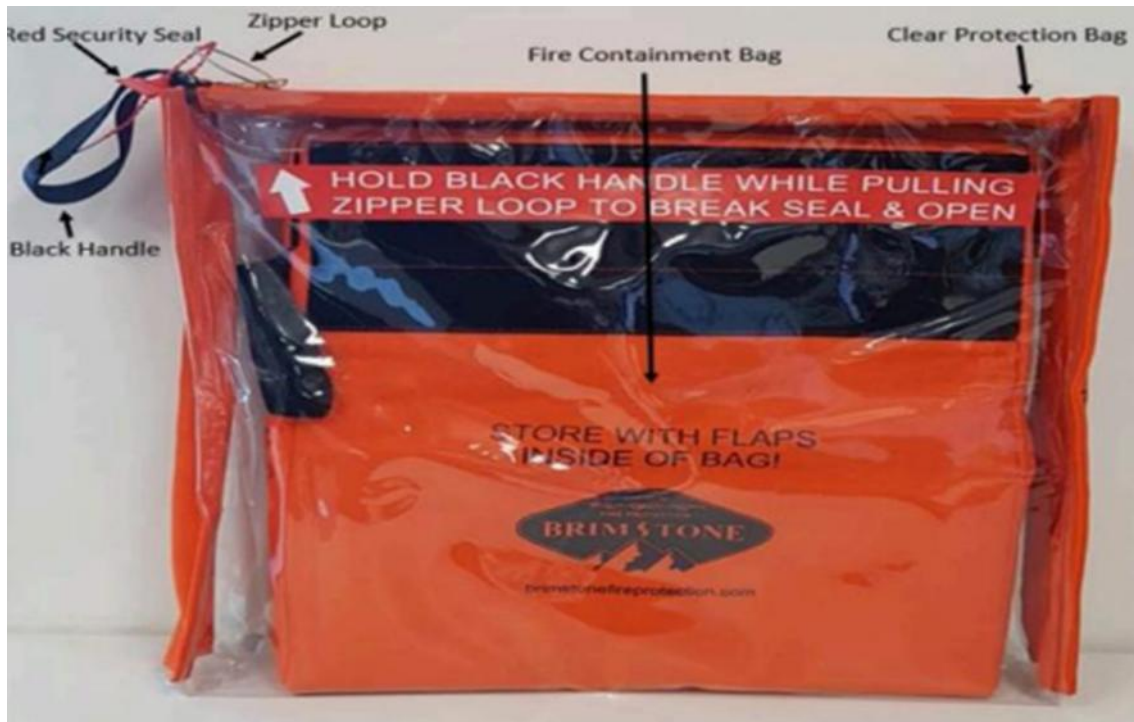
Figure 5: Fire containment bag

A larger bag, designed to fit a device the size of a laptop, was carried in the aircraft cabin (Figure 5). The purpose of this bag was to place the device in after it was cooled post-fire, so that it could be stored in a water filled container in a secure place.
