Premature parachute deployment involving Cessna 208, VH-DVS

over Tully Airport, Queensland, on 20 September 2025

ATSB Transport Safety Report

AO-2025-057

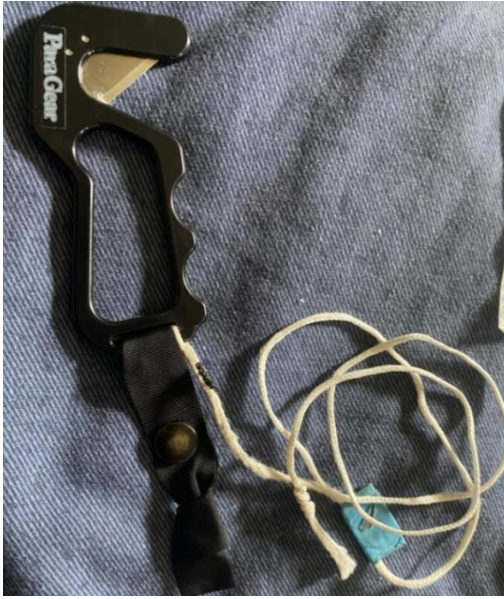
Figure 10: Parachutist's hook knife and lanyard

- Sunpath Javelin Odyssey harness and container, SN 25429, manufactured December 2003.
- Airtec CYPRES 2 Expert automatic activation device, SN 96270 manufactured July 2014.
- Icarus Safire 2 139 main parachute, which was royal blue, fluoro yellow with a white centre cell.
- Bottom of container throwaway main deployment type.
- Performance Designs Optimum 143 reserve parachute, SN 25632, manufactured in October 2021. The reserve was repacked on 13 August 2025 by Freefall Support and valid for 12 months.
- A hook knife in a pouch attached to their chest strap and secured with a lanyard (Figure 10).

This accident highlights the importance of parachutists being mindful of their handles particularly when exiting the aircraft. Additionally, this accident demonstrates that carrying a hook knife secured to the parachute container could be lifesaving in the event of a premature reserve parachute deployment. It is also a reminder for pilots conducting parachute operations of the importance of wearing an emergency parachute and knowing how to deploy it. Parachute aircraft operators should also ensure, where possible, that there is a suitable open door for the pilot to exit in the event of an irretrievable loss of aircraft control.
