Loss of control and collision with terrain involving a Morgan Cougar Mk1 aircraft, VH-LDV

19 km north-north-west of West Sale Airport, Victoria, on 16 November 2024

ATSB Transport Safety Report

AO-2024-058

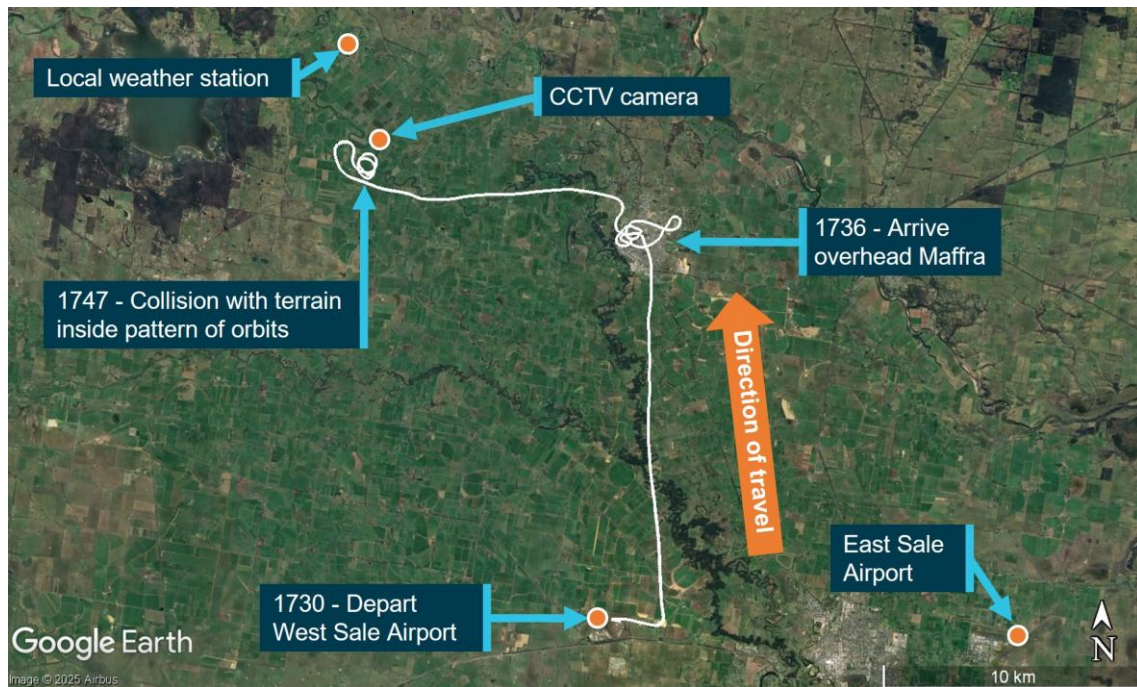
Figure 1: Accident flightpath with key timings and locations

At 1730 local time on 16 November 2024, an amateur-built Morgan Cougar Mk 1 aircraft, registered VH-LDV, with a pilot and 2 passengers on board, departed from West Sale Airport, Victoria for a local area flight. The pilot was seated in the front left seat, and the passengers were seated in the front and rear right seats. A review of Airservices Australia automatic dependent surveillance-broadcast (ADS-B) data identified that the aircraft conducted a left turn on departure and tracked 15 km north of West Sale Airport to the town of Maffra, where they arrived overhead at about 1736 (Figure 1).

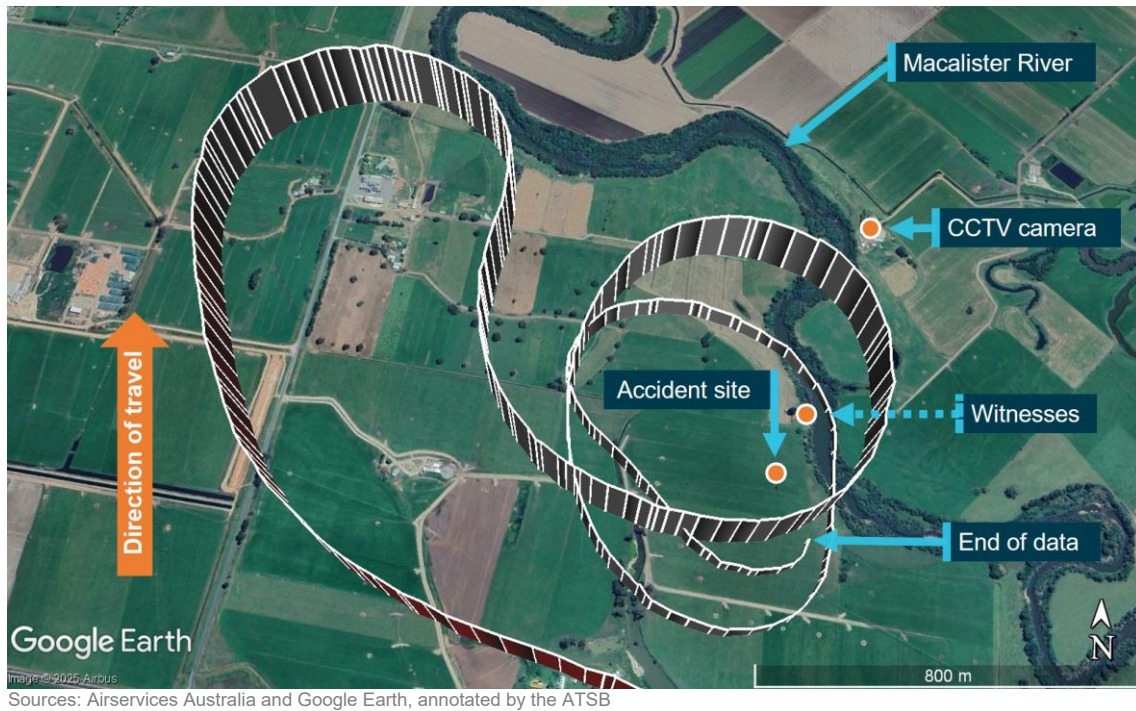
Figure 2: Orbits and the location of witnesses

The aircraft made a series of turns overhead the town of Maffra for about 4 minutes. At 1740, the aircraft departed from overhead Maffra and tracked about 11 km west towards Tinamba West. The aircraft conducted a right-hand turn overhead a property at Tinamba West, which belonged to relatives of the aircraft occupants, before commencing a series of left-hand turns (orbits) around a point about 1 km to the south-east of the property over open paddocks (Figure 2).

On the second orbit, the aircraft made a low pass along the Macalister River, adjacent to where several witnesses, which included 2 adults, were located. The 2 adults later stated that they had witnessed the aircraft conduct 2 orbits past their location before the accident. They reported the second pass along the river was lower than the first, such that they could both see the occupant in the rear seat, and that the aircraft sounded normal.

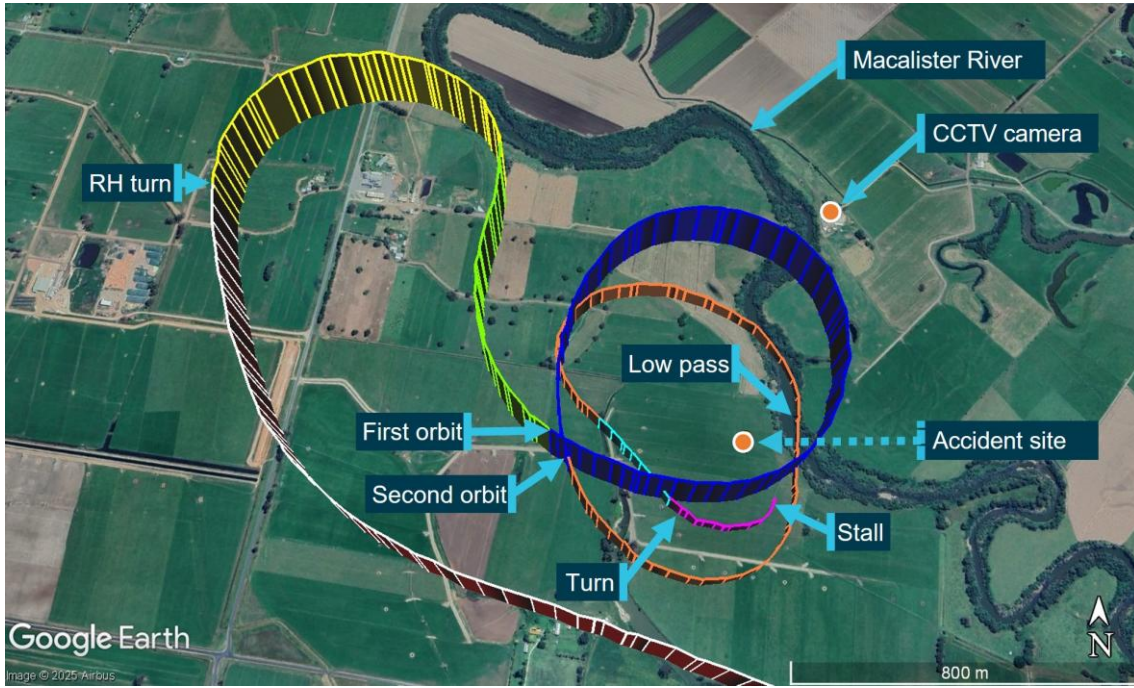
Figure 16: Accident flight path

With reference to Figure 16:

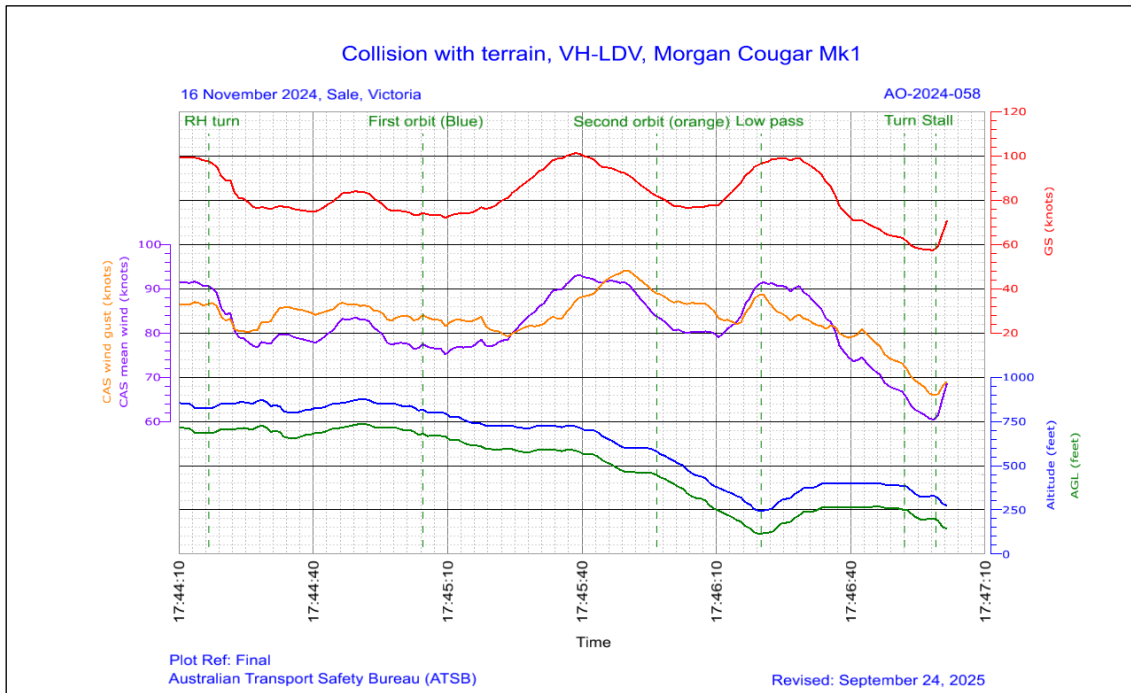
Figure 17: Plot of ADS-B data and CAS calculations with the start of each orbit

In the accompanying Figure 17, the start of the right turn (RH turn), start of the first orbit (First orbit), start of the second orbit (Second orbit), low pass (Low pass), start of the final turn (Turn) and stall (Stall) are annotated. The lowest speeds were recorded on the segment from the final turn to the stall, which was also the segment with the smallest turn radius.
