Flight control event involving Embraer E190, VH-UZD

29 km south-east of Launceston Airport, Tasmania, on 15 April 2025

Aviation Occurrence Investigation (Short)

AO-2025-021

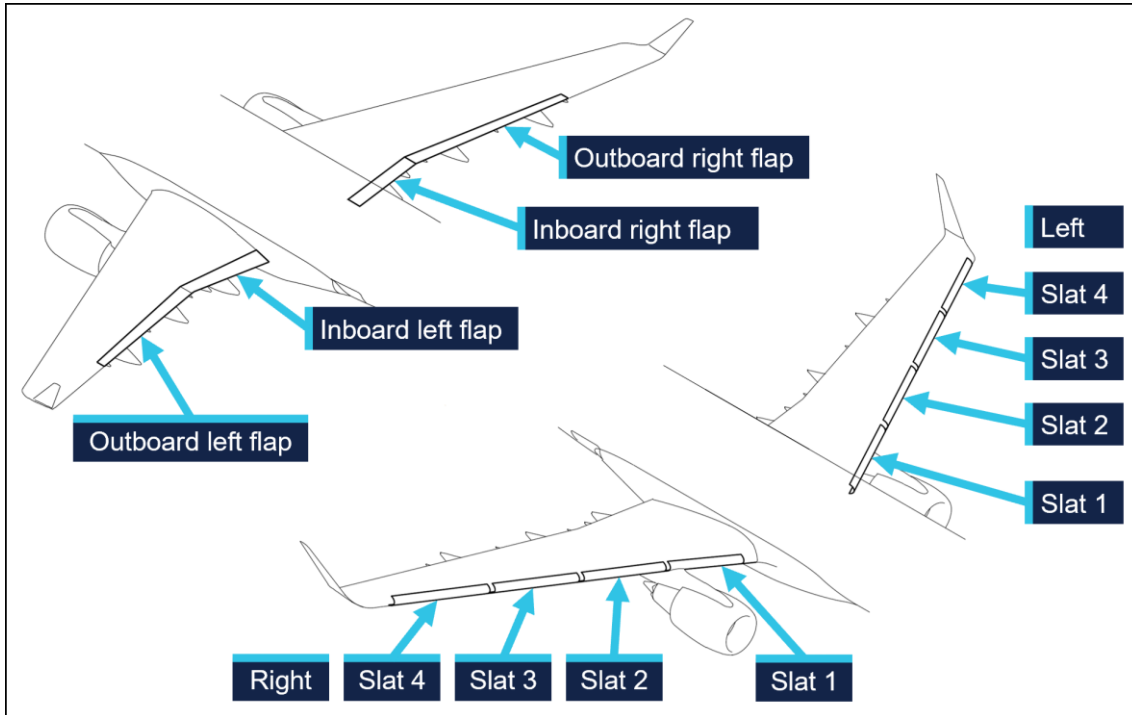
Figure 3: Embraer E190 slats and flaps

The E190 is fitted with devices to increase the lift produced by its wings during take-off and landing. On the leading edges of the wings there are 8 slat panels and on the trailing edges of the wings there are 4 flap panels (Figure 3), where each set (slats/flaps) extends and retracts together.

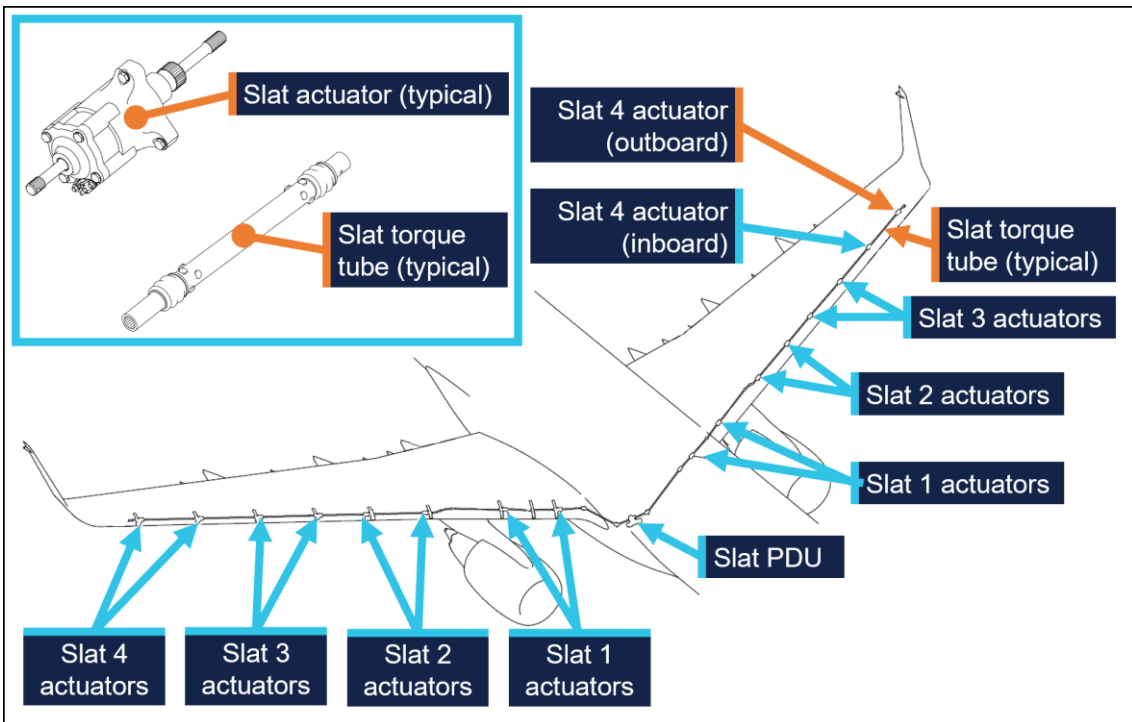
Figure 4: Embraer E190 slat drive system

Slat and flap extension and retraction is controlled from the cockpit by using the slat/flap control lever (SFCL). When the SFCL is moved from its 0 (up) position,⁷ the flap and slat power drive units (PDUs) drive torque tubes which in turn drive actuators, transferring the rotary motion of the torque tubes to linear motion that extends the slats and flaps (Figure 4 and Figure 5).
