Australian Government
Australian Transport Safety Bureau

Ground proximity alerts involving Sikorsky S-92A, VH-IPE

71 km north-north-west of Exmouth Aerodrome, Western Australia, on
1 February 2025

ATSB Transport Safety Report
Aviation Occurrence Investigation (Defined)
AO-2025-005
Final – 4 February 2026

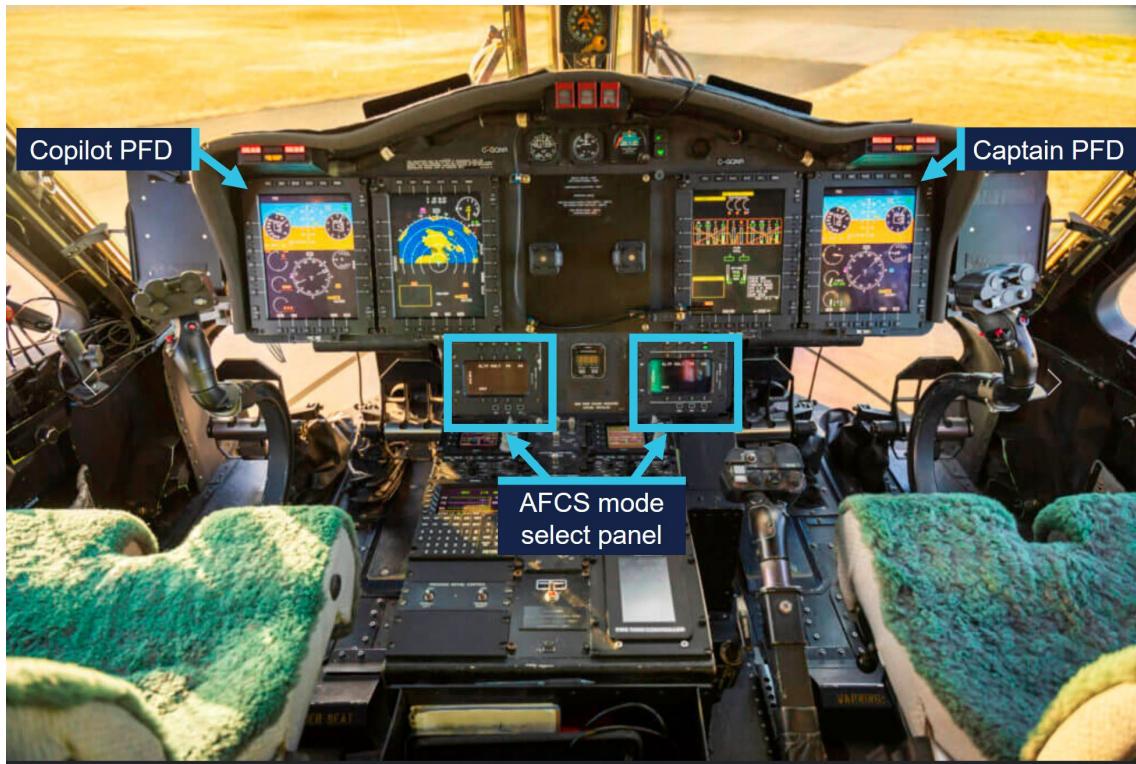
Figure 3: Sikorsky S-92A cockpit

All operators of Sikorsky S-92A helicopters are advised of the potential hazard that exists with differing display versions of the automatic flight control system mode select panel. Due to the lighting design of the panel, distinguishing between hard and soft keys is more difficult at night. More recent versions of the mode select panel include a tactile white finger barrier installed between the rows of hard and soft keys which reduce but do not eliminate the risk of a mode selection error.

Two AFCS mode select panels were located on the lower middle section of the helicopter instrument panel (Figure 3). The rotorcraft flight manual described the mode select panel (MSP) functions:

The S-92A cockpit lighting environment was reviewed by the operator with subject matter experts to consider if an engineered improvement was practicable. A procedural change was implemented by PHI International Australia that required the use of small lights that are worn on the pilot's fingers to improve visibility of the cockpit environment (such as switches, buttons, and controls) during S-92A night flights.

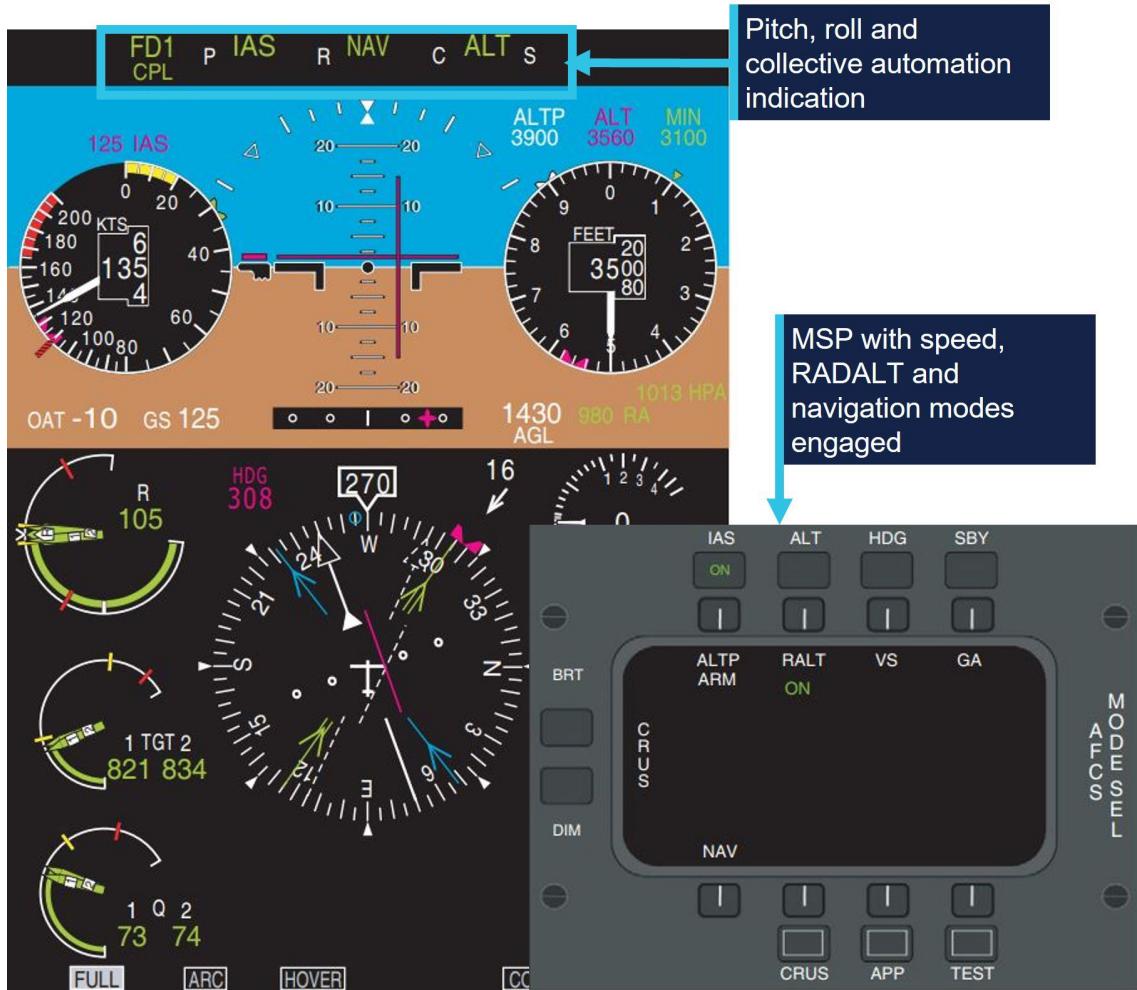
Figure 6: Sikorsky S-92A primary flight display

colour or lighting to the soft key itself when selected. Active automation modes captured on the AFCS MSP were also displayed on the flight crew's primary flight display (PFD) (Figure 6).
