VFR into IMC and controlled flight into terrain involving Cirrus SR20, VH-TEL

12 km east of Braidwood/Percheron aircraft landing area, New South Wales, on 18 September 2025

ATSB Transport Safety Report

AO-2025-056

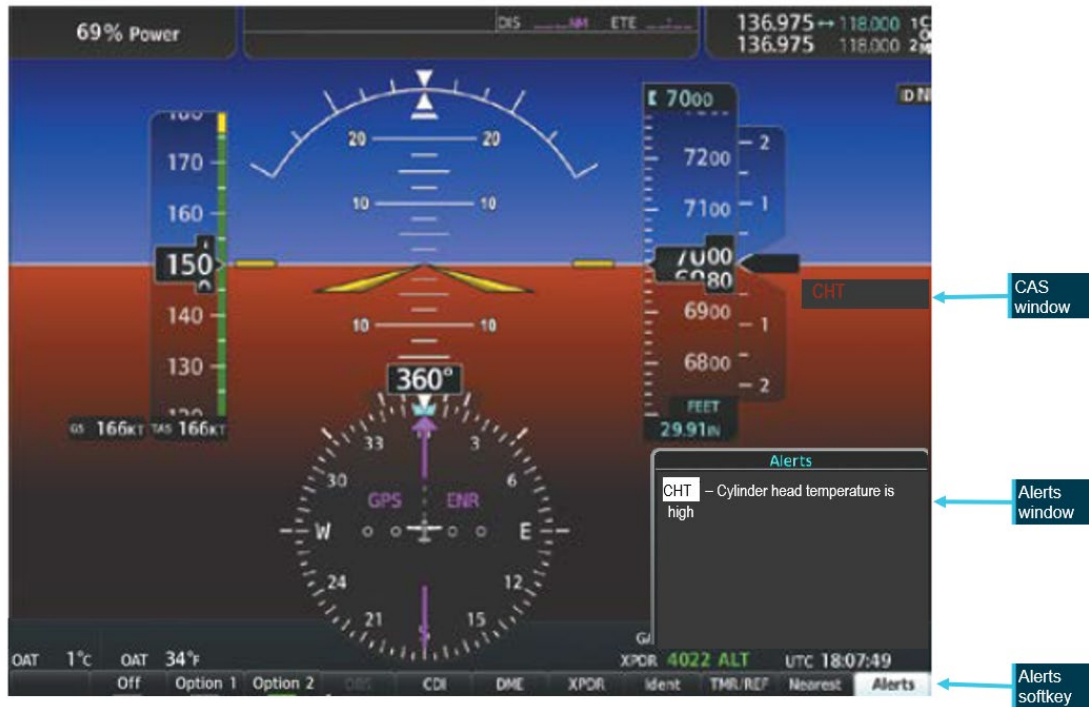
Figure 8: Exemplar window showing the crew alerting system (CAS) location and text for a CHT warning, the highlighted alerts softkey, and related alerts window text

In the event CHT exceeds 420°F, the MFD will display “Check CHT” in a yellow advisory box in the lower right corner of the MFD. In the event CHT exceeds 460°F, the MFD will display “Check CHT” in a red advisory box in the lower right corner of the MFD.

The emergency procedure for a high cylinder head temperature from the Cirrus SR20 *Airplane Flight Manual (AFM)* indicated that if the CHT is in the caution range to land as soon as practical, and if it is in the warning range to land as soon as possible.¹⁸

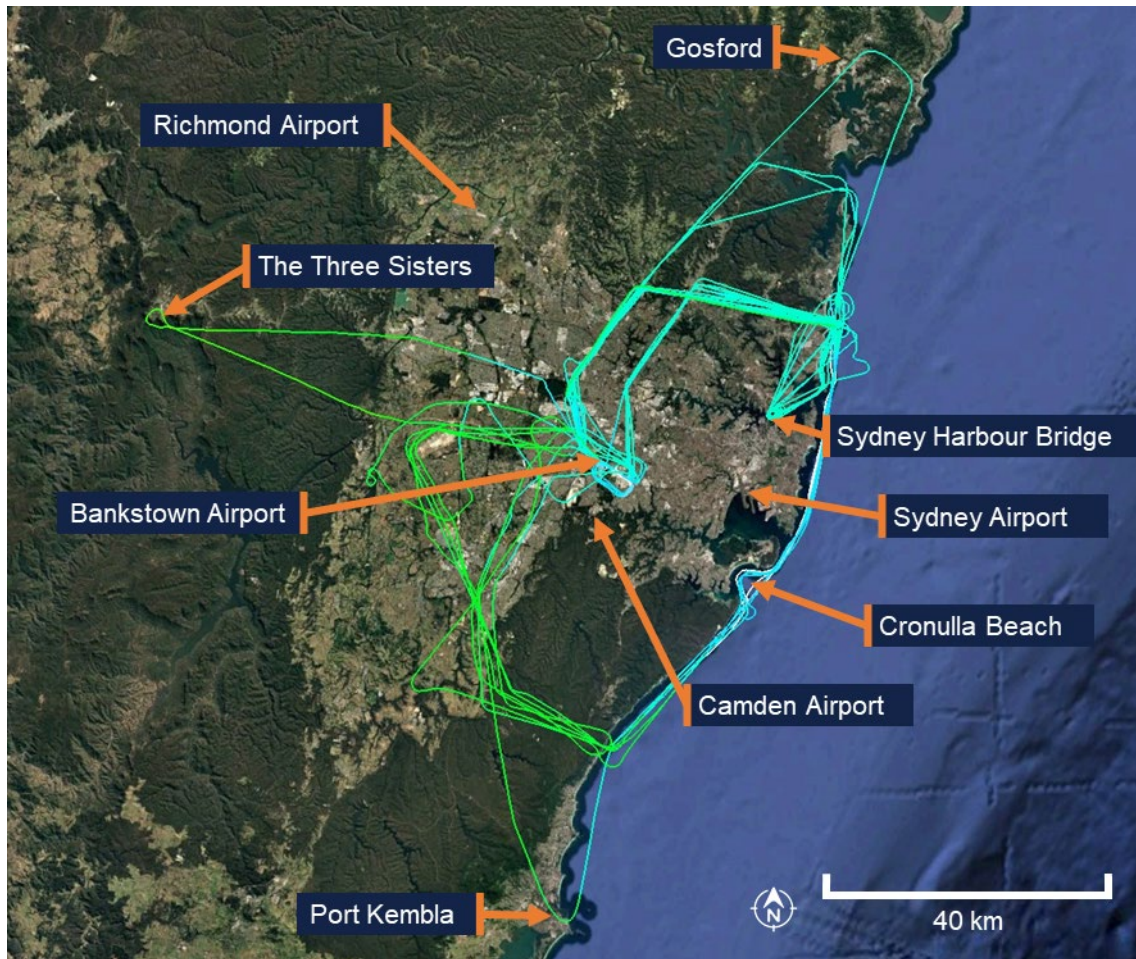
Figure 10: Previous flight data

In the 12 months preceding the accident, the pilot had accumulated 31.9 hours of flight time between the Cirrus SR20 and the Piper PA-28 Cherokee. The pilot's longest flight during this period was 1.9 hours in duration, with an average flight time of 1.4 hours. All flights were conducted within the Sydney area, with the furthest north being Gosford, the furthest south being Port Kembla, and the furthest west being the mountainous area around the Three Sisters landmark in the Blue Mountains (Figure 10). The accident flight was the pilot's first flight of more than 4 hours since January 2023.
