VFR into IMC and controlled flight into terrain involving Cirrus SR20, VH-TEL

12 km east of Braidwood/Percheron aircraft landing area, New South Wales, on 18 September 2025

ATSB Transport Safety Report

AO-2025-056

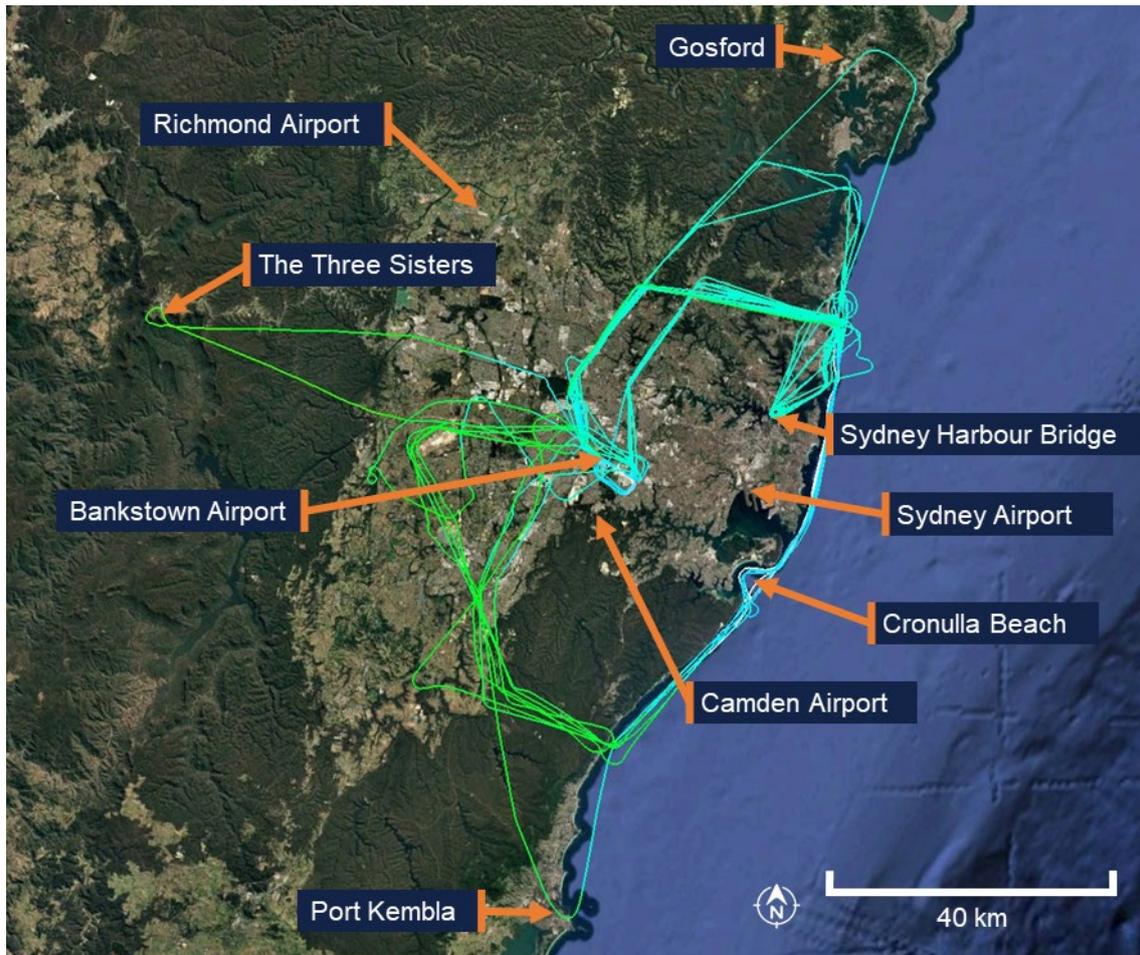
Figure 10: Previous flight data

In the 12 months preceding the accident, the pilot had accumulated 31.9 hours of flight time between the Cirrus SR20 and the Piper PA-28 Cherokee. The pilot's longest flight during this period was 1.9 hours in duration, with an average flight time of 1.4 hours. All flights were conducted within the Sydney area, with the furthest north being Gosford, the furthest south being Port Kembla, and the furthest west being the mountainous area around the Three Sisters landmark in the Blue Mountains (Figure 10). The accident flight was the pilot's first flight of more than 4 hours since January 2023.
