Australian Government
Australian Transport Safety Bureau

Collision with terrain following an engine power loss involving Cessna 172M, VH-WTQ

12 NM (22 km) north-west of Agnes Water, Queensland | 10 January 2017

ATSB Transport Safety Report
Aviation Occurrence Investigation
AO-2017-005
Final – 17 October 2019

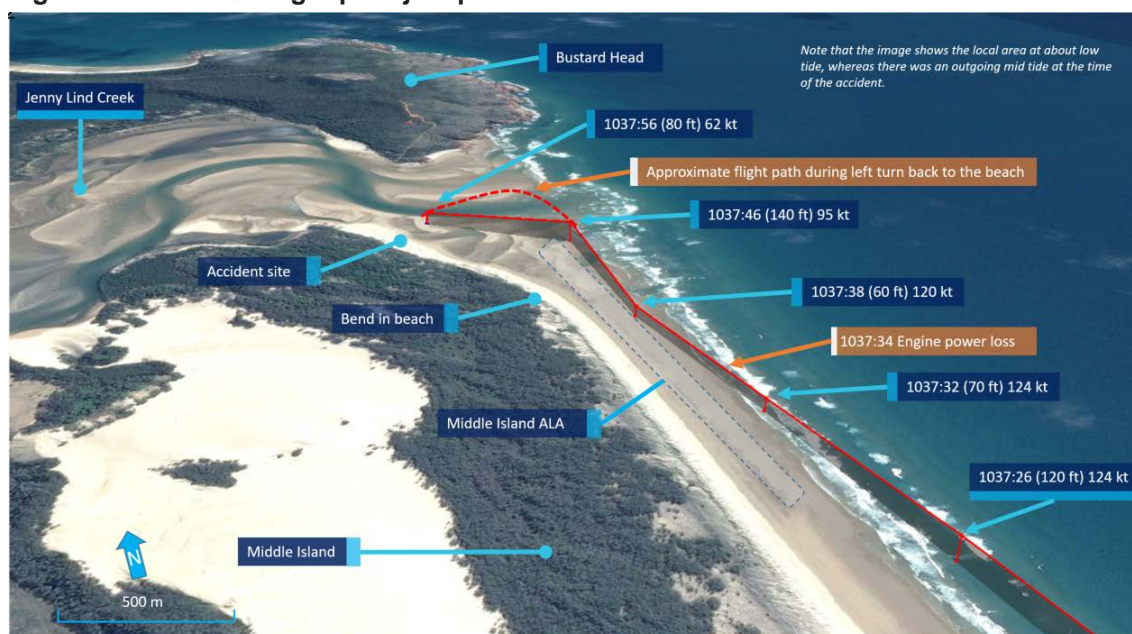
Figure 2: VH-WTQ's flight path just prior to the accident

Figure 2 shows the last 36 seconds of recorded GPS data (represented by the red line). As indicated in the figure, at 1037:26, the aircraft was approaching the southern end of the landing area and still descending.

This image shows the altitude and position data from the last five recorded data points prior to impact. The red lines are direct connections between each recorded data point and do not represent the aircraft's actual flight path between points. The landing area is based on reviewing the GPS data for many previous landings; most landings to the south would use the northern end of the area. The Google Earth image was taken in May 2016, and reflects conditions with a lower tide than at the time of the accident. Source: Google earth, modified by the ATSB.

In addition, the pilot reported that the engine power loss occurred at about the position annotated with the time 1037:38 in Figure 2 rather than the position annotated by the time 1037:34. That is, he believed the power loss occurred about 240 m further north than indicated by the recorded GPS data (after calibrating this data with the video footage).

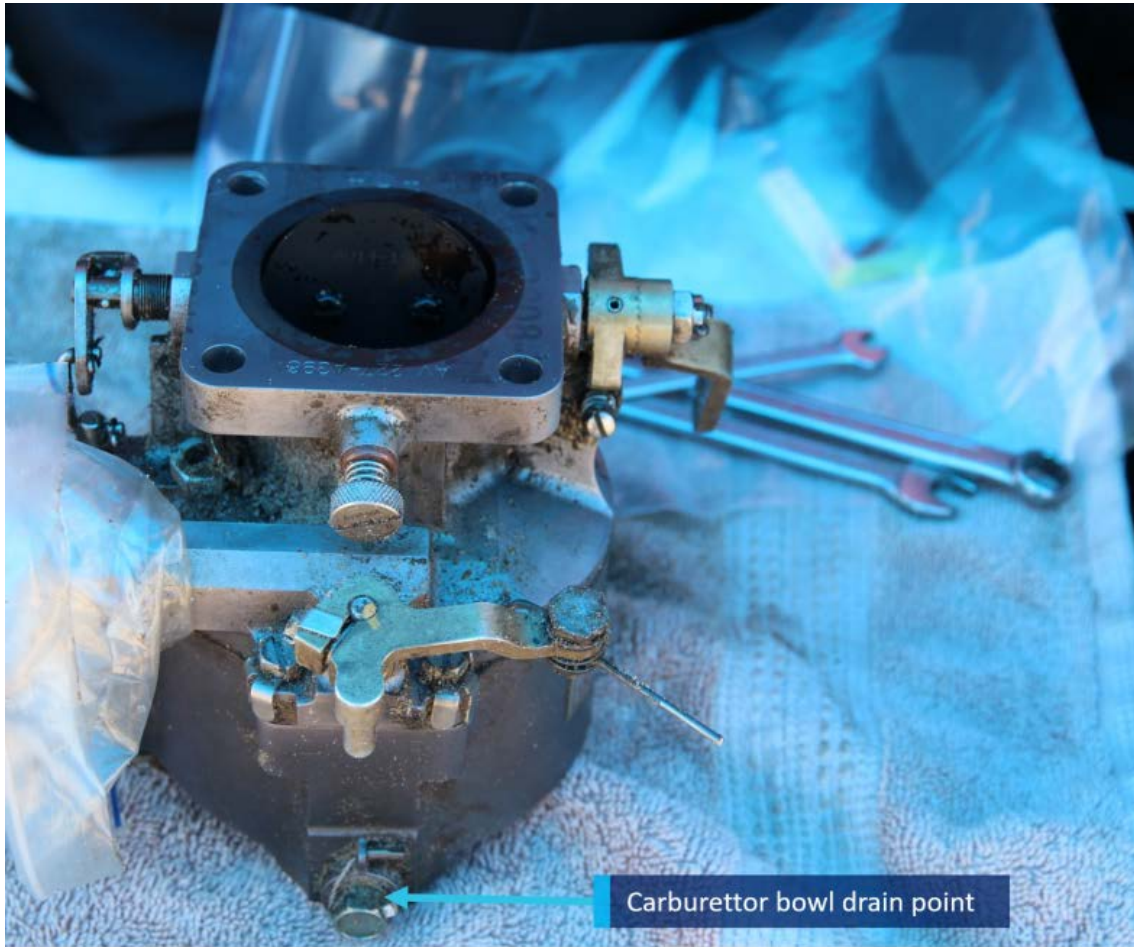
Figure 12: Carburettor showing drain point located at its base

As part of the removal process, care was taken not to invert the carburettor so as to prevent fuel draining out of the unit. With the carburettor in an upright position, the carburettor bowl drain was removed in order to ascertain if any fuel remained in the unit (Figure 12). No fluid of any kind was drained from the unit. It is possible that some fuel had leaked out of the unit while it was on its side; however the orientation of the unit meant that some fuel should have remained in the carburettor bowl.

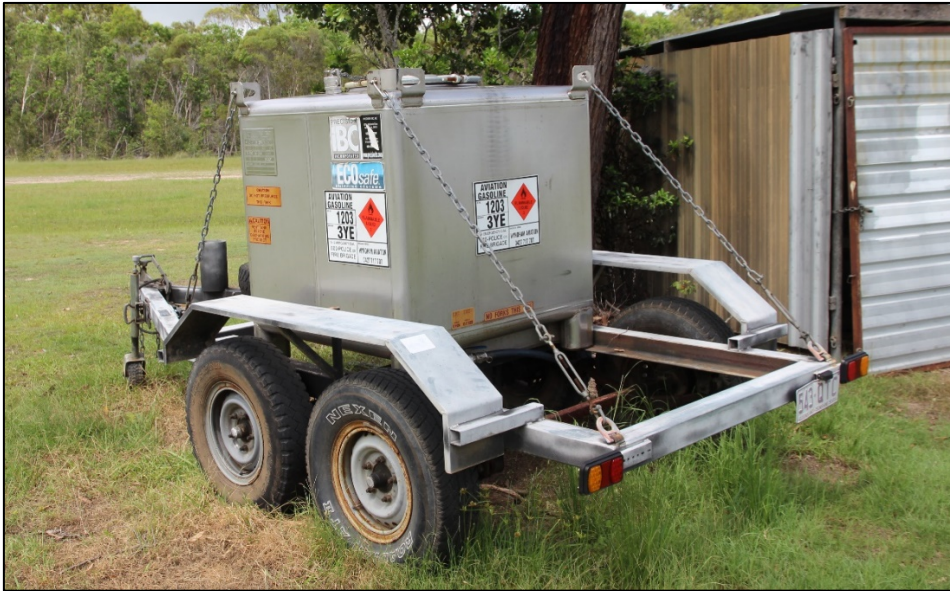
Figure 15: Fuel storage tank containing aviation grade gasoline

The fuel storage tank at Agnes Water ALA (Figure 15) was utilised by both of the operator’s Cessna 172 aircraft, with the same batch of fuel being used in the period leading up to the day of the accident without any problems being noted.

The chief pilot stated that the fuel in the storage tank was checked visually for quality and the presence of water prior to each aircraft refuel. When the fuel storage tank was empty it was taken to Bundaberg Aerodrome and refuelled with 100LL aviation grade gasoline.

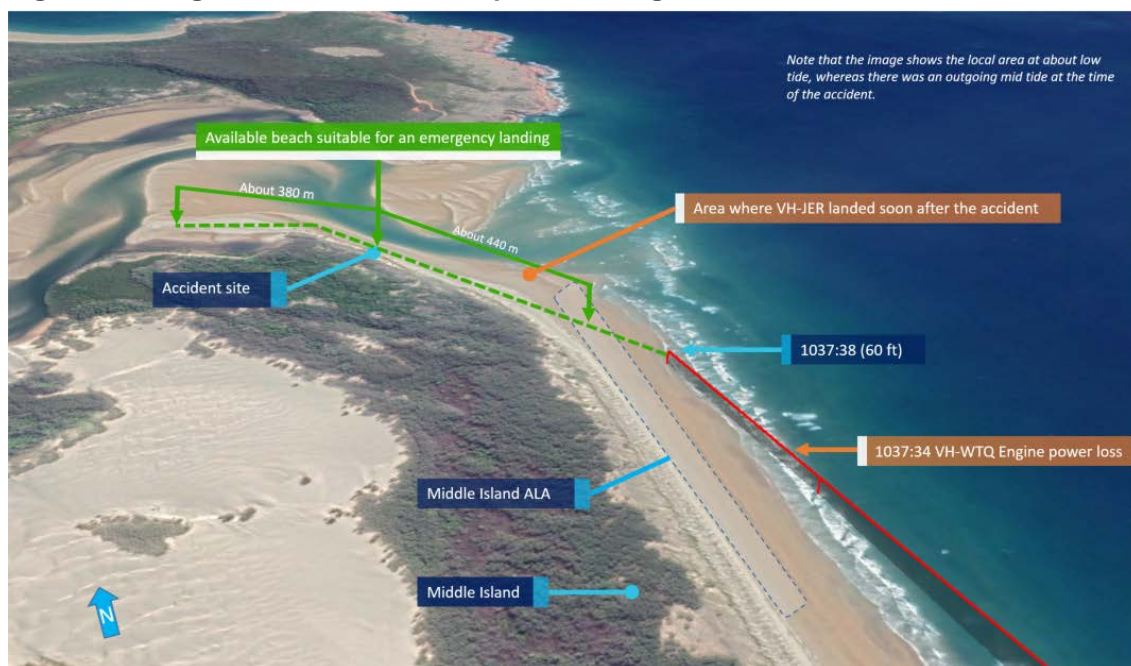
Figure 18: Image of Middle Island aeroplane landing area and the beach area to the north

Figure 18 shows a Google Earth image of the landing area and beach north of the landing area. This image was taken in May 2016, and it was the Google Earth image that most closely represented the conditions at the time of the accident flight. Based on reviewing video footage taken from the accident flight, and the following flight in VH-JER, there was significantly less beach area around Jenny Lind Creek inlet at the time of the accident compared to this Google Earth image. The width of the beach near the landing area was also slightly narrower. However, there was still a substantial amount of beach surface north of the landing area at the time of the accident.

In summary, most of the beach area north of the ALA indicated in Figure 18 was present at the time of the accident flight. More specifically, as indicated in the video footage from VH-WTQ, the aircraft was almost over the beach at the time of the engine power loss (1037:34). Figure 18 compares this location with the estimated touchdown point of VH-JER (heading south) a few minutes after the accident (see also Figure 6). Based on a review of video footage from VH-JER, from 1037:38 (just after the pilot commenced a right turn), there was about 440 m (1,440 ft) along the beach until abeam where the aircraft wreckage was located. In addition, there was about

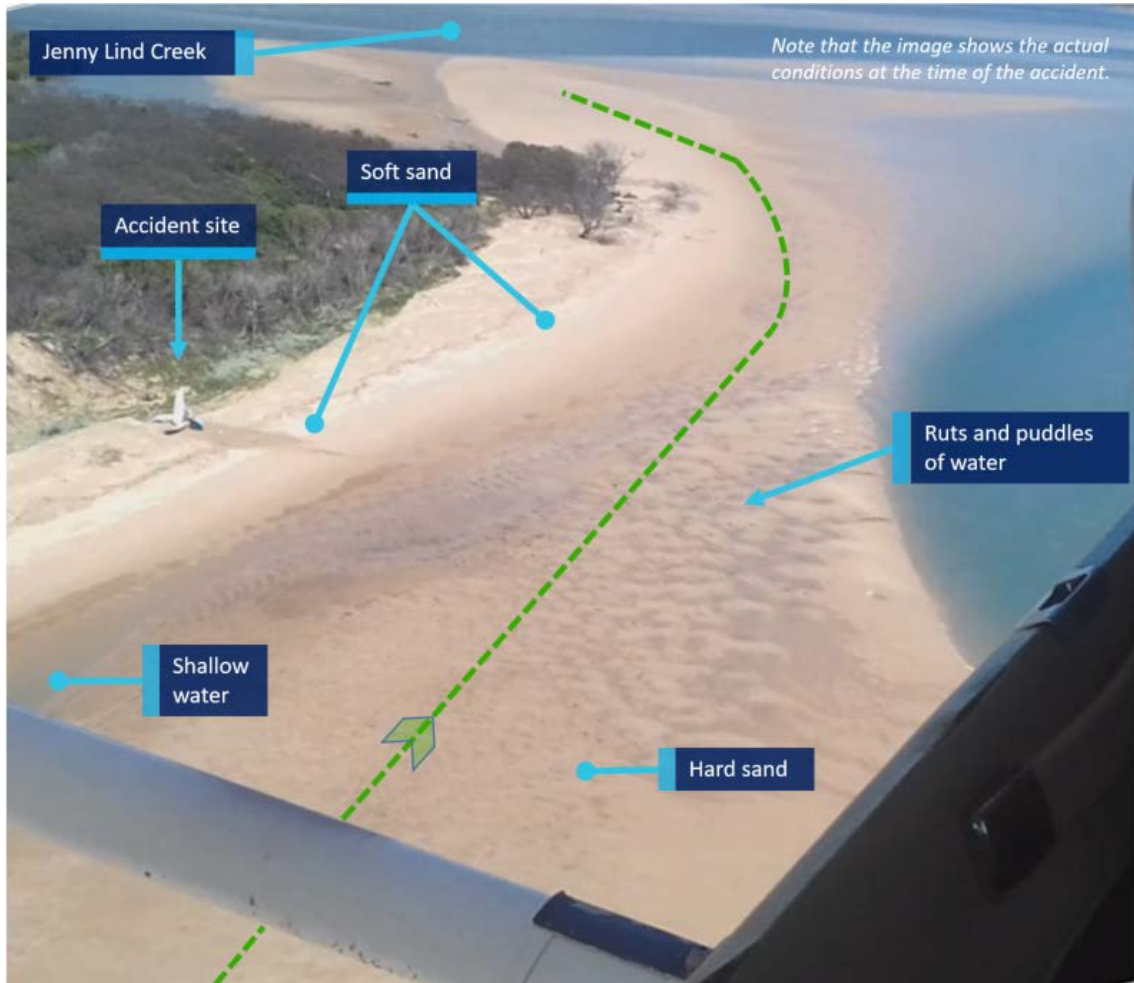
Figure 19: Image taken from VH-JER soon after the accident showing area of beach to the north of the landing area

Figure 19 shows the beach area to the north of the accident site as seen just after the accident. As indicated in this image, most of the sand area shown in Figure 18 was present at this time. The beach included an area of shallow water just south of the accident site, areas of hard sand, areas of hard sand with ruts and very shallow puddles and areas of soft sand. Figure 20, also taken from VH-JER just prior to it landing, shows the beach from the accident site up to the camp site.

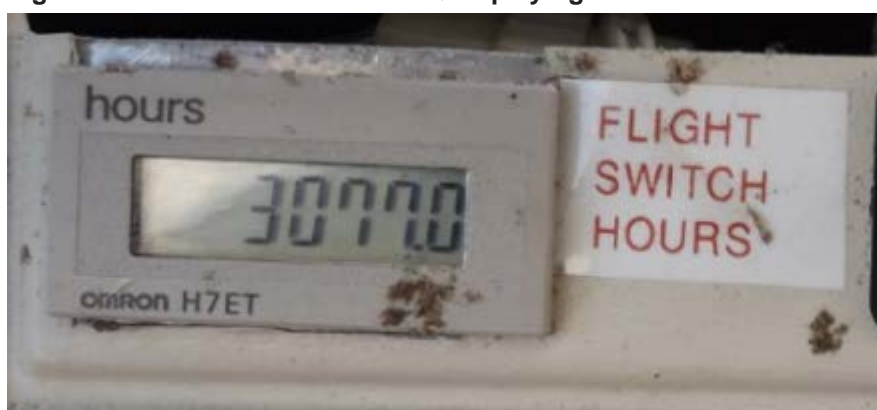
Figure A1: Hour meter on VH-WTQ displaying the value at the time of impact

- The hour meter reading after the accident was 3,077.0 hours (Figure A1), and this figure was also visible in the video footage of the accident flight at 1037:39 (20 seconds prior to impact). The reading prior to take-off would therefore have been about 3,076.9 hours. This figure indicated there had been 167.8 hours flight time since the 12 November 2015 inspection. It also indicated that the flight time documented on the maintenance releases underestimated the actual flight time by 34.3 hours (or 20 per cent) during the period from 12 November 2015 to 10 January 2017.
- There was no evidence in the maintenance records that the hour meter was considered faulty during the period that Wyndham Aviation used the aircraft from 2013 to 2017. The chief pilot and pilot of the accident flight reported that they were not aware of any problems with the aircraft's hour meter.

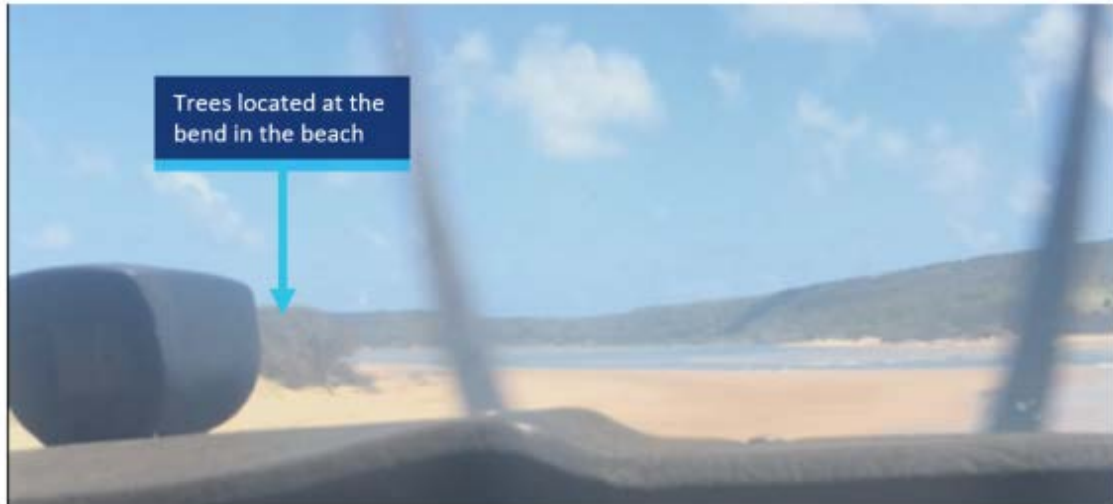
Figure B1: A still image taken from the video footage 2 seconds after engine power loss (1037:36)

- At 1037:36, 2 seconds after the engine power loss, the video footage showed that the aircraft was still a significant distance south of the bend in the beach on Middle Island (see Figure B1 and the location of the bend in Figure 2). Given the aircraft's groundspeed was about 124 kt (or 64 m/s) at that time, the image shown in Figure B1 was taken about 130 m north of the engine power loss. If the engine power loss had occurred at the position reported by the pilot, then the area of beach north of the bend should have been visible in Figure B1. Instead, this image is consistent with what would be expected if the engine power loss occurred at the position indicated in Figure 2 (based on the recorded GPS data).

At the time this image was taken the phone camera was oriented to the left of the aircraft's heading. The image shows an area of sand on Middle Island beach, just prior to a bend to the left with further beach beyond.
 Source: Queensland Police Service.

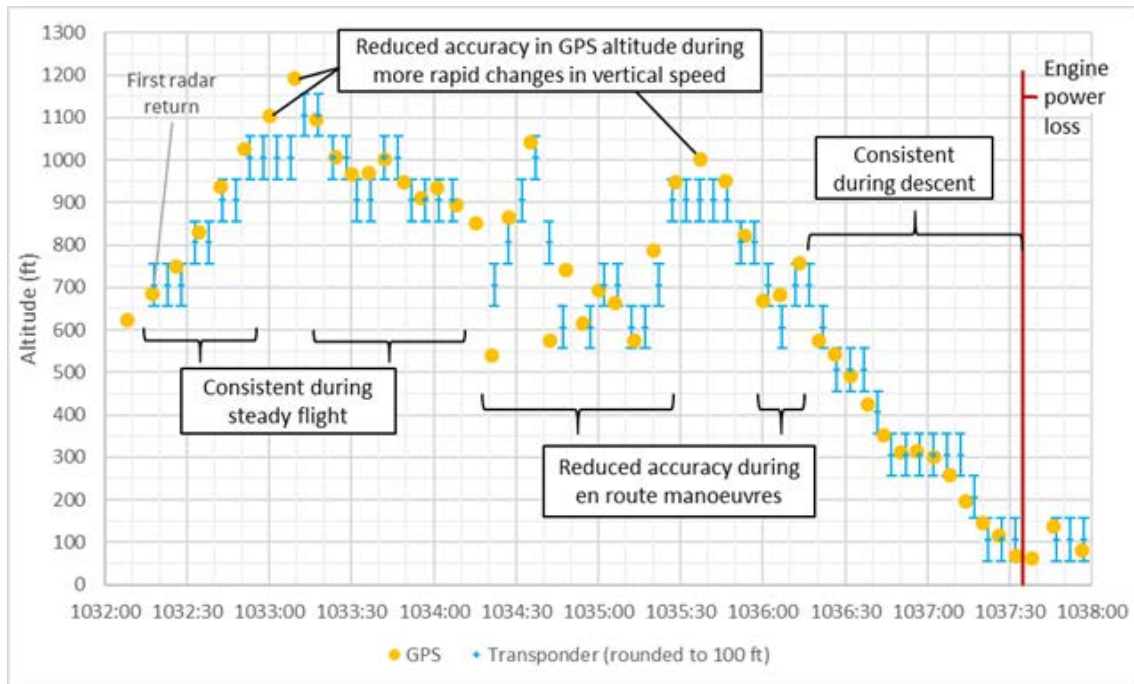
Figure B2: Comparison of recorded GPS and transponder altitudes

⁷⁰ 'QNH' refers to the altimeter barometric pressure subscale setting used to indicate the height above mean seal level. Transponder altitude data is based on a standard QNH of 1,013.2 hPa, which was very slightly below the QNH measured at a nearby town (Seventeen Seventy) at 0900 (1,013.4 hPa). This would result in the transponder altitude reading about 6 ft too low. The ATSB corrected the transponder altitude for this analysis.
