Australian Government  
Australian Transport Safety Bureau

# Aviation Short Investigations Bulletin

Issue 40

**ATSB Transport Safety Report**  
Aviation Short Investigations  
AB-2015-034  
Final – 22 April 2015

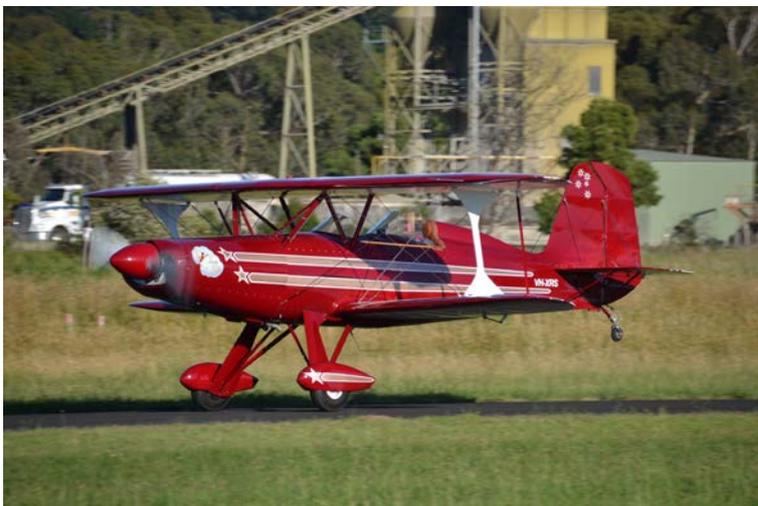
Figure 1: VH-XRS

On 2 January 2015, at about 1400 Eastern Daylight-saving Time, the pilot of a Starduster SA300 aircraft, registered VH-XRS (XRS), commenced pre-flight preparations for a local private flight at Tyabb Airport, Victoria (Figure 1). The pilot of XRS observed the windsock indicating calm conditions. The pilot elected to follow the airport operator's procedures for nil wind, and use the preferred runway, runway 17. During the next 30 minutes, no aircraft operated in the circuit. The pilot did not hear any broadcasts on the common traffic advisory frequency (CTAF) during that time.

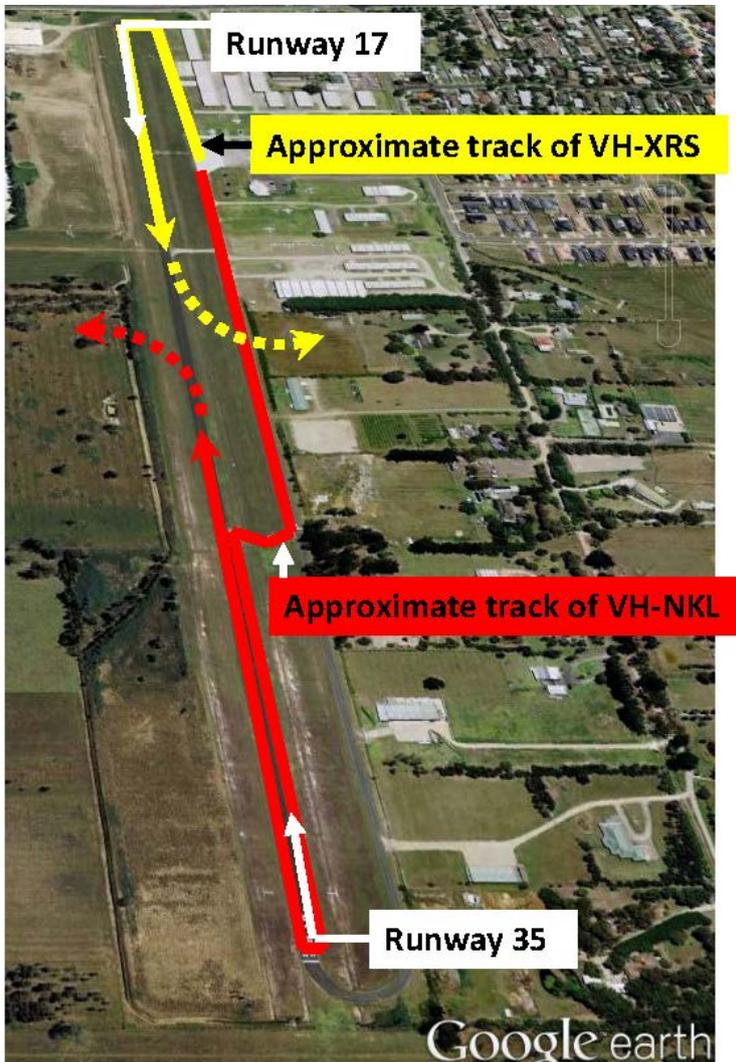
**Figure 2: Tyabb Airport and aircraft tracks**

When about 500 m along the runway and at rotate speed, the instructor of NKL pointed out the airspeed to the student and the aircraft lifted off. The instructor then sighted XRS in the take-off run on the opposite runway. The instructor immediately took control of the aircraft from the student and commenced a left climbing turn, while keeping XRS in sight (Figure 2).

When about 300 m along the runway, XRS lifted off. When at about 10 ft above ground level, the pilot of XRS sighted NKL, about 300 m ahead and banking to the left. He also commenced a left turn to increase separation between the two aircraft, which then passed about 50 m from each other, with NKL slightly higher than XRS. The pilot of XRS then joined the circuit for runway 35 on the crosswind leg, and broadcast that he was joining the circuit to return to land at Tyabb.

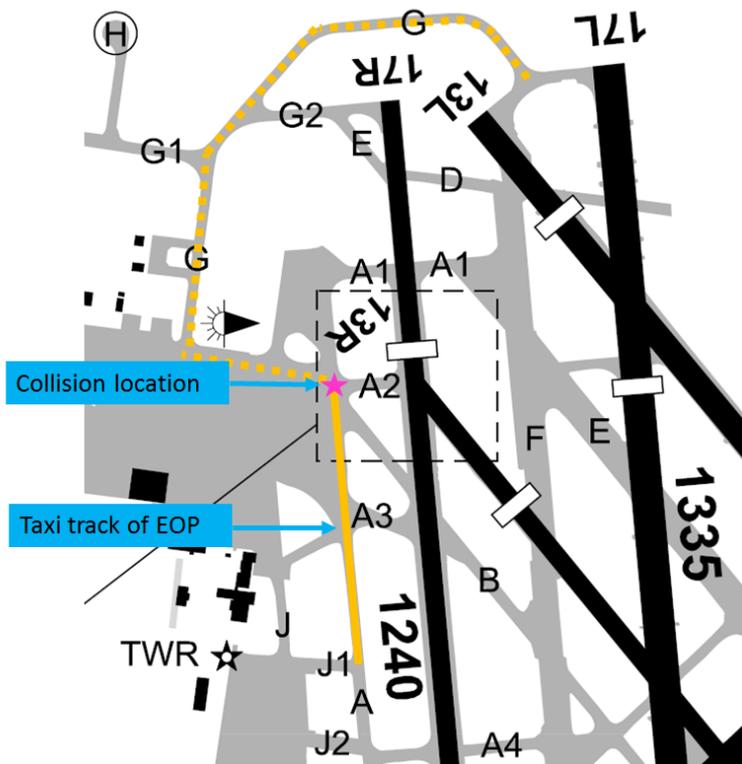
Figure 1: Extract of Moorabbin Airport En Route Supplement Australia entry

On 29 January 2015, the student pilot of a Cessna 172S aircraft, registered VH-EOP, taxied for a solo training flight at Moorabbin Airport, Victoria. The student was cleared by air traffic control (ATC) to taxi via taxiway 'A' (Figure 1) to the holding point on taxiway 'G' for a departure from runway 13 Left (13L).

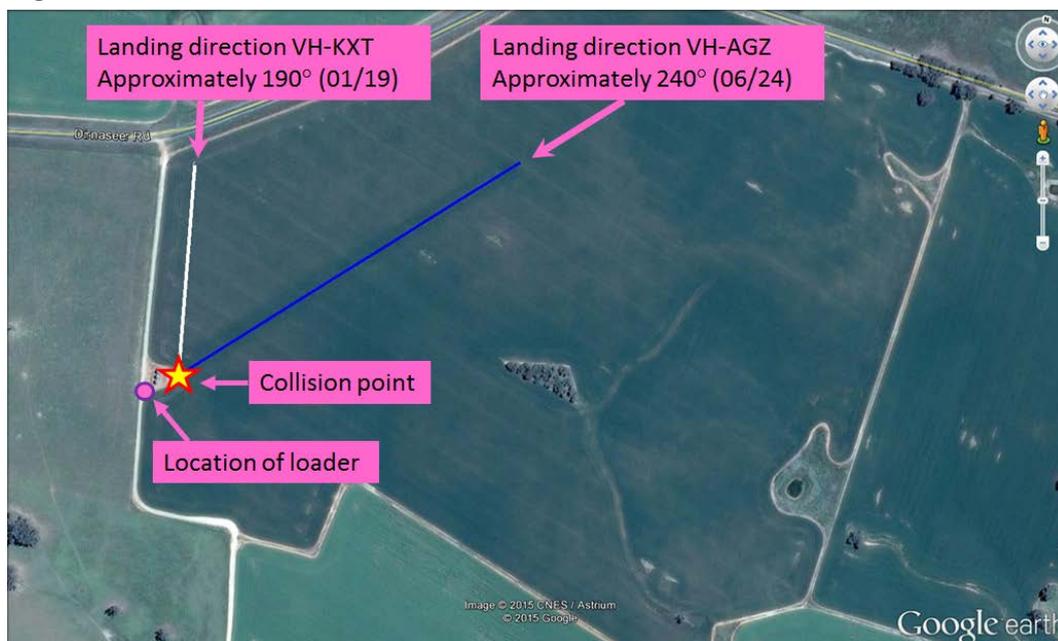
**Figure 1: Accident location**

The pilots commenced spreading fertilizer at about 0730 Eastern Daylight-saving Time (EDT) using two runways, one aligned in approximately the 01/19 direction, and the other 06/24 (Figure 1). Both of the aircraft were taking off from runway 06, however, AGZ was landing on runway 24, and KXT was landing on runway 19. Each load took about 6 minutes to spread. During about 90 minutes of flying operations, the pilot of AGZ had not seen KXT landing, but had observed it being loaded and taking off from runway 06. With both aircraft taking a similar amount of time to spread their load, they were in an alternating sequence and so did not need to hold and wait for the other aircraft to be loaded.
