Aviation Short Investigations Bulletin

Issue 45

ATSB Transport Safety Report
Aviation Short Investigations
AB-2015-135
Final – 22 December 2015

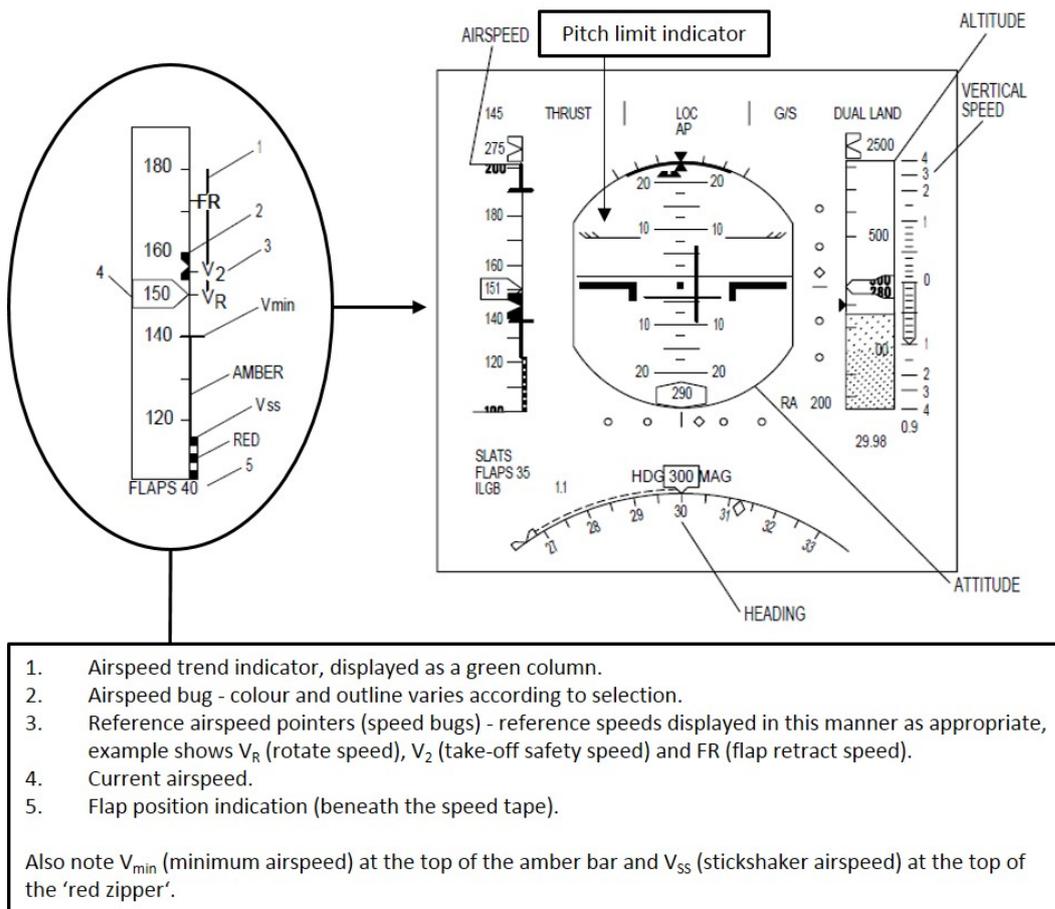
Figure 3: Primary flight display and description of relevant airspeed indications

The airspeed range for activation of the stickshaker is displayed as a 'red zipper' on the lower part of the airspeed indicator (Figure 3). V_{SS} marks the top of the red zipper. When the airspeed is below V_{SS} the pitch limit indicator (which provides an indication of the angle-of-attack margin to the activation of the stall warning system) changes colour from cyan to red, to provide an additional alert to the crew. Additionally, the digits (and the outline box surrounding the digits) representing the current airspeed indication turn red if the airspeed falls below V_{SS} .

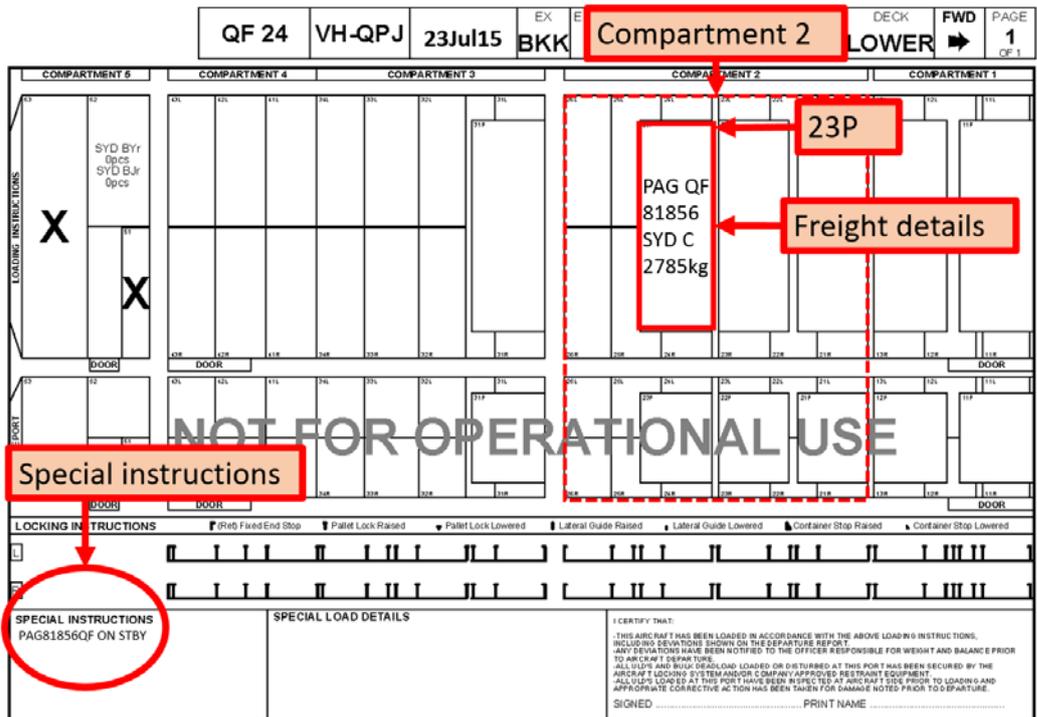
Figure 1: Load instruction report showing freight positions and special instructions

The loading supervisor commenced by reading out the description and weight of the pallet loaded into position 23P. The load controller responded that the pallet in 23P was on standby as per the Special instructions, and directed the loading supervisor to offload that freight. The supervisor responded 'yes', and stated that the loading was in accordance with the LIR. The loading supervisor then continued to read the loading to the controller, again commencing with the pallet in 23P, followed by the rest of the loaded freight. The pallet in 23P remained loaded on the aircraft.

During the partial read back, the offload instruction caused confusion as to whether the pallet in 23P was to be loaded or not, and that confusion was not resolved.

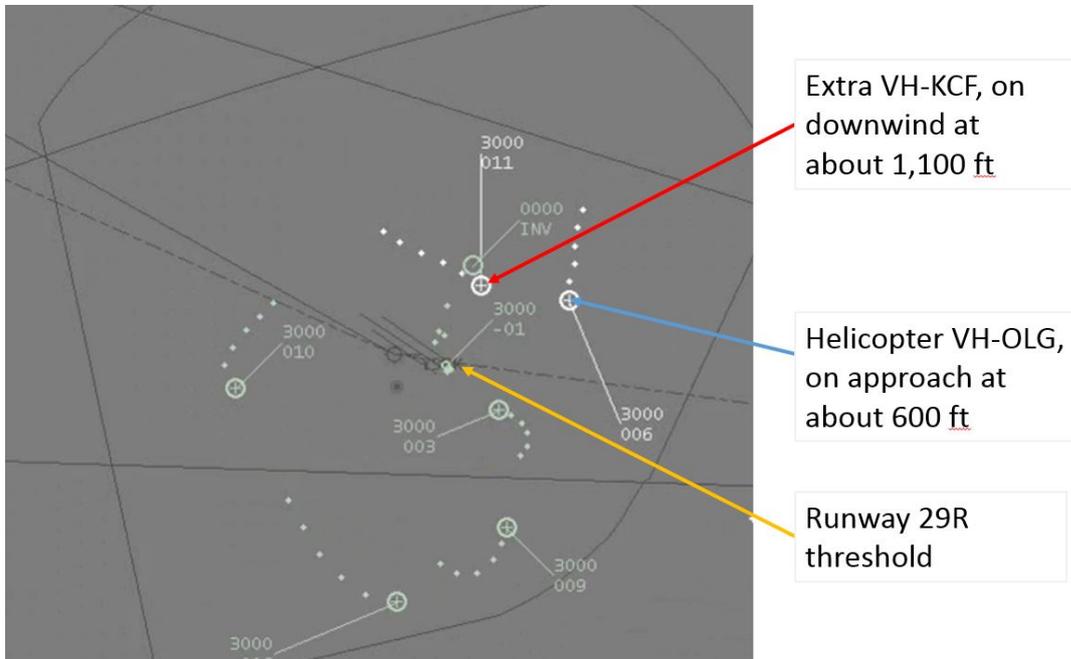
Figure 5: Radar plot showing both aircraft approaching their relative landing areas

During the descent and sideslip of the Extra, the pilot of the R44 continued their descent at about 100-150 fpm toward N1. While descending through about 350-300 ft, the passengers and pilot on the R44 saw the underside of the Extra pass from right to left in front of the helicopter. They estimated it was within 100 ft of the R44's altitude and about 70-100 m in front of them (Figure 5).

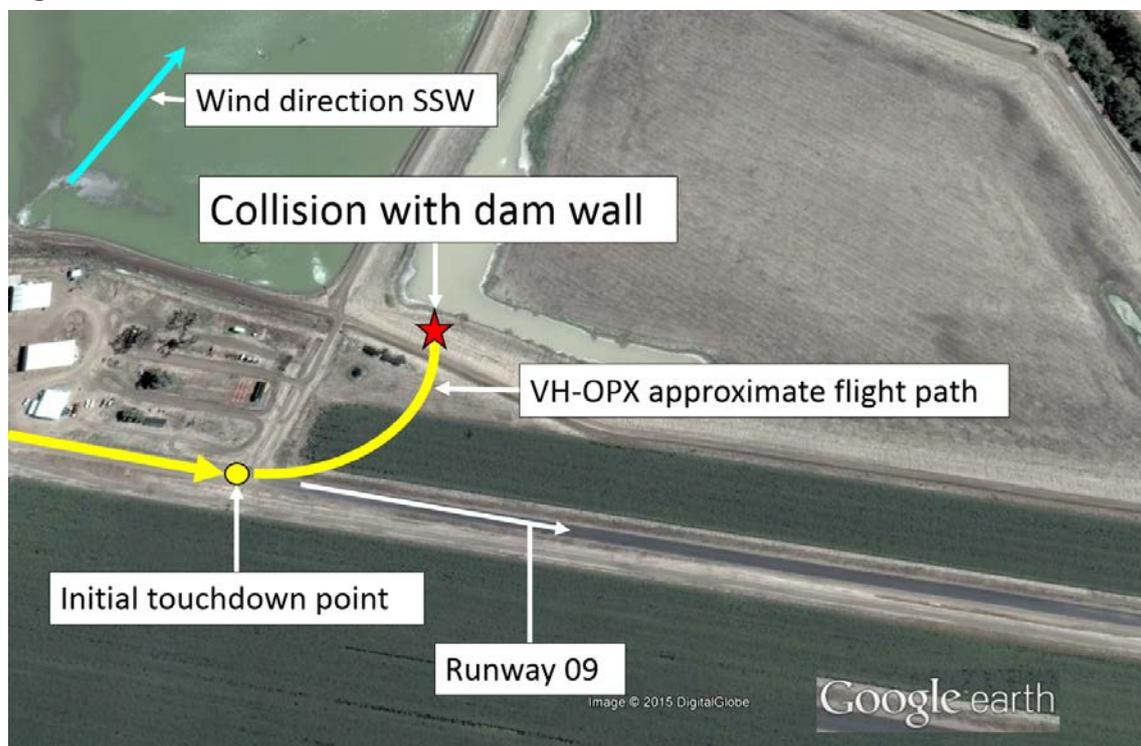
Figure 1: Accident site

The right main landing gear touched down first, and the aircraft bounced back into the air. The pilot immediately applied full power to initiate a go-around. However, the left wing dropped and the aircraft yawed to the left. The aircraft's left wing and propeller then collided with a dam wall (Figure 1). The aircraft stopped abruptly and spun around. The engine separated from the aircraft and came to rest about 20 m away, the tail broke off and the nose landing gear collapsed. The pilot suffered minor injuries, and the aircraft sustained substantial damage (Figure 2).

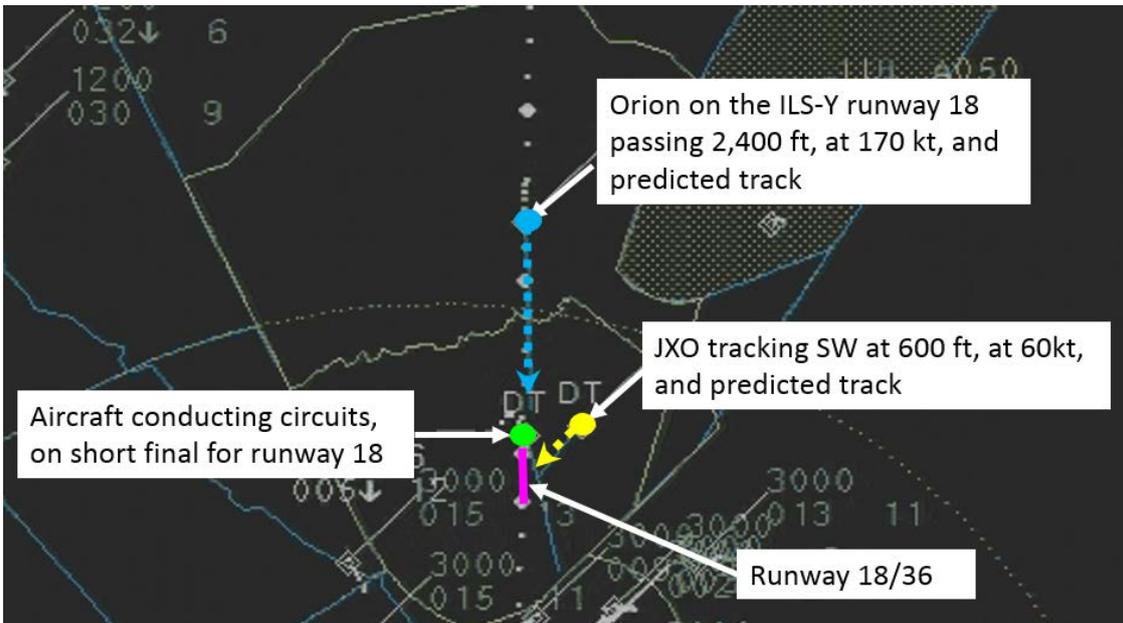
Figure 3: Aircraft positions when JXO was cleared to Calvin Grove (time 1512)

At about 1512, the Orion was passing 2,400 ft, on a 6.5 NM final and travelling at 170 kt. JXO was at 600 ft and travelling at 60 kt (Figure 3). Based on the expected tracking of the three aircraft, the TWR controller 2 assessed that JXO would safely cross the runway centreline in front of the Orion, and behind the aircraft conducting circuits (then on a short final). Consequently, the TWR controller 2 cleared JXO to track to Calvin Grove. The pilot heard the call and responded, but the radio was still selected to transmit on UHF not VHF, so the controller did not receive a response. The pilot was flustered and expecting an onwards clearance to Clare Valley, consequently had turned right to track northwards to Clare Valley.

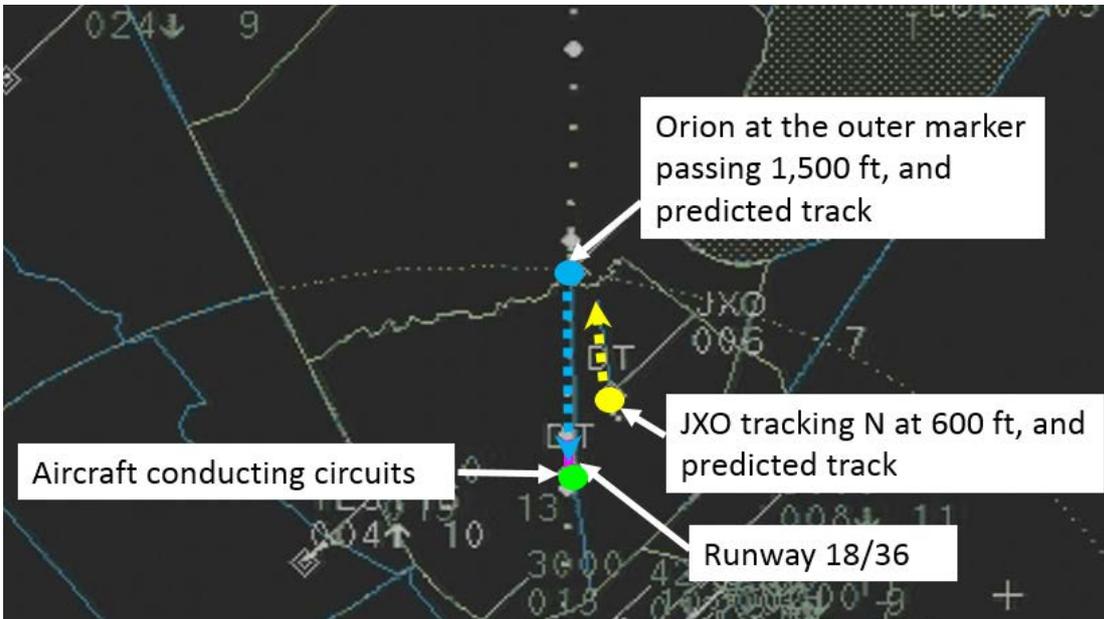
Figure 4: Orion at the outer marker (time 1513)

At about 1513, the pilot of the Orion reported at the outer marker on the ILS (4.2 NM from the runway threshold), and the TWR controller 2 cleared the Orion to land (Figure 4). JXO was then tracking north-northwest, about 3 NM from the Orion, and converging. The TWR controller 2 was then apprehensive about JXO's tracking. Although the crew of the Orion had heard the controller's attempts to contact JXO, as the controller had not provided them with directed traffic information, they were unaware of JXO's position, and assumed it was not a consideration for their tracking.

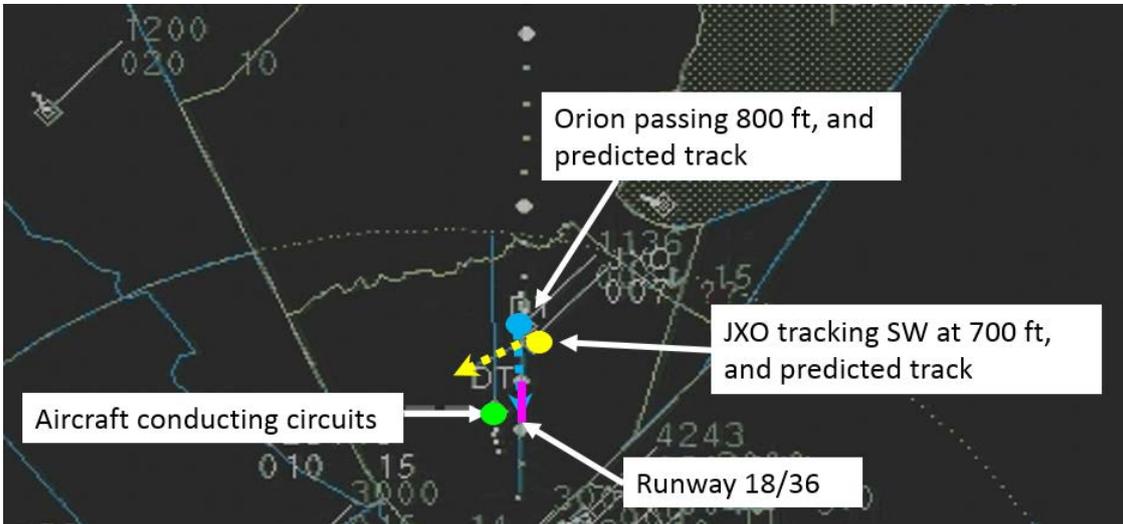
Figure 5: Relative positions when ATC advised JXO of the Orion (time 1514)

Immediately following the pilot of JXO's response, the TWR controller 2 asked whether the pilot had the 'P3' (Orion) in sight, advising that it was then in the pilot's 1 o'clock³ position at about 2 miles. The pilot queried the aircraft type, and the TWR controller 2 advised that the 'P3 Orion' was now at about 1 mile in the pilot's 2 o'clock position. The pilot was initially unable to sight the Orion, as it was below, to the right, and behind the helicopter, and therefore not in the pilot's 1 or 2 o'clock position (Figure 5). The pilot then saw the Orion's shadow on the ground and sighted the Orion. The pilot of JXO responded having the aircraft in sight, and the TWR controller 2 directed the pilot to pass behind that aircraft.

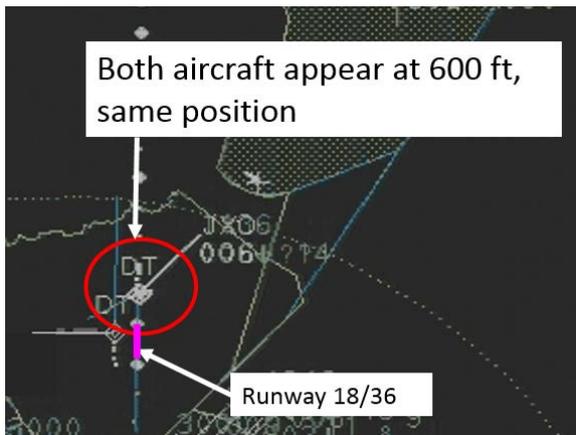
Figure 6: Aircraft collocated on radar SDD

By the time the controller completed that transmission, JXO had passed overhead the Orion. On sighting the Orion, the pilot of JXO had immediately initiated a climb to avoid a collision, and estimated the Orion passed about 100 ft below. On hearing the controller pass the Orion as traffic to the pilot of JXO, the Orion crew immediately became concerned about the helicopter's proximity, and looked for it. The co-pilot (non-flying pilot) of the Orion sighted JXO, assessed there was a risk of collision, and called 'go low, go low, go low'. The captain (flying pilot), also sighted JXO, and increased the rate of descent to pass beneath the helicopter. The Orion crew estimated that JXO passed about 50 ft directly above the Orion, and were concerned it may collide with the Orion's vertical tail fin. On the radar SDD, at 1514:25, both aircraft appear in the same position at 600 ft (Figure 6).
