Loss of control and equipment contact with water involving Bell 412EP, VH-VJF

57 km north-east of Strahan Airport, Tasmania, on 10 March 2025

ATSB Transport Safety Report
Aviation Occurrence Investigation
AO-2025-013
Interim – 17 March 2026

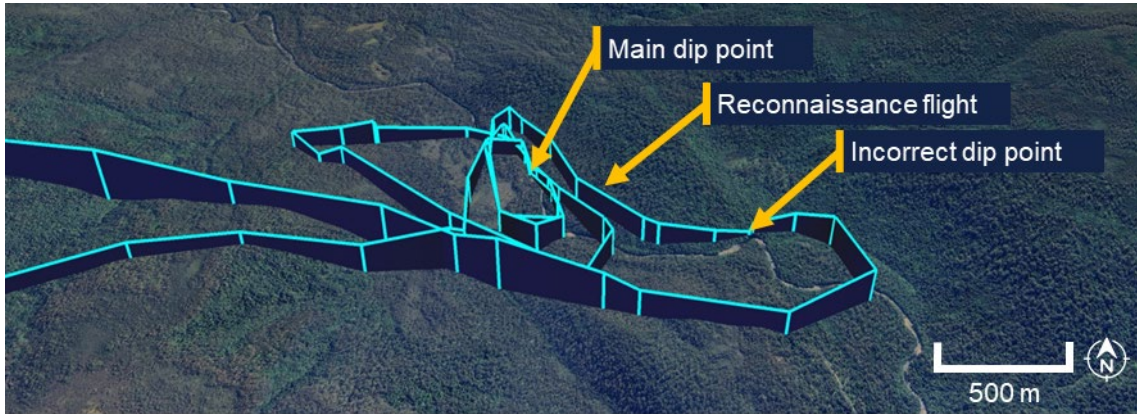
Figure 2: Second fuel cycle flight path

The pilot recalled that various dip sites along the river looked similar. Flight data (Figure 2) indicated the pilot initially conducted a descent into an incorrect dip site. The pilot recognised this and undertook reconnaissance to find the intended dip site. Once reaching the dip site, the pilot resumed bucketing operations.

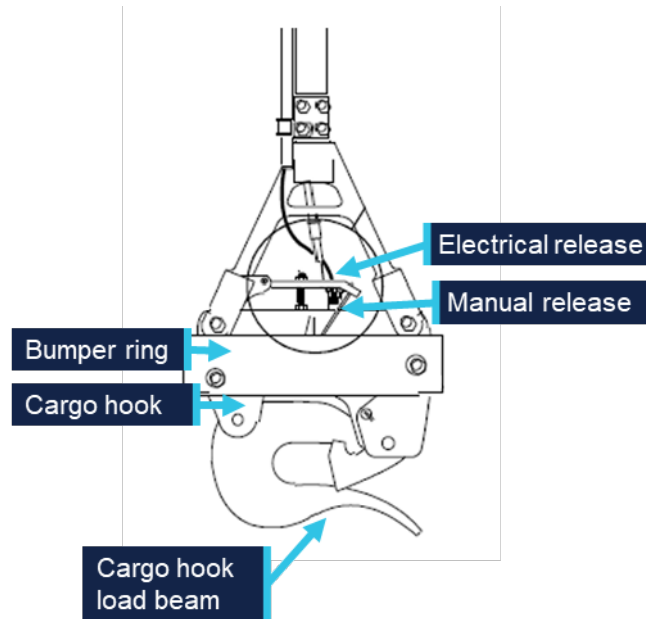
Figure 4: Onboard Systems International cargo hook suspension system on the Bell 412

VH-VJF was equipped with an Onboard Systems International cargo hook suspension system. The system attached to an existing Bell hard point and hung at approximately the centre of gravity. It extended through an opening in the lower fuselage, which was fitted with a protective rubber ring around the edge (Figure 4). This protective ring was used to reduce the risk of damage if the hook hit the edge of the opening.

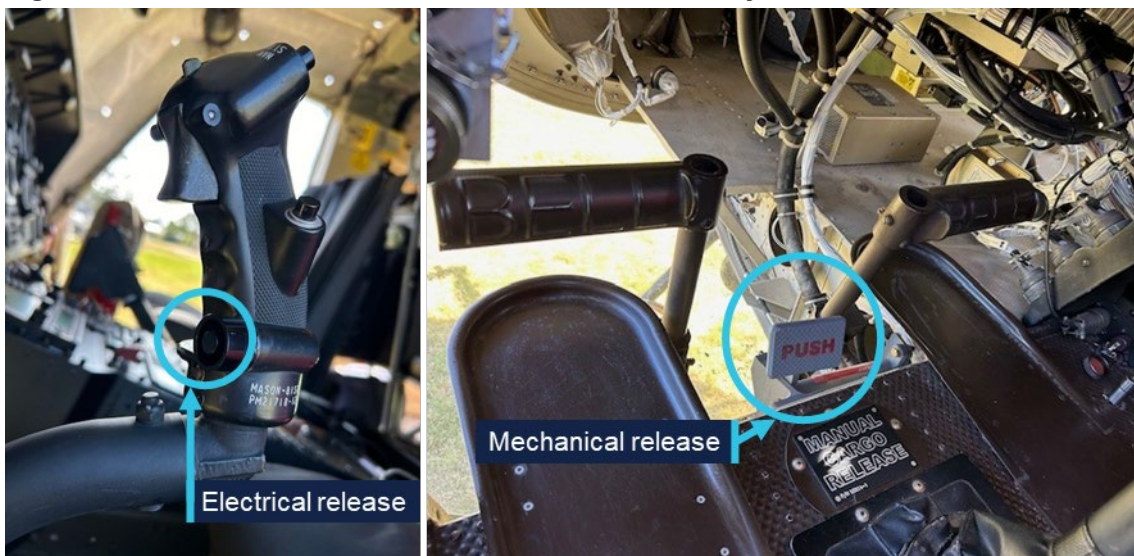
Figure 5: Electrical and mechanical external load release systems

Prior to this manoeuvre, the pilot reported they were unable to jettison the longline, which they attributed to pressing on the button's ring guard instead of its centre, and the longline subsequently became taut. The helicopter then came to an abrupt stop and the pilot heard a 'loud clunking noise'. The pilot then recovered the helicopter to a stable hover approximately 30 ft above the water and initiated rearward flight to release the water and retrieve the bucket from the river. The pilot observed an engine torque split⁶ and once the bucket and longline were recovered they initiated a climb to clear the surrounding trees.

The release of the hook could be initiated electrically or mechanically. Normal release was completed by pilot actuation of a push button on the side of the cyclic (Figure 5, left). The button is guarded by a small ring to prevent inadvertent pilot activation. When this button is pressed the latch of the cargo hook is opened.

In addition to the electrical release, in an emergency a mechanical release can be completed by pushing a small pedal located between the 2 tail rotor pedals at the pilot's feet (Figure 5, right). This activated a manual release cable attached to the cargo hook.

Coulson Aviation required pilots to test the electrical and manual release system prior to conducting flights for the day. The pilot recalled testing both the electrical and mechanical release the morning of the accident. They stated that both systems were in working order. In addition to the tests, the pilot recalled that when landing at Zeehan after the accident, the electrical release was used to drop the longline and bucket without issue.

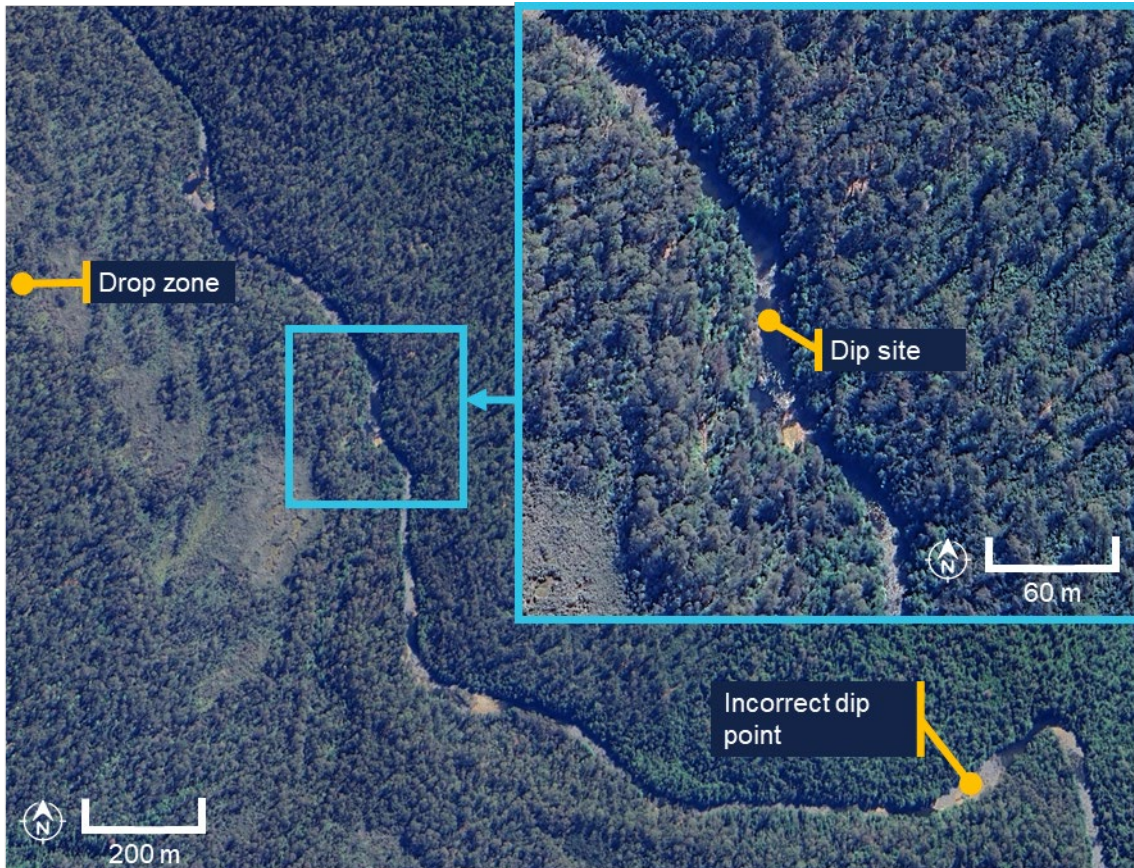
Figure 13: Dip site location on Murchison River

HT204's dip site was approximately 700 m from the next nearest dip site with working helicopters. The dip site was approximately 1 km south-east of the drop zone, along the Murchison River. Google Earth images indicate the river width at the dip point was approximately 20 m (Figure 13).

The pilot described the dip site as a narrow section of river, approximately 50–60 m wide, with tall trees lining the bank. They reported that there were limited locations deep enough to operate the bucket, which constrained where they could dip and they stated they had used the same dip point on the days prior.
