Australian Government
Australian Transport Safety Bureau

Train overspeed by run 805K

through BN 318 turnout, Blacktown, New South Wales, on 21 April 2024

ATSB Transport Safety Report
Rail Occurrence Investigation (Defined)
RO-2024-003
Final – 24 March 2026

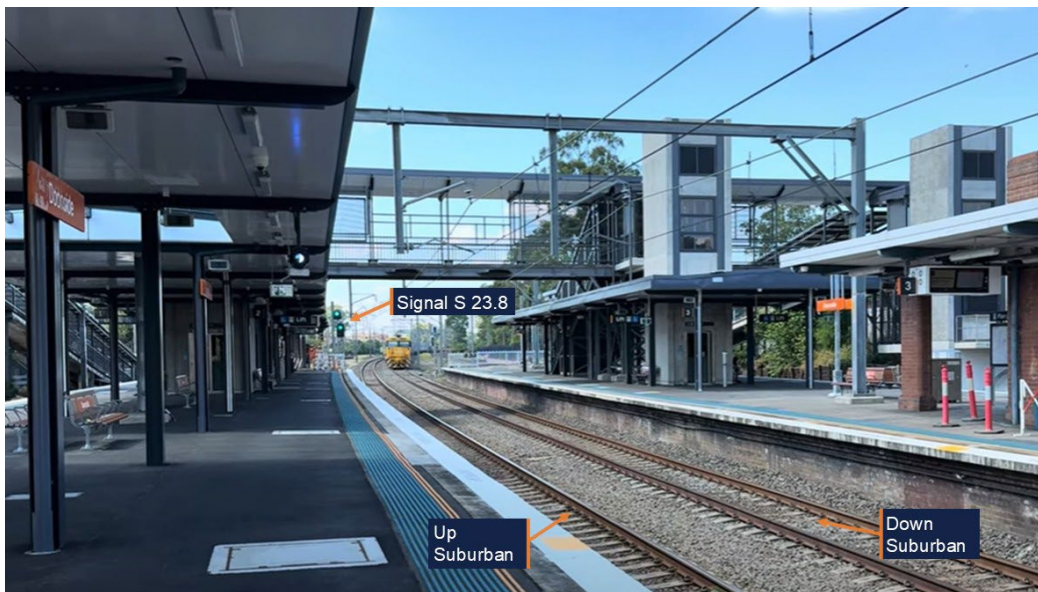
Figure 4: Signal S 23.8

On departure, the train passed automatic signal S 23.8 which was showing a Clear³ indication, and the driver applied maximum power to accelerate the train (Figure 4).

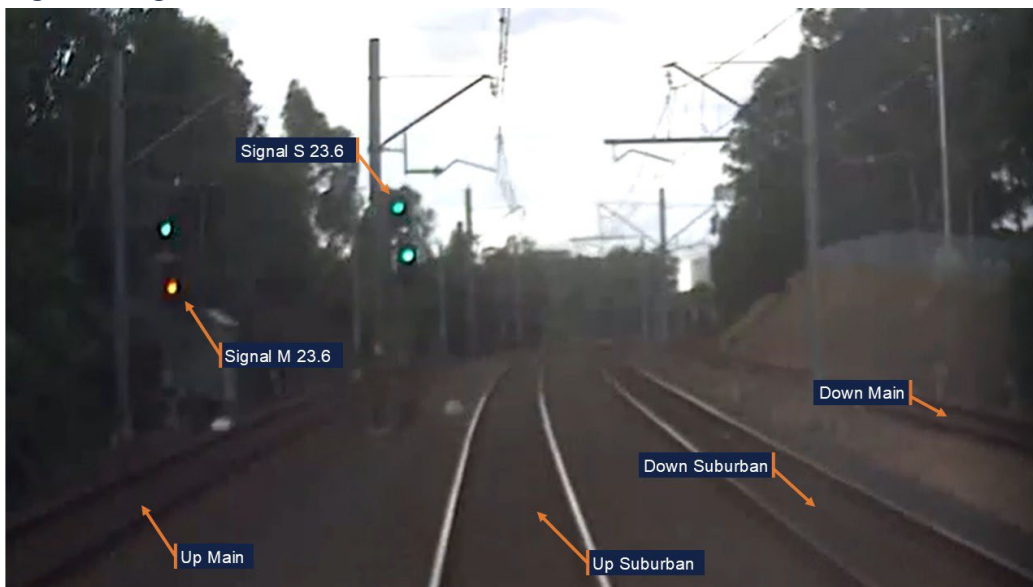
Figure 5: Signal S 23.6

Around 44 seconds later, at 1420:36, the train had travelled 650 m and reached a speed of 81 km/h as it passed automatic signal S 23.6 (Figure 5). This signal also showed a Clear indication, and the driver maintained the same power setting as they proceeded into the next block⁴.

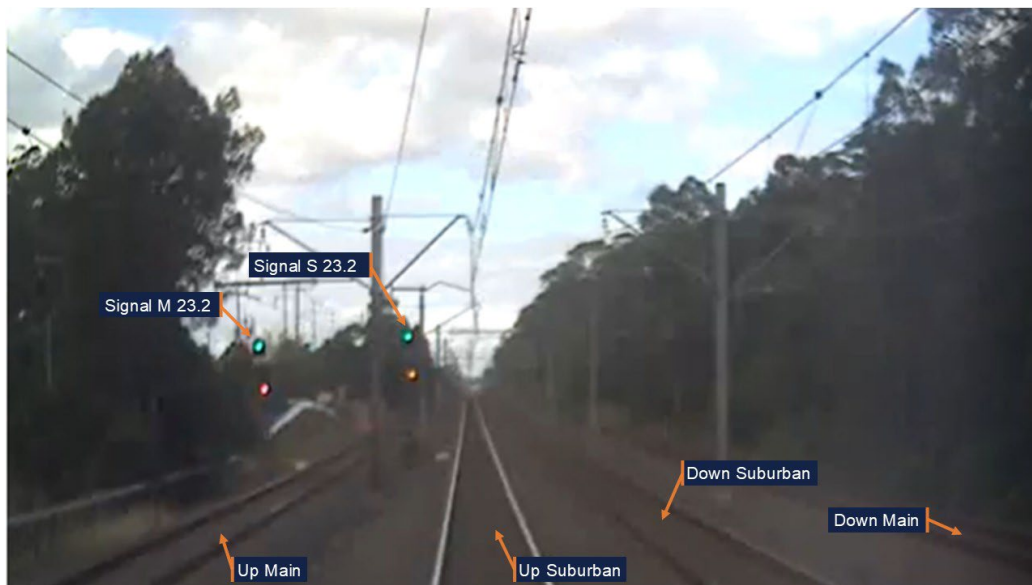
Figure 6: Signal S 23.2

The train travelled another 624 m in the next 24 seconds, passing automatic signal S 23.2 at 1421:00 at a speed of 106 km/h (Figure 6). This signal was displaying a Preliminary Medium⁵ indication, which warned the driver that the next signal would be displaying at least a Medium⁶ indication. The driver maintained maximum power as they passed signal S 23.2 and only moved the power handle to OFF to coast the train when the speed reached 110 km/h around 11 seconds later.

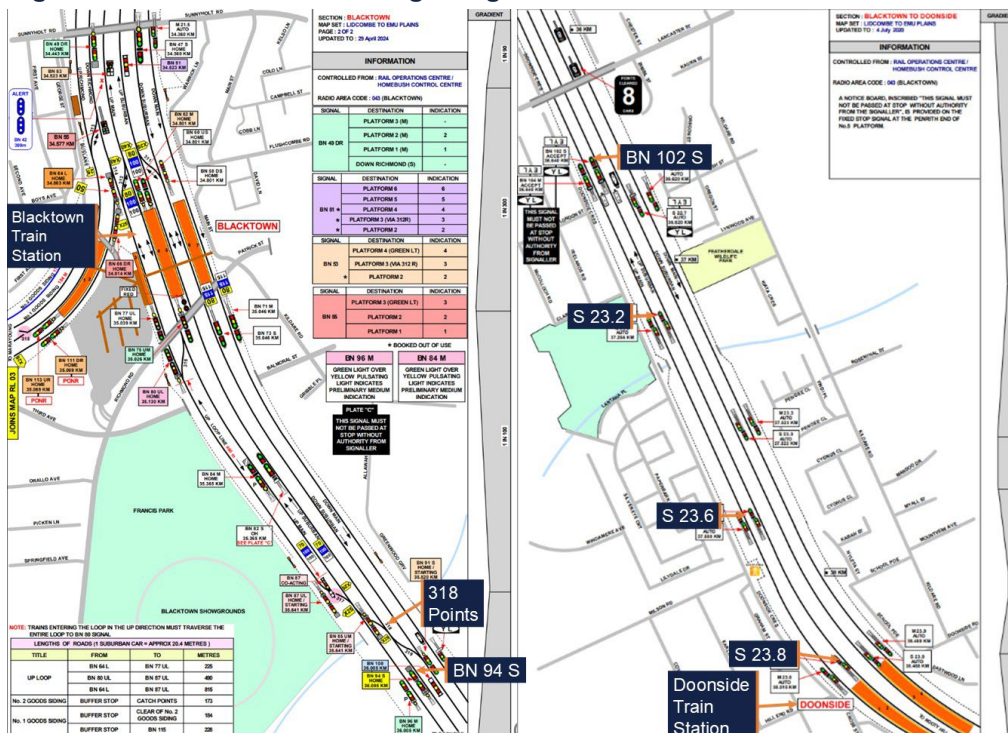
Figure 11: Driver route knowledge diagrams – Doonside and Blacktown

While crews operating Up services on the Western Line generally expect to run via the Up Main, they are qualified for both tracks as part of their route knowledge requirements. Driver route knowledge diagrams document the information crews are required to know and support familiarisation and retention (Figure 11).

The track between Doonside and Blacktown, indicates a slight right hand curve leaving Doonside then straight track to BN 318 turnout. Source: Sydney Trains, annotated by OTSI

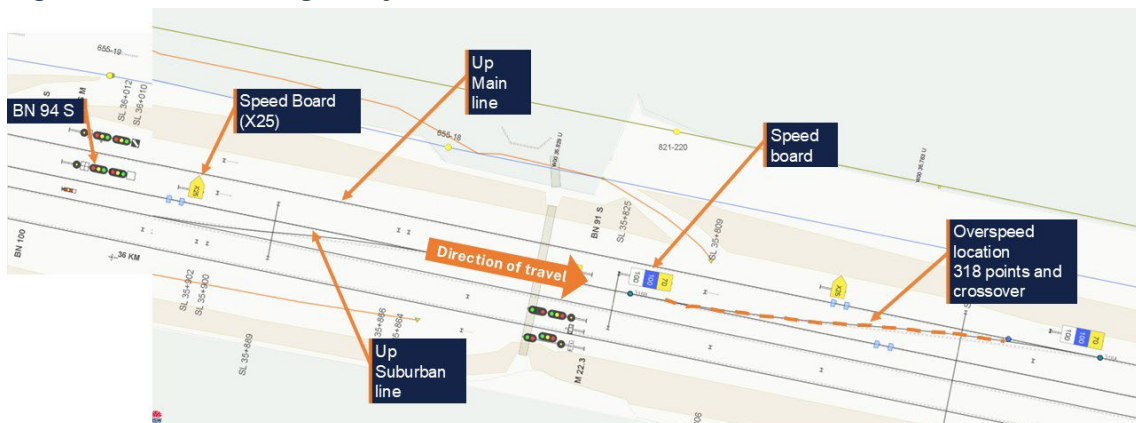
Figure 13: Track and signal layout at Blacktown West

A ladder of bi-directional points connected the country-end of Blacktown Up Loop to the Down Suburban, and each turnout had a speed limit of 25 km/h. This included BN 318 turnout, which facilitated movements between the Up Main and Up Suburban (Figure 13).

Map (not to scale) – BN 94 S route indicator and signal, X25 speed board and BN 318 turnout.
Source: WebGISME, annotated by OTSI

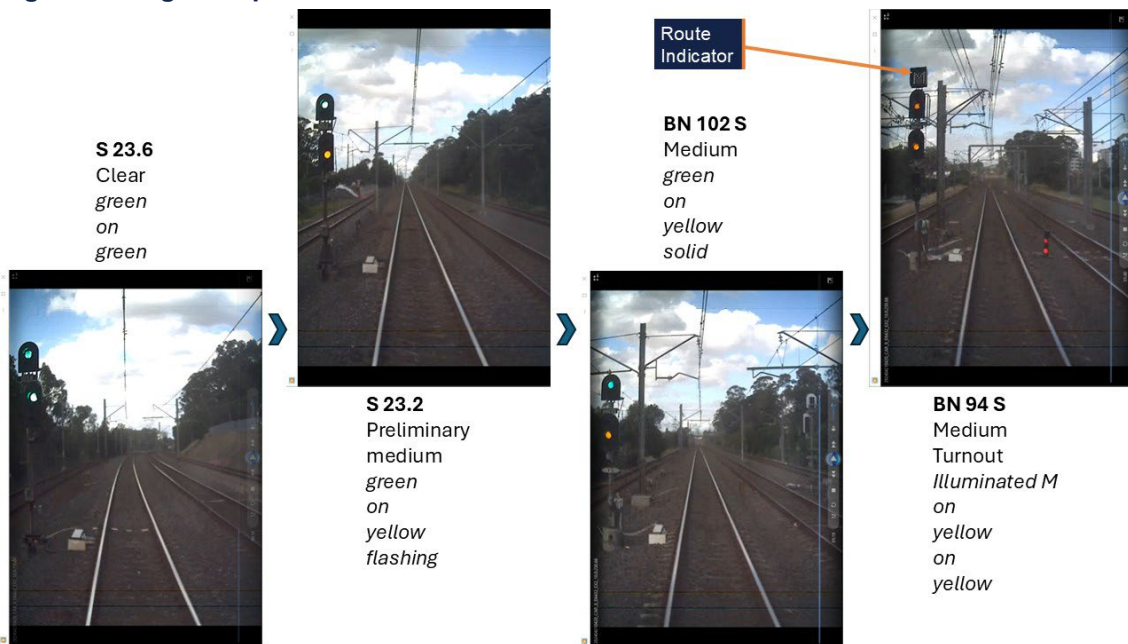
Figure 15: Signal aspects from S 23.6 to Blacktown West and BN 318 turnout

There was a slight right-hand curve between signals S 23.8 and S 23.6, but the corridor was straight with unobstructed sightlines from signal S 23.6 to Blacktown West. In clear weather conditions, signal BN 94 S had a sighting distance of around 1.5 km (Figure 15).

Front of Train CCTV - Signal sequence approaching Blacktown from Doonside, starting with S 23.6. Source: Sydney Trains, annotated by OTSI

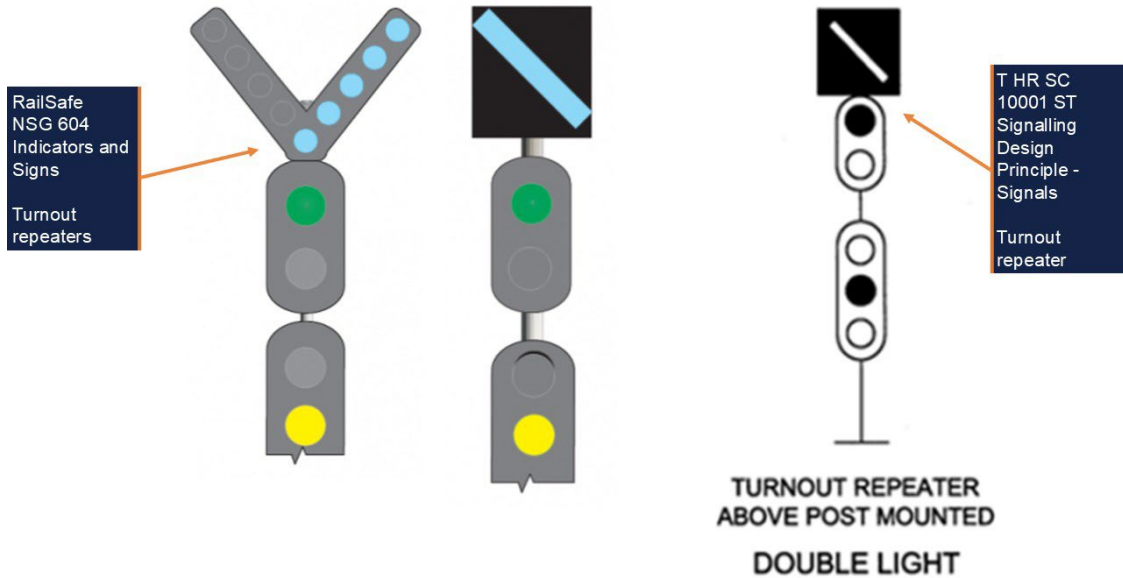
Figure 17: Turnout repeaters

Following the incident, Sydney Trains identified that there was no turnout repeater²⁸ for signal BN 94 S as an advanced warning mechanism for BN 318 turnout (Figure 17).

In its investigation, Sydney Trains confirmed that turnout repeater signals enhanced overall visibility and signal recognition for drivers and provided additional confirmation of primary signal indications. Sydney Trains also noted that turnout repeaters could improve a crew's situational awareness, but that they did not eliminate the risk or prevent the consequences of an overspeed.
