Engine failure involving Boeing 737, VH-VYH

Sydney Airport, New South Wales, on 8 November 2024

Aviation Occurrence Investigation (Short)

AO-2024-057

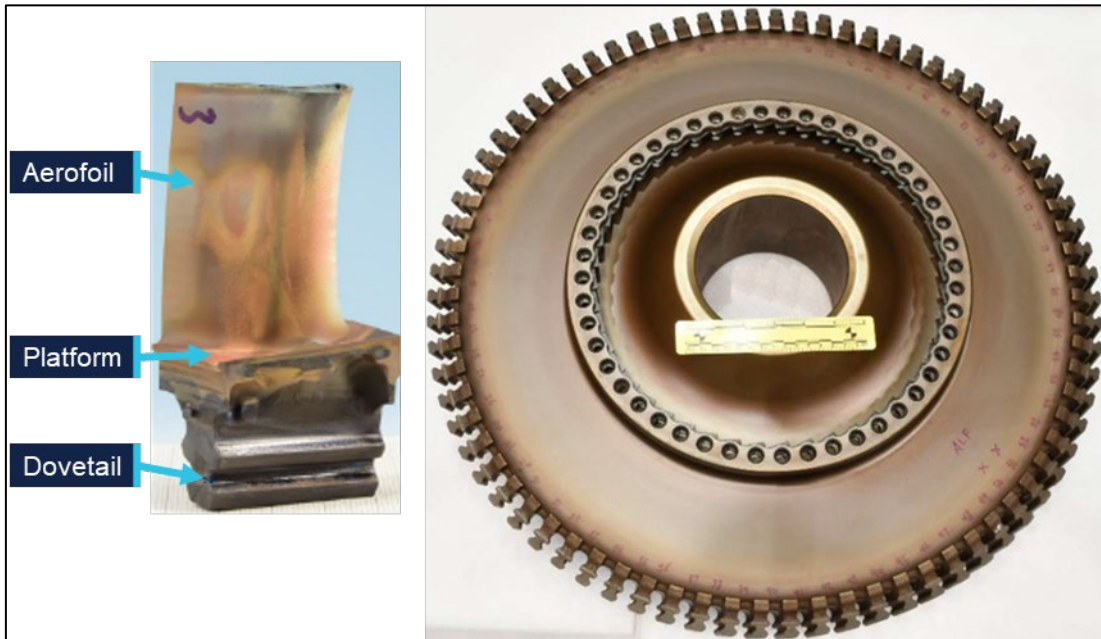
Figure 5: CFM56-7B HPT blade (left) and disc (right)

CFM International conducted further metallurgic examination on the HPT blades and disc. Evidence of fatigue cracking was found in 28 blades, originating in the region described as the ‘min-neck’ of the blade dovetails. This was the area on the blade where the dovetail cross-section was at its thinnest point. The fatigue cracks originated on the ‘convex side’ of the blade, which is the face visible in Figure 5.
