Misaligned take-off involving Bombardier DHC-8-315, VH-TQM

Mildura Airport, Victoria, on 25 February 2025

ATSB Transport Safety Report

AO-2025-008

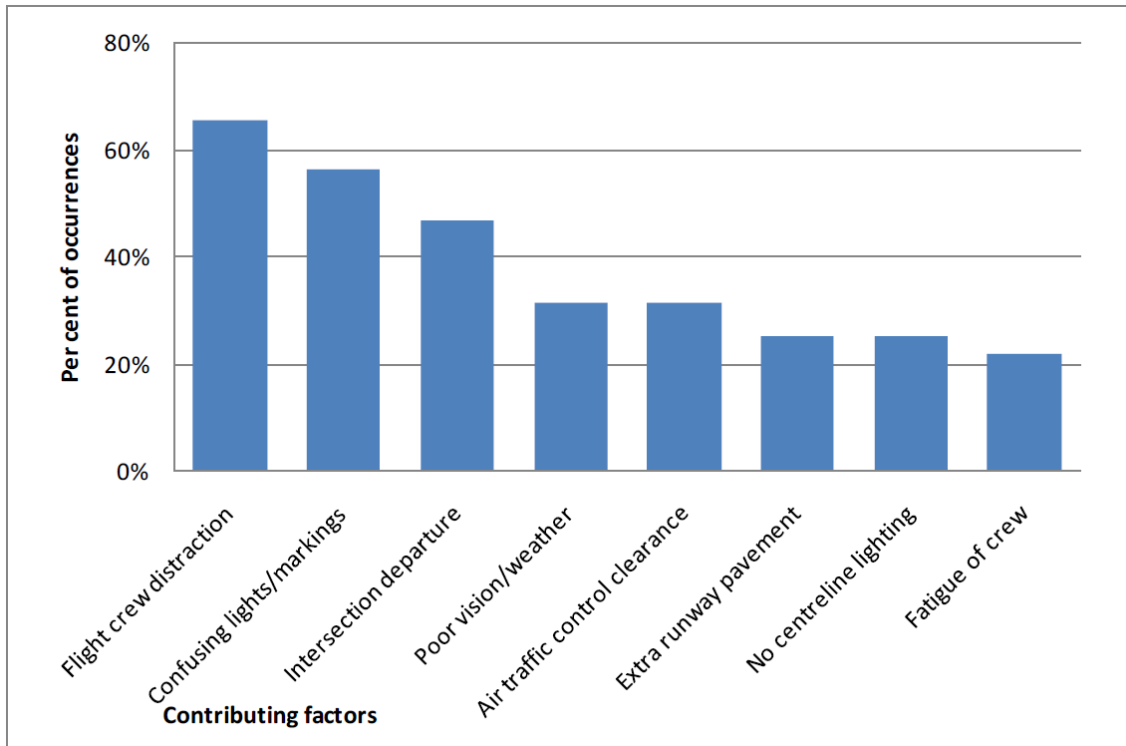
Figure 6: Factors contributing to misaligned take-off occurrences

Environmental factors were the predominant contributors, which included physical features such as the runway layout, line markings and lighting. Weather and visibility were also considerations. The report identified that confusing runway entry, lighting or taxiway layout/lighting were the most frequent factors and that additional areas of pavement around taxiway entry and runway threshold areas could provide erroneous cues for pilots at night.
