Antenna failure involving Beechcraft King Air B200, VH-EEL

55 km west of Bankstown Airport, New South Wales, on 18 June 2025

ATSB Transport Safety Report

AO-2025-031

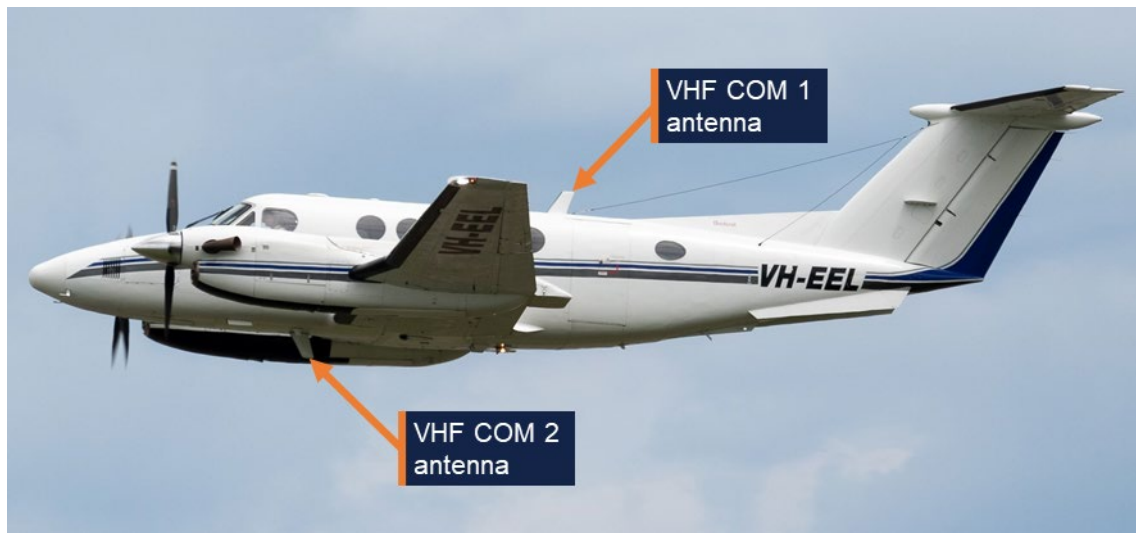
Figure 2: VHF antennas on VH-EEL

The Beechcraft King Air B200 is a pressurised, low-wing, twin turbine-engine aircraft. It has 2 VHF antennas: COM 1 is fitted on top of the fuselage, and COM 2 is underneath the fuselage (Figure 2). VH-EEL was manufactured in the United States in 2000 and registered in Australia in the same year. CJ Aerospace had been the registered operator of the aircraft since July 2021.

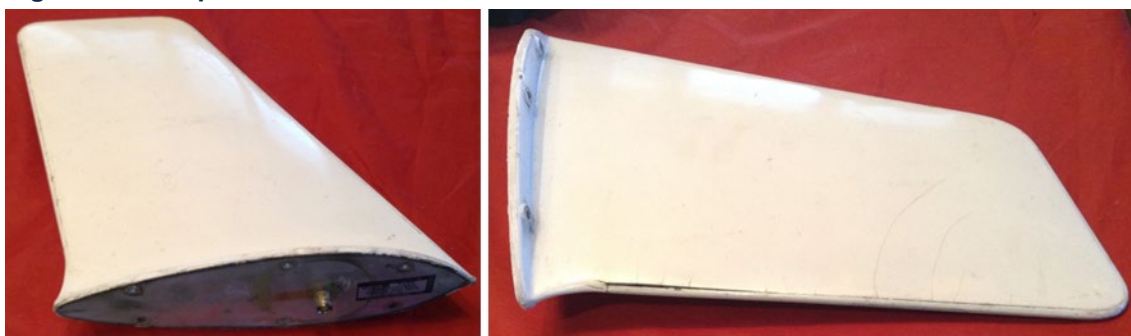
Figure 6: Exemplar VHF COM antenna

The detached antenna was not located. The antenna base was examined at the ATSB's engineering facility in Canberra. The manufacturer's label indicated that it was manufactured by the Trivec-Avant corporation. The part number was 18-40-01 and the serial number was 11514. The antenna was not original to the aircraft, and its installation date could not be determined. The Trivec-Avant corporation ceased operation in about 2011, and no technical drawings or other details could be obtained for the antenna. However, images of an antenna with the same part number were sourced online (Figure 6). It comprised a base and upper structure with an internal electrical antenna.
