# **Collision with terrain at night involving Robinson R22 Beta II, VH-LYD**

25 km south-south-east of Kowanyama, Queensland, on 9 October 2025

**ATSB Transport Safety Report**

AO-2025-063

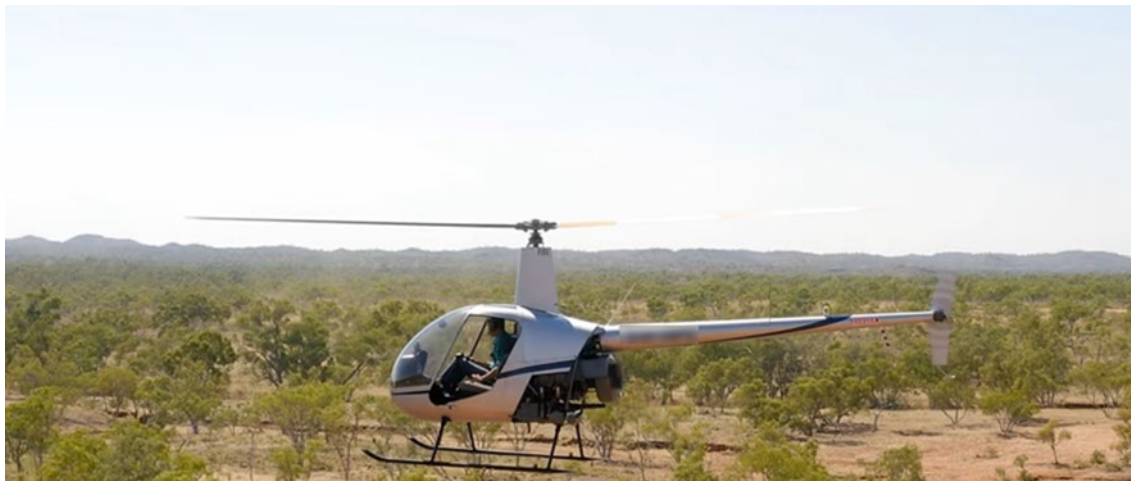
**Figure 3: Exemplar Robinson Helicopter Company R22**

VH-LYD was a Robinson Helicopter Company R22 Beta II helicopter, serial number 4471 (Figure 3). It was powered by a Textron Lycoming, O-360-J2A, 4-cylinder piston engine. VH-LYD was manufactured in the United States on 12 February 2010 and first registered in Australia on 19 May 2010. It was equipped and maintained to a day VFR standard. Its last 100-hourly maintenance was conducted on 24 September 2025. At the time of the accident VH-LYD had accumulated approximately 14,645 hours total time in service.
