Main landing gear wheel separation involving Saab 340, VH-VEZ

Canberra Airport, Australian Capital Territory, on 29 January 2026

Aviation Occurrence Investigation (Short)

AO-2026-008

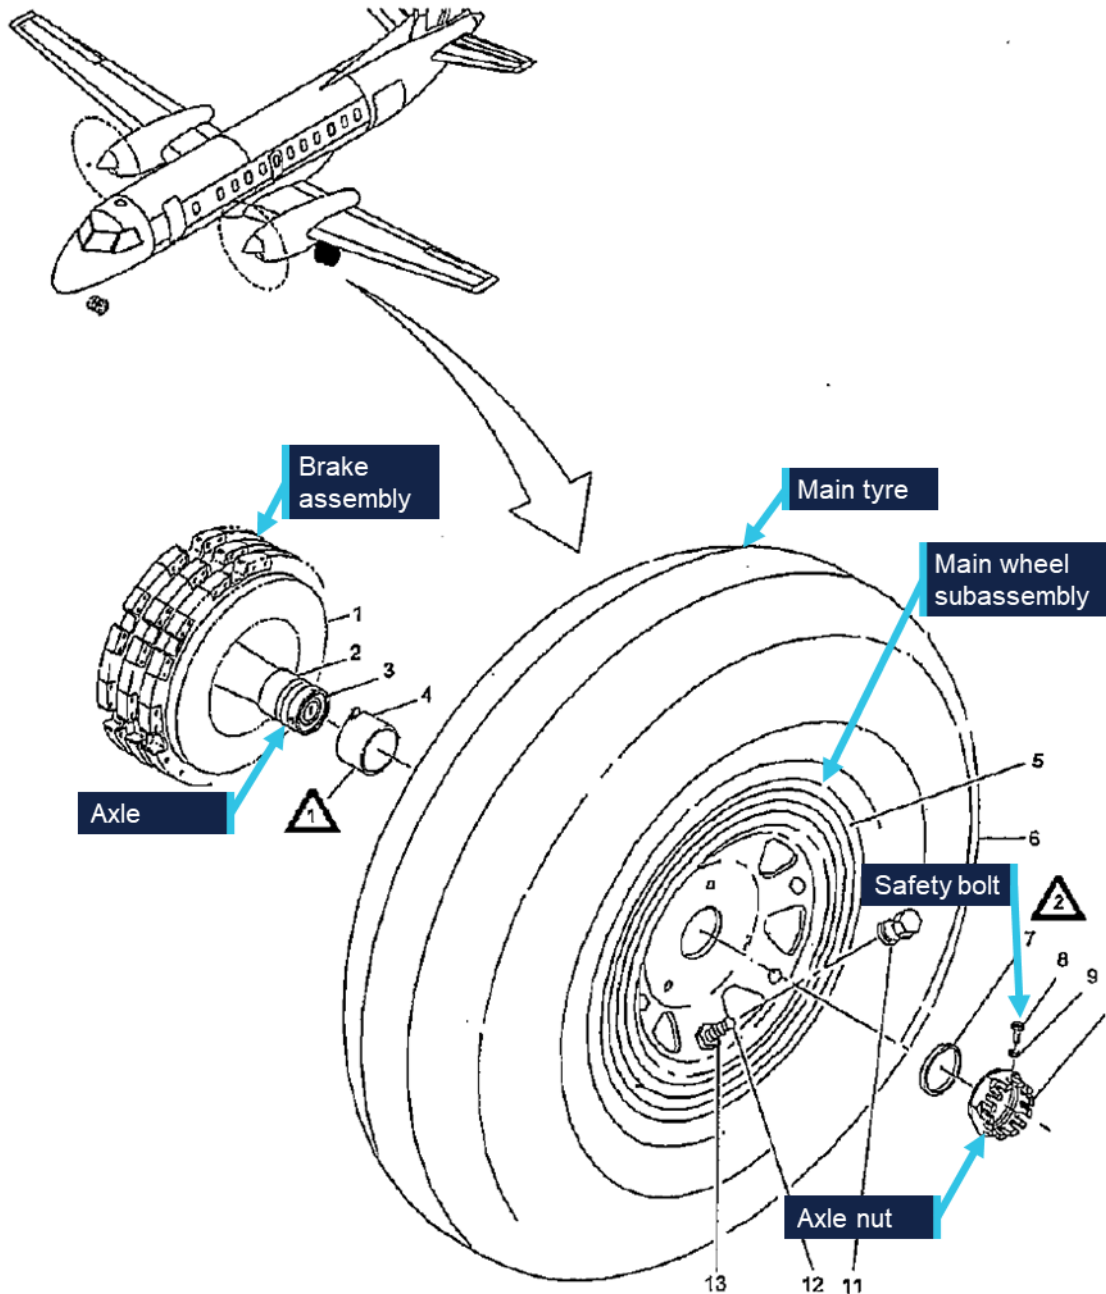
Figure 2: Saab 340 main wheel assembly

An overview of a main wheel is shown in Figure 2. The main wheel assembly consists primarily of the tyre and the wheel subassembly; also referred to as the wheel hub. The main wheel assembly connects to the axle via an inboard and outboard tapered roller bearing, installed in the wheel subassembly as shown in Figure 2. The main wheel assembly is held onto the axle via a single axle nut and safety bolt.

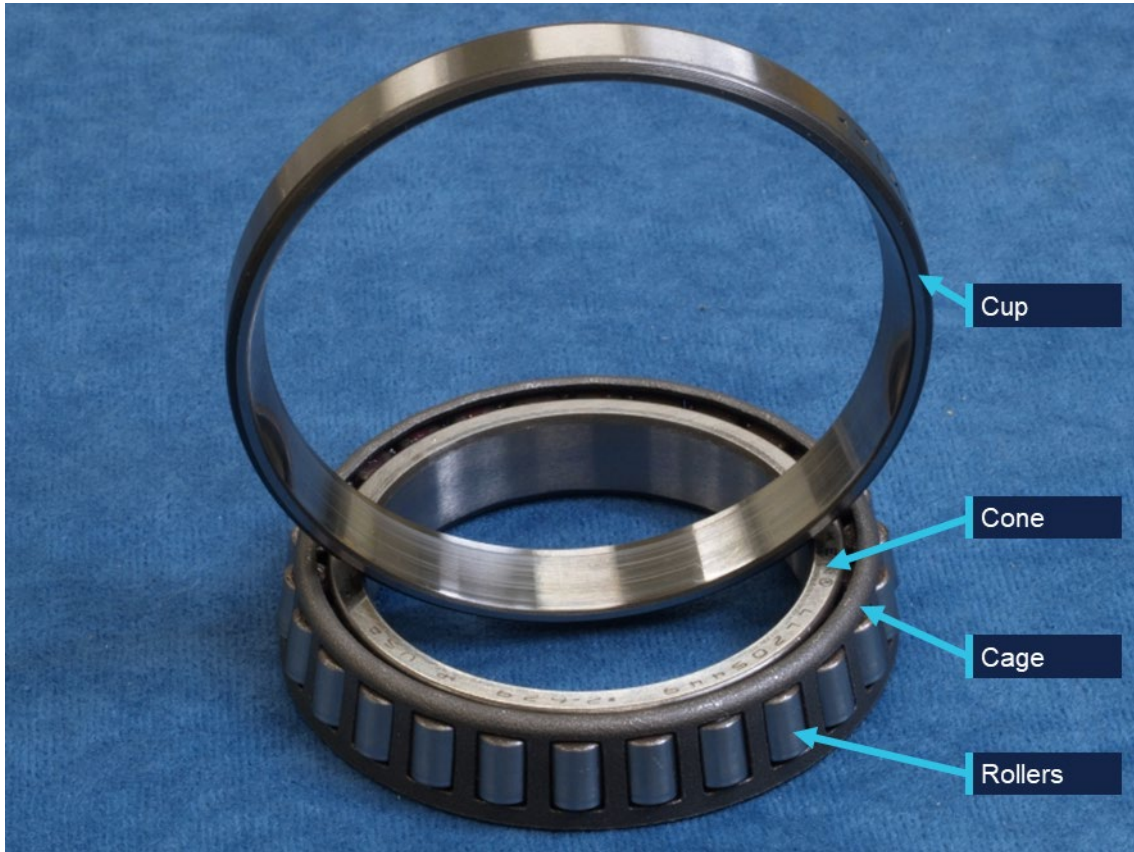
Figure 4: Example bearing

Each wheel subassembly bearing is comprised of a cup (outer race), cone (inner race), cage, and rolling elements (rollers) (Figure 4), held in place with a retaining ring. The bearing cups are shrink fitted into the wheel subassembly. Each bearing then has an inner and outer seal to protect it from contamination while preserving the grease lubrication. The cup or the cone-and-rollers can be replaced independently without changing the entire bearing.
