Power loss and ditching involving Robinson R44, VH-8HR

19 km north-west of Hamilton Island, Queensland, on 25 January 2026

ATSB Transport Safety Report

AO-2026-009

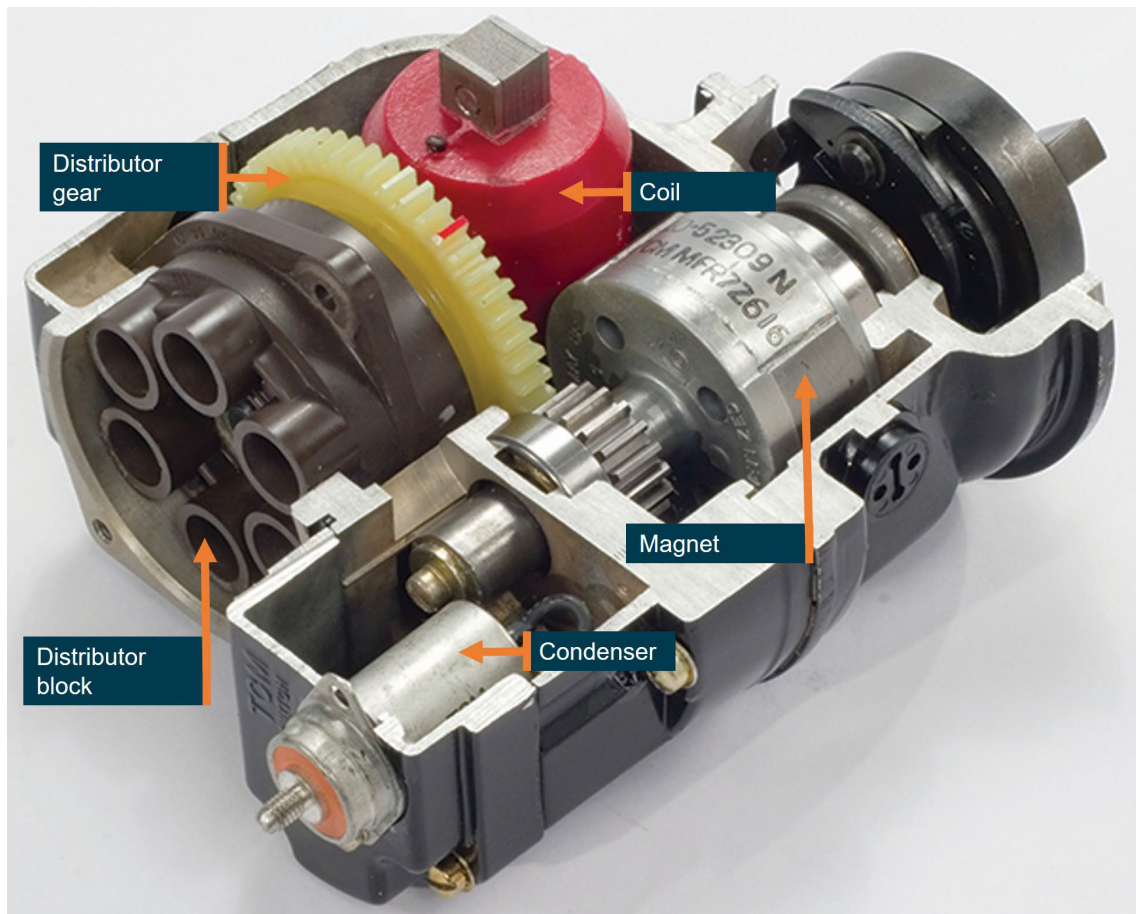
Figure 2: Sectioned view of an exemplar magneto

The right magneto distributor gear jammed when an internal rotating electrode became loose. This led to a mechanical failure of the gear teeth that affected the engine timing and subsequently reduced the helicopter power output.

At the time of the occurrence, the Lycoming engine was fitted with 2 magnetos (part number 10-6006-46-201), manufactured by Continental Aerospace Technologies (CAT), that produced high voltage for the 12 spark plugs. Fitted to the distributor gear of each magneto (Figure 2) was a rotating electrode that provided the timing of the electrical energy to the distributor block⁴ and then to the relevant spark plug via a high-tension lead.

*This magneto is similar to the one that was fitted to VH-8HR.
Source: Aviation Safety Magazine, annotated by the ATSB*
