# Collision with terrain involving Wolf Pitts S1-11X, VH-PVX

Avalon Airport, Victoria, on 28 March 2025

## **ATSB Transport Safety Report**

AO-2025-017

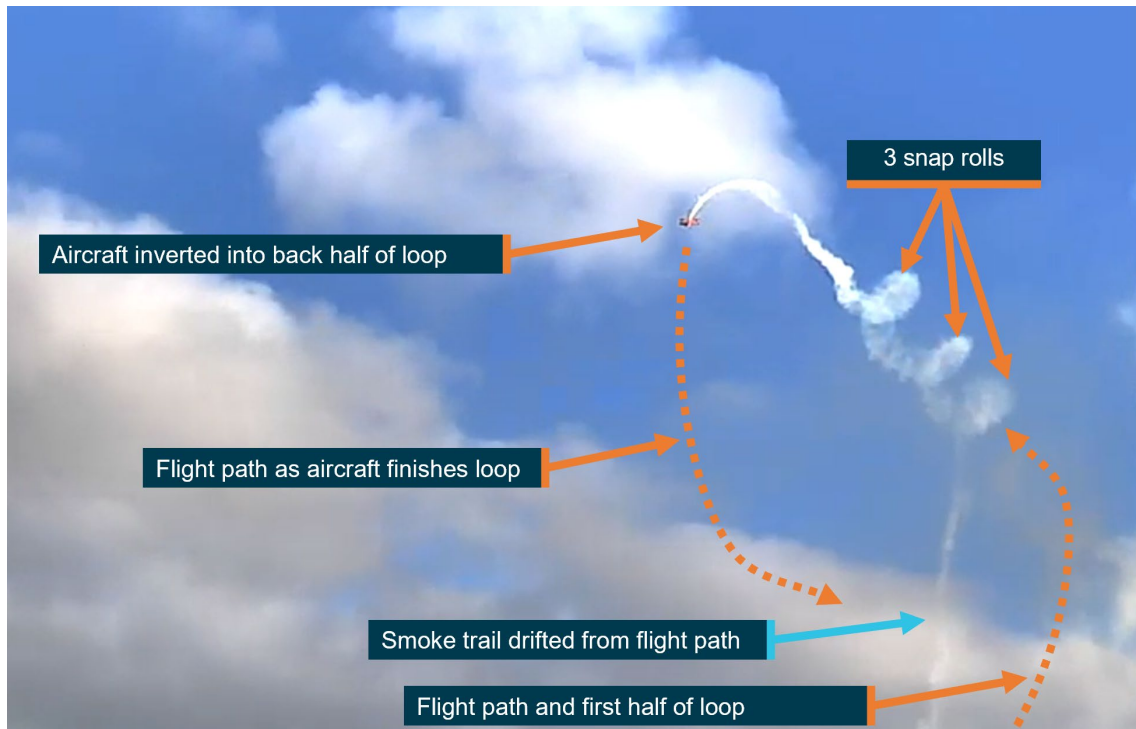
**Figure 1: A successful triple avalanche manoeuvre performed by the pilot in VH-PVX on 26 March 2025**

*This is a still image extracted from a video recording of the validation flight (see Validation flight).  
Source: AMDA, annotated by the ATSB*

The pilot described the normal process they would use to complete the triple avalanche manoeuvre, which included the first half of a loop followed by 3 snap rolls and then the final part of the loop (Figure 1). They stated they would normally enter the loop pulling about 4–5 g, then gradually reduce the g toward the top of the loop to start the snap rolls with a slight nose up attitude. Through the process of completing the snap rolls, it was possible for the aircraft to laterally cross the intended show line (*see Air display information*). In this circumstance, the pilot reported they usually checked the ground position immediately following the completion of the snap rolls and made corrections if they were no longer aligned with the show line. The pilot indicated their personal minimum height for commencing the snap rolls was 1,000 ft AGL.

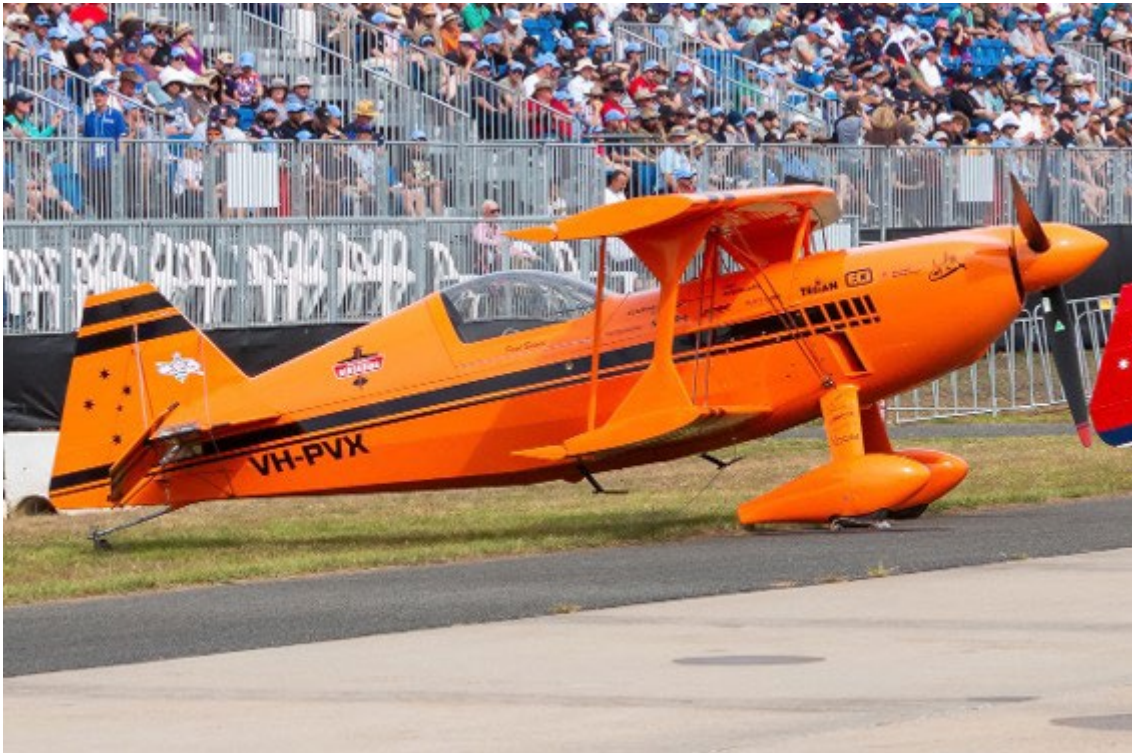
**Figure 3: VH-PVX at Avalon Airshow prior to the accident**

VH-PVX (Figure 3) was first registered in Australia in 2015 and issued with a special certificate of airworthiness in the experimental category.<sup>6</sup> It had been operated by Paul Bennet Airshows since that time.

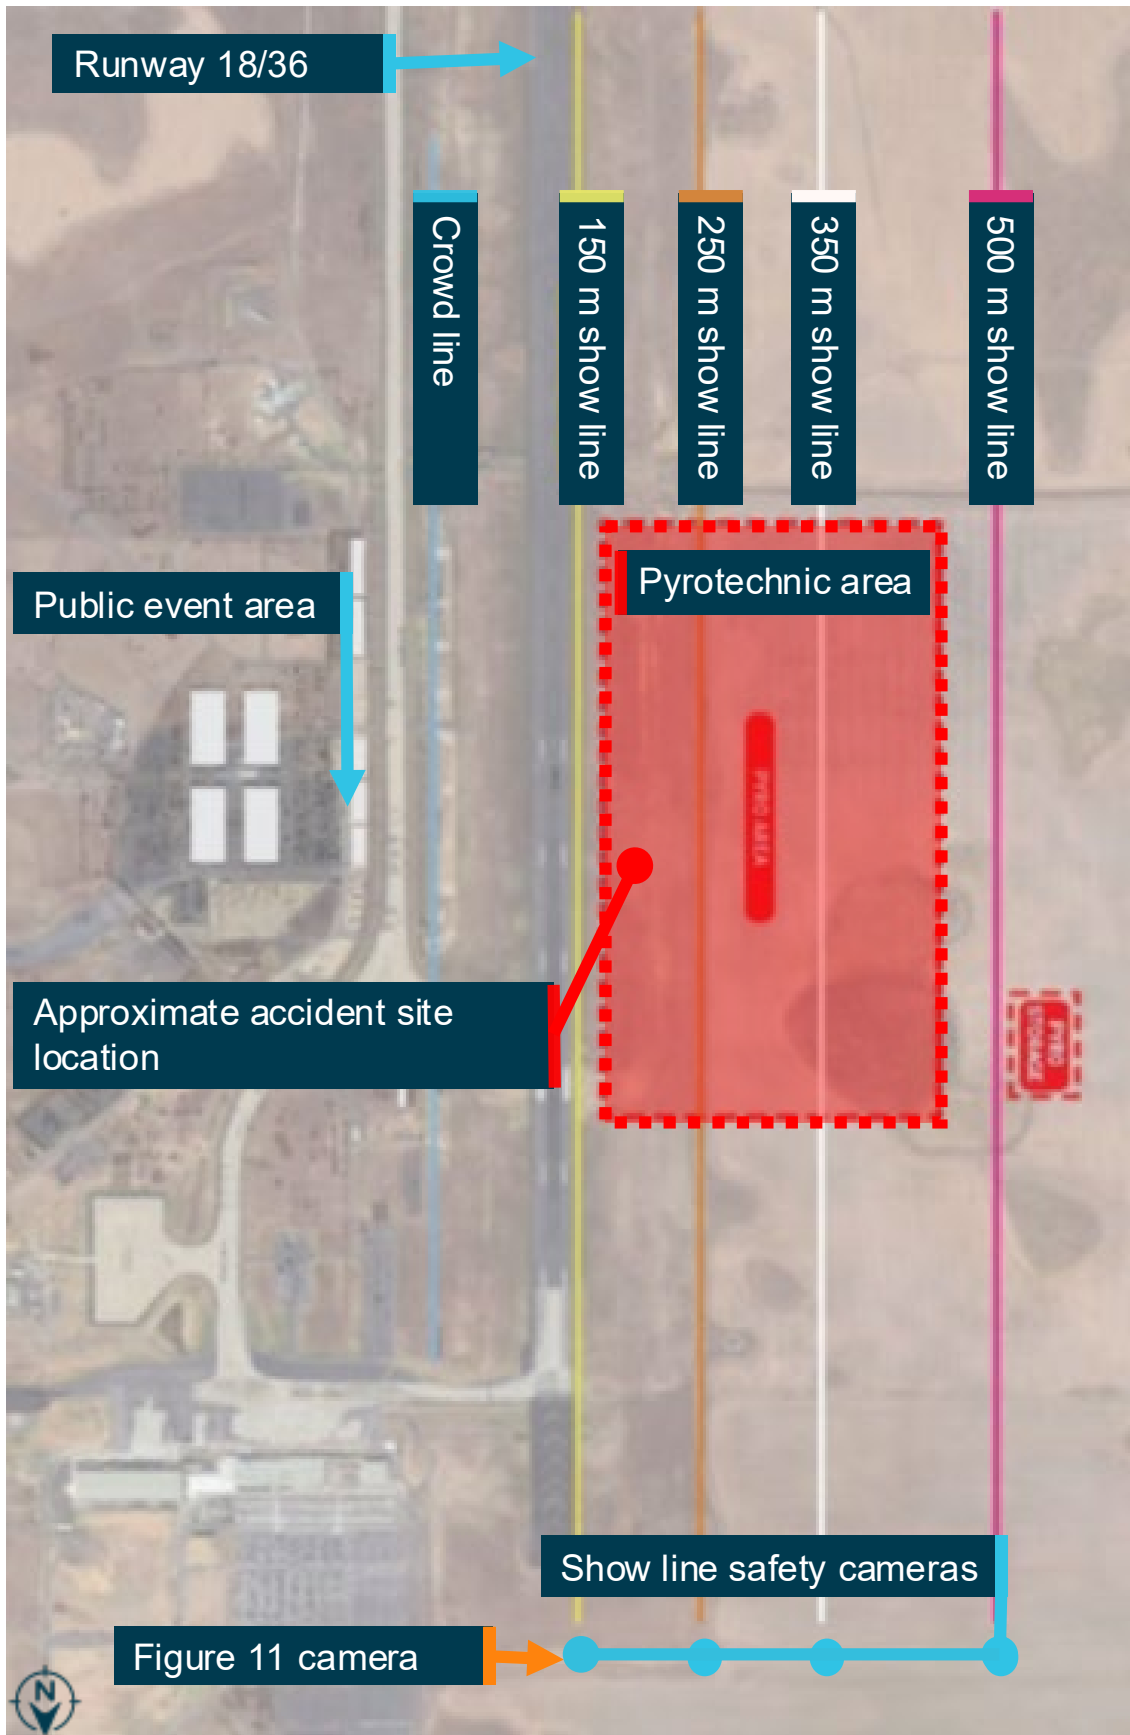
Figure 10: Avalon Airport designated areas

Designated areas were mapped on Avalon Airport to assist in segregating the airshow from spectators. The airshow had several displays that used pyrotechnics, including the Sky Aces routine. The pyrotechnics detonation area was located to the west of runway 18/36 inside the flight display area. Show lines were created to assist aircraft with conducting displays at an appropriate distance from the crowd (150 m, 250 m, 350 m and 500 m). The show line to which a display could be performed to, was determined by the aircraft's speed during the display. Cameras were placed on each show line and monitored to ensure aircraft were conducting their displays at a safe distance from the spectators (Figure 10).

The display pilot briefing provided by AMDA stated that aircraft with a maximum display speed between 101 kt and 200 kt could conduct their display as close to the crowd as the 150 m show line. At the time of the accident manoeuvre, the pilot was performing at about 160 kt and performing close to the 150 m show line.

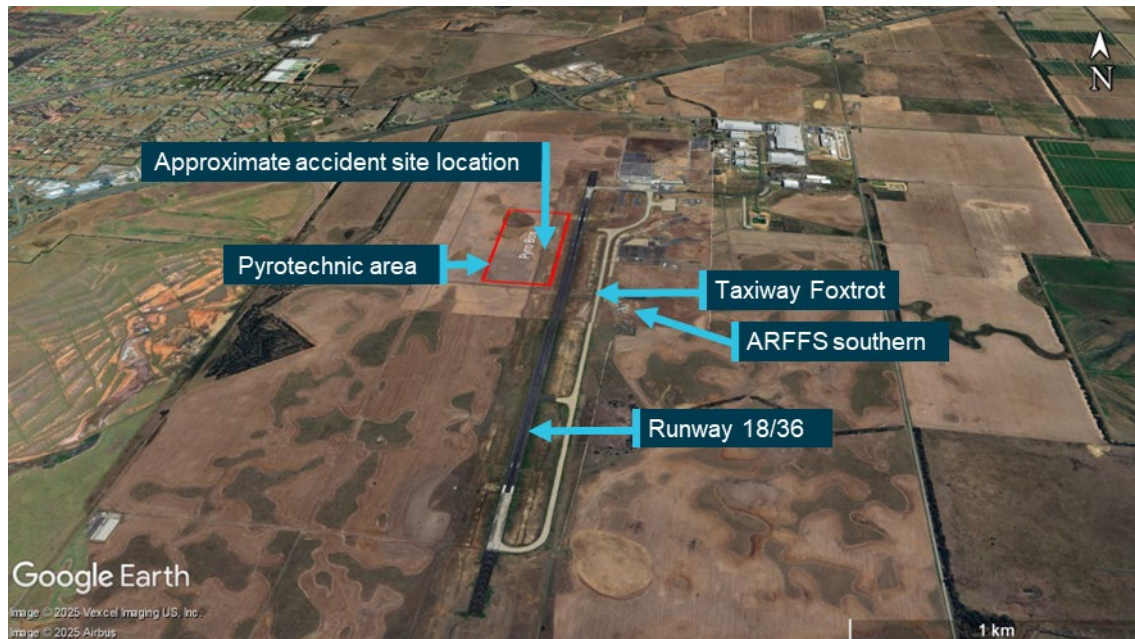
**Figure 12: Avalon Airport taxiway and ARFFS southern location**

- pyrotechnic display operator injured/killed by aircraft wreckage and/or flare debris impact into pyrotechnic area during airshow
- aircraft/vehicle malfunction or crash during atypical flying display
- vehicle or aircraft transits across the pyro [pyrotechnic] box bursting or igniting flammable liquid explosives
- blocking ARFF [Aviation Rescue Fire Fighting Services] route out of the fire station (Figure 12) with resultant impact on ARFF emergency response times.

To ensure taxiway Foxtrot (Figure 12) remained clear for ARFFS units leaving the southern fire station in an emergency, aircraft movements to/from the southern tarmac were controlled by Airservices Australia air traffic control.
