Unstable approach involving Airbus A320, VH-VQL

Hervey Bay Airport, Queensland, on 11 August 2025

ATSB Transport Safety Report

AO-2025-050

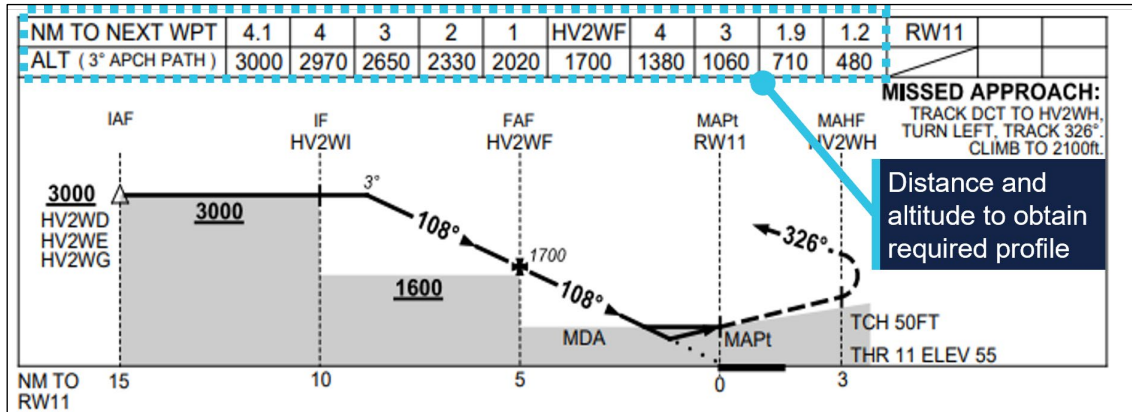
Figure 3: Published approach profile

Hervey Bay Airport is a non-controlled, certified aerodrome consisting of a 2,000 m long and 30 m wide runway orientated 11/29. The approach profile for runway 11 is 3° and is published on the relevant approach chart (Figure 3).

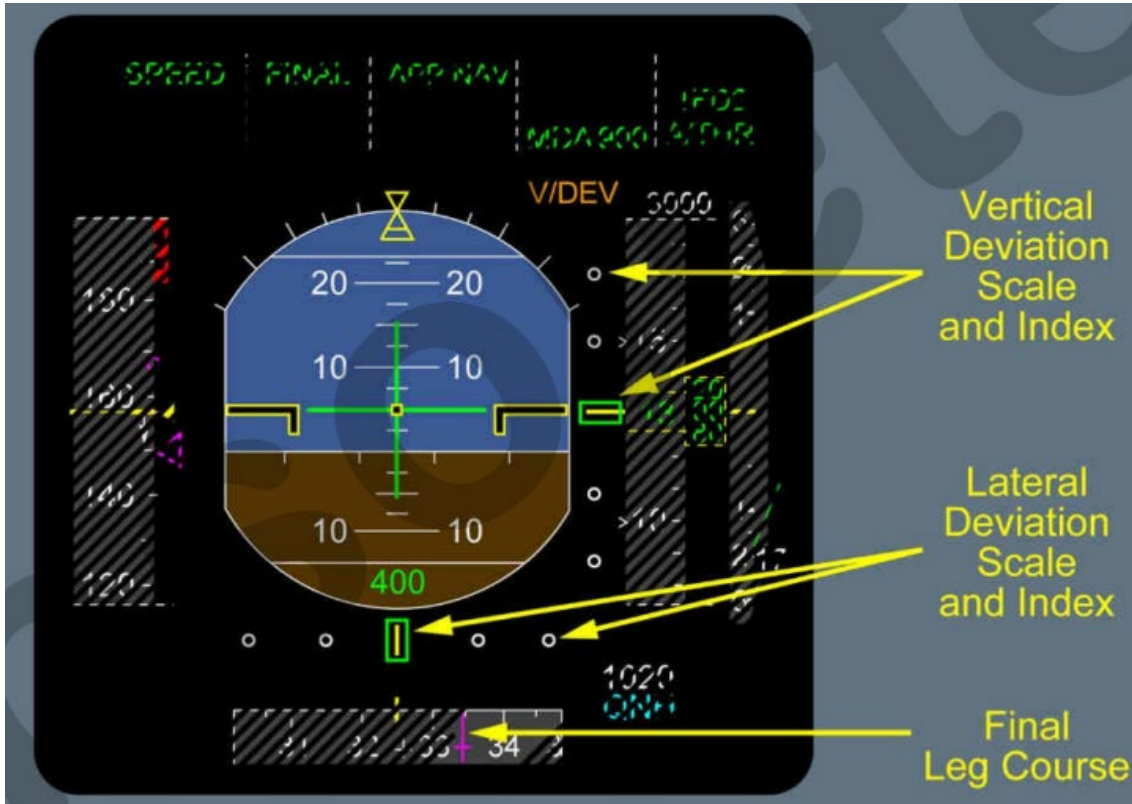
Figure 4: Primary flight display on A320

The information used by the flight crew during the approach would have been predominantly through the PFD, which had an indication of the vertical and lateral profile being flown (Figure 4). The aircraft's ND and MCDU in the flight deck can be set to show the distance to the runway in the current programmed flight plan.

In this occurrence, the PF reported the vertical and lateral deviation indicator was in the expected location on the PFD, to indicate that there was no deviation from the datum (slope and track).
