# **Collision with terrain involving Piper PA-32R-300, VH-JVA**

Shellharbour Airport, New South Wales, on 11 October 2025

Aviation Occurrence Investigation (Short)

AO-2025-064

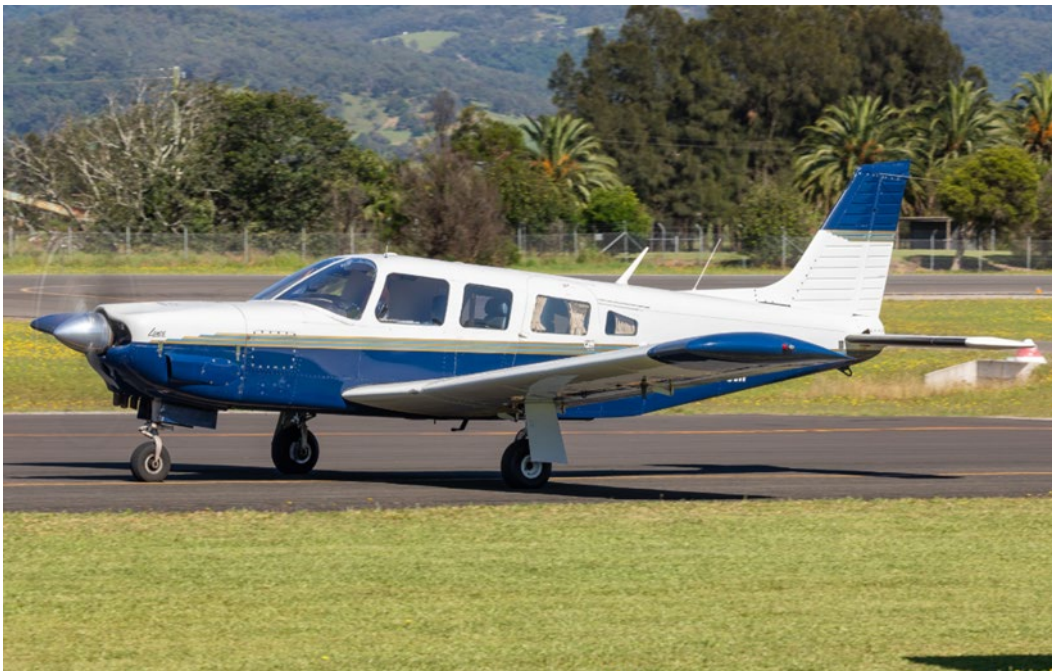
**Figure 4: VH-JVA**

The Piper PA-32R-300 Cherokee Lance is a single-engine, low-wing, retractable-tricycle landing gear aircraft. The Lance is powered by a Lycoming IO-540 fuel-injected, horizontally-opposed piston engine driving a 3-blade, variable-pitch propeller. VH-JVA (Figure 4), serial number 32R-7680030, was manufactured in the United States in 1975 and first registered in Australia in 1985. The maintenance release stated that the aircraft was approved for IFR, visual flight rules<sup>4</sup> (VFR) night and VFR day operations.

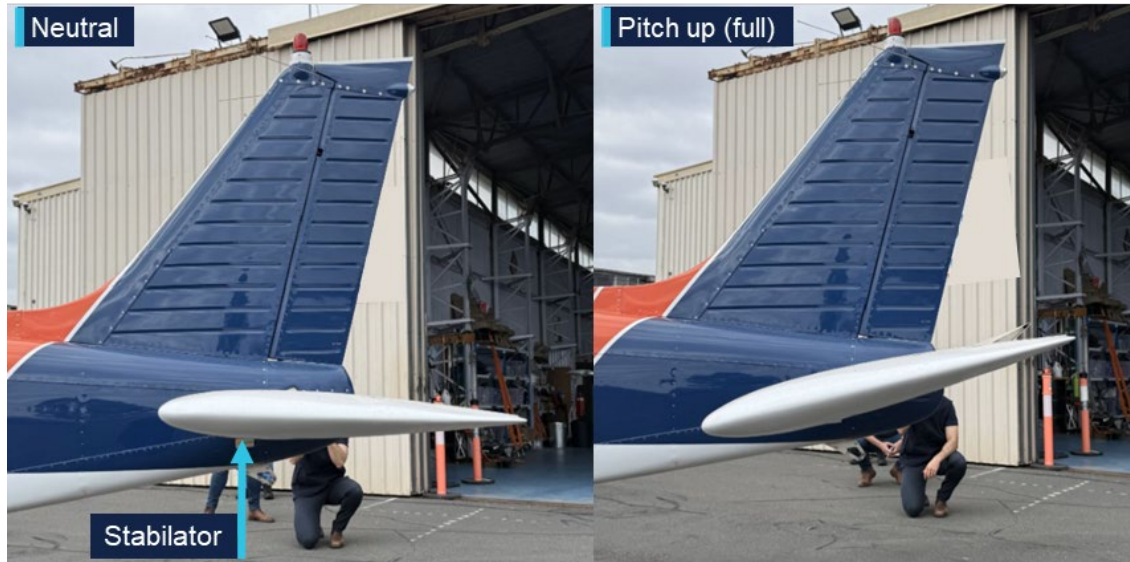
**Figure 5: Horizontal stabilator**

The aircraft was fitted with a horizontal stabilator (Figure 5), sometimes referred to as an all-moving tail. A horizontal stabilator is a fully movable aircraft horizontal stabiliser in which the entire horizontal tail surface is responsive to control column inputs.

*The figure shows the stabilator of a representative Piper Lance (not VH-JVA).*  
Source: ATSB

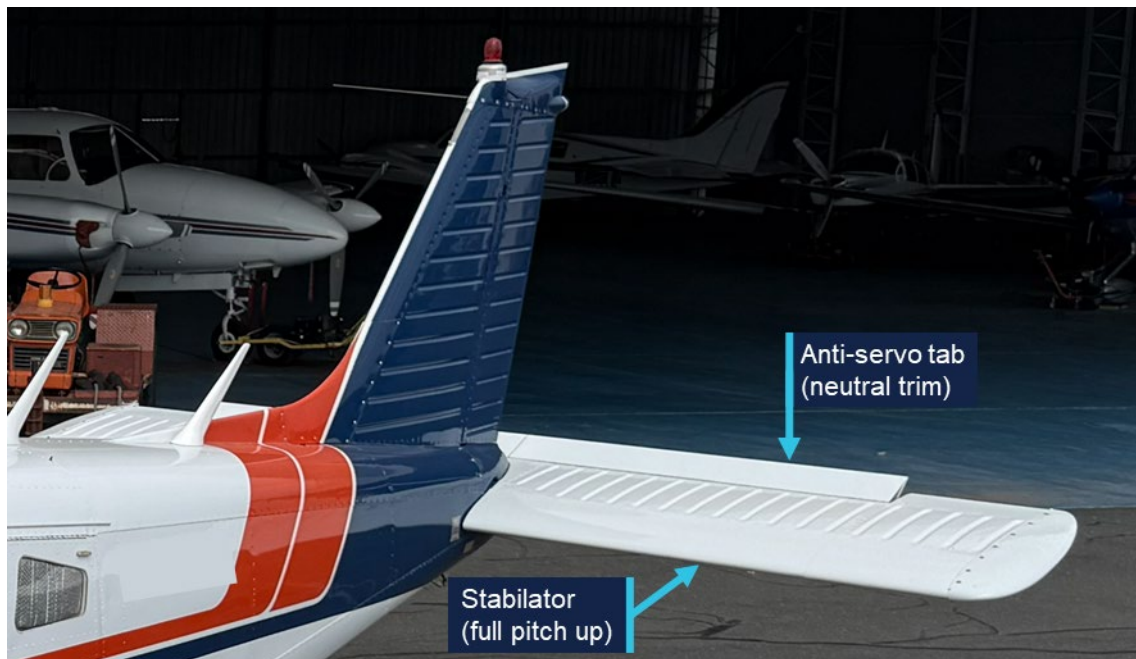
**Figure 6: Stabilator and anti-servo tab**

The stabilator was fitted with an anti-servo tab (Figure 6), a small, hinged surface set into the trailing edge of the stabilator. As the stabilator deflected from the trim position, the tab moved in the same direction, but further than the stabilator, to provide an opposing force.

*The figure shows the stabilator of a representative Piper Lance (not VH-JVA).*  
Source: ATSB

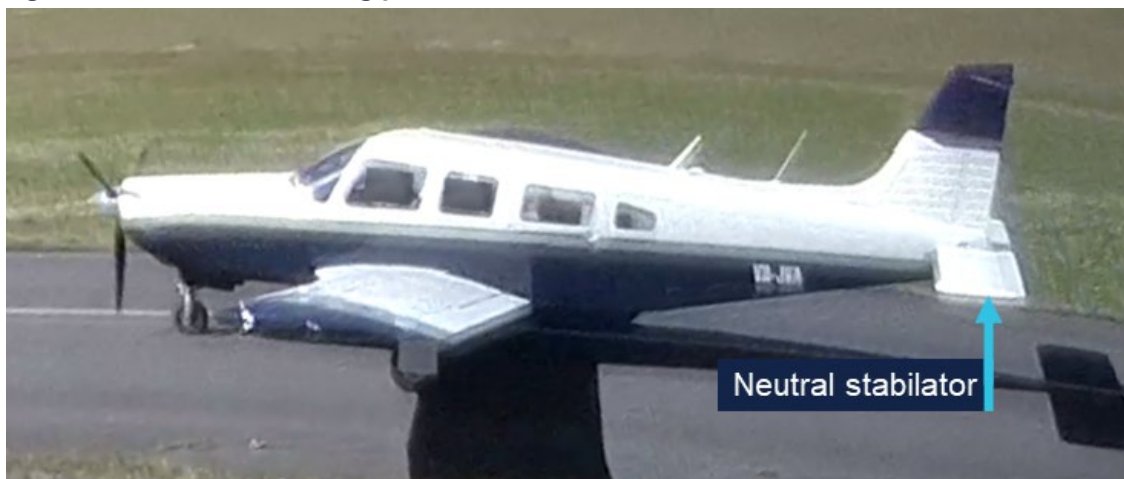
**Figure 11: The aircraft taxiing prior to take-off**

The ATSB obtained recorded automatic dependent surveillance-broadcast (ADS-B) data for the accident flight. In addition, several security cameras captured the aircraft before and during the flight (Figure 11 and Figure 12)
