Breakaways involving *Wide India*, *Volans*, *Viking Passama* and *MSC Barbara*

Port of Brisbane, Queensland, on 24 November 2025

ATSB Transport Safety Report
Marine Occurrence Investigation
MO-2025-012
Interim – 5 June 2026

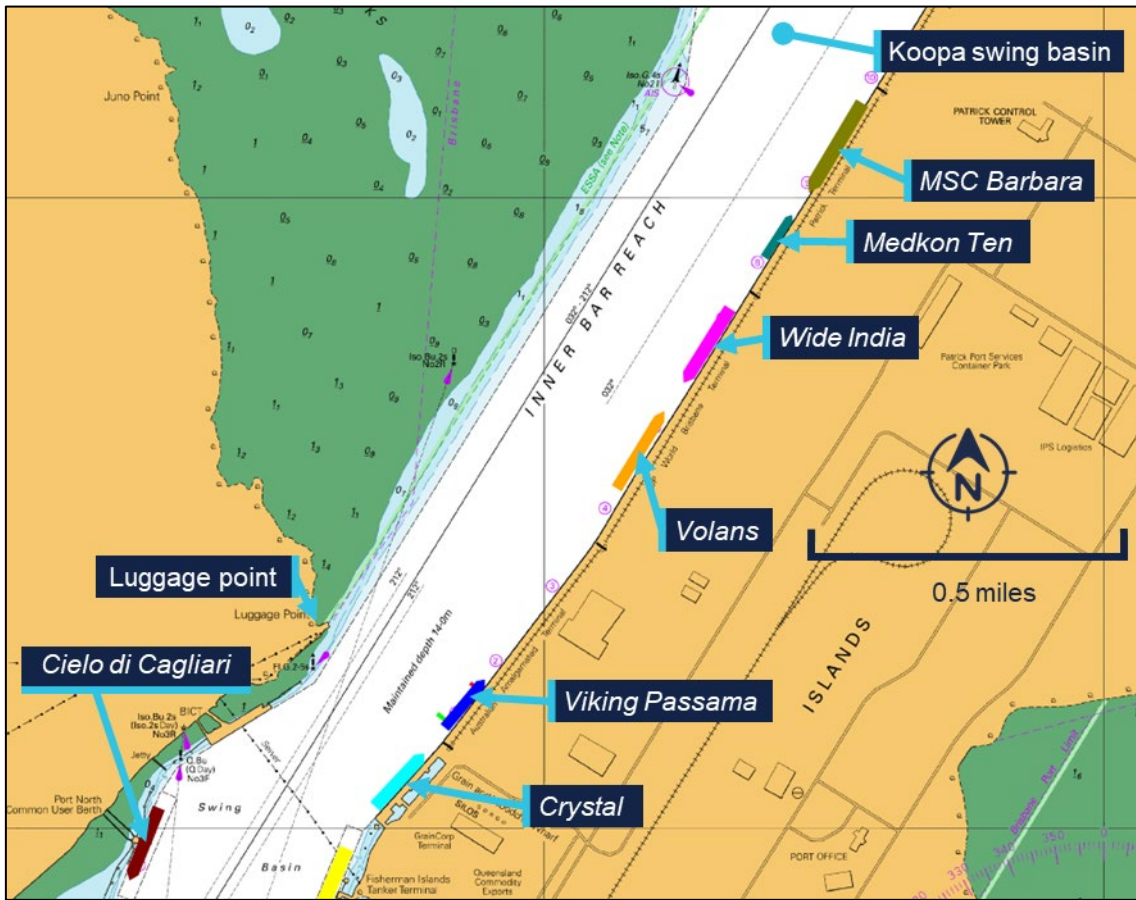
Figure 2: Mooring locations at Fisherman Islands preceding the storm

The container ships *MSC Barbara*, *Medkon Ten*, *Wide India* and *Volans* had arrived in the Port of Brisbane in the preceding days. The ships were moored at the container berths of Fisherman Islands and were loading and unloading containers. As part of these routine cargo operations, hatch covers from *Wide India* and *MSC Barbara* were offloaded onto the berth.

Additionally, the woodchip carrier *Crystal* was moored at the Fisherman Islands grain and woodchip wharf just south of Fisherman Islands berth 1 (Figure 2).

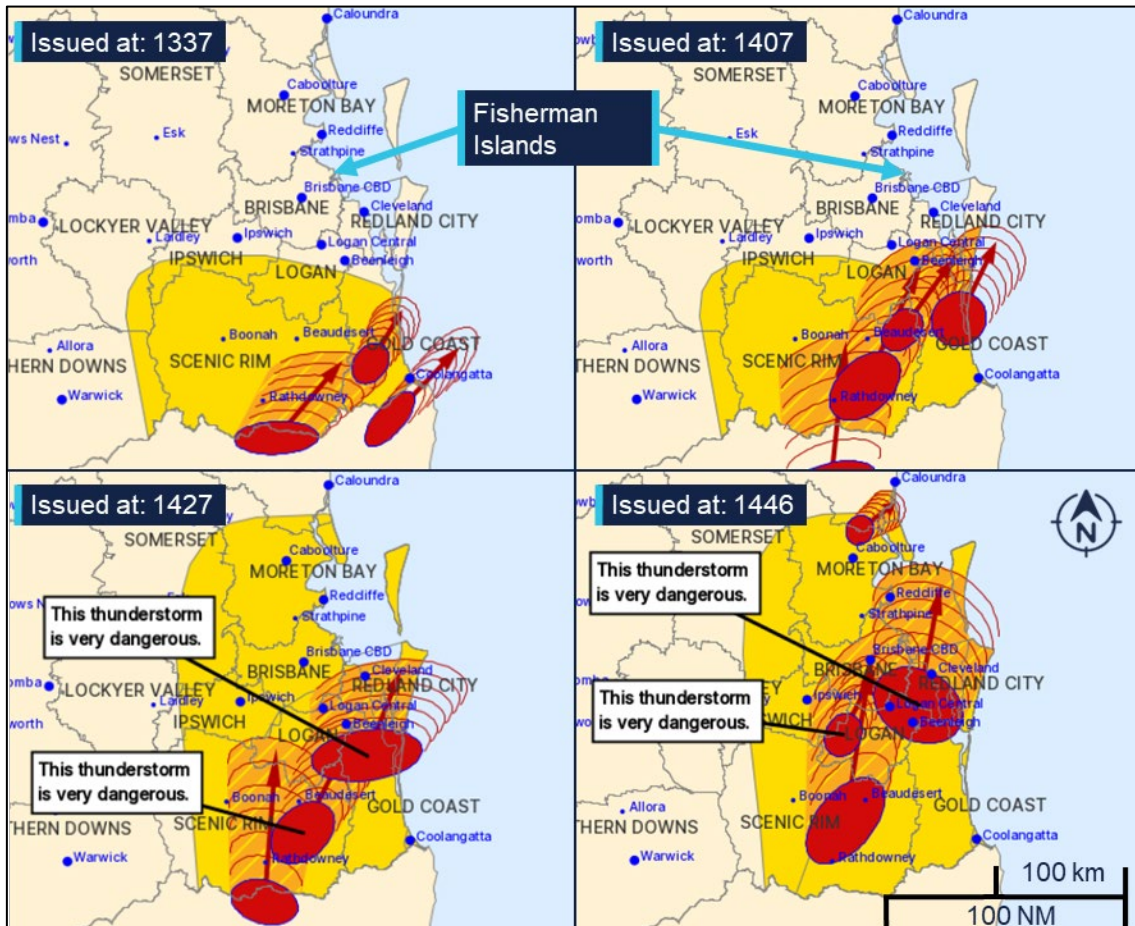
Figure 3: Storm warnings 1337 to 1446

Updated warnings were issued by the BoM at 1310 and 1337, with observations and short-term forecasts now showing storms in the Gold Coast area tracking north-east (Figure 3). At 1407, an updated warning predicted storms tracking further north, potentially passing close to Brisbane port.

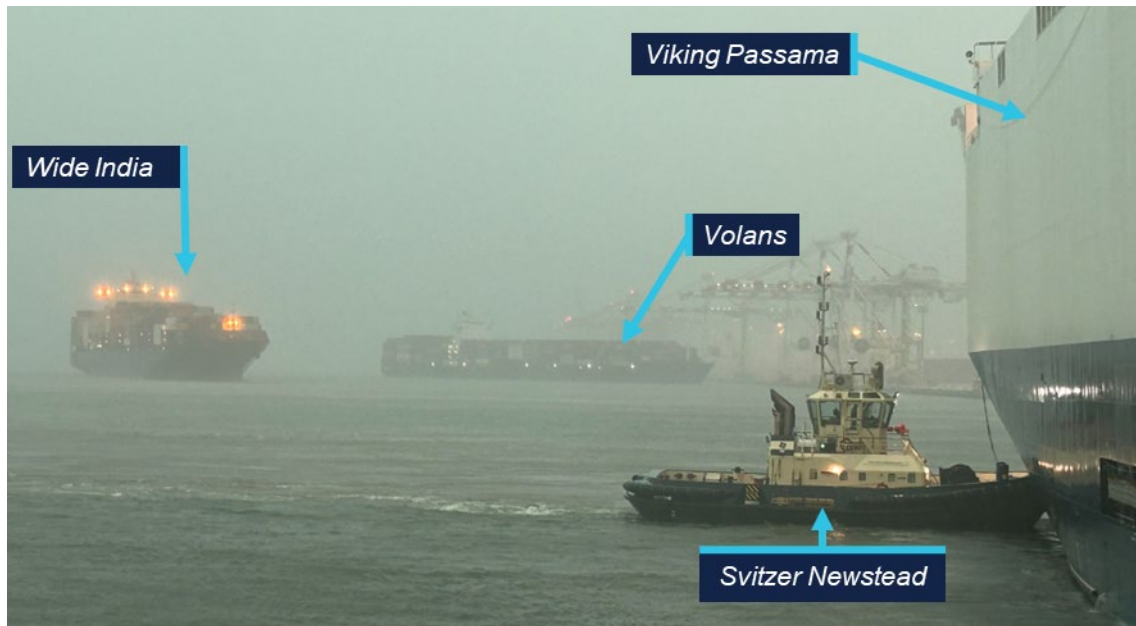
Figure 7: 1532 view from *Bullara*

The master started the main engine, to prevent the ship from drifting astern into *Medkon Ten*. The duty VTSO radioed the ship and gave the master permission to use the ship's engine to manoeuvre. The master replied that they were already underway as all lines had parted, after which the VTSO informed them that tugs were some time away and requested them to 'manoeuvre and handle your situation the best you see fit'. *Wide India* moved slowly upriver, maintaining steerageway⁴ as the master dredged⁵ the ship's starboard anchor and used the bow thruster to maintain heading control. At 1526, *Wide India* passed closely around the stern of *Volans* (Figure 7).

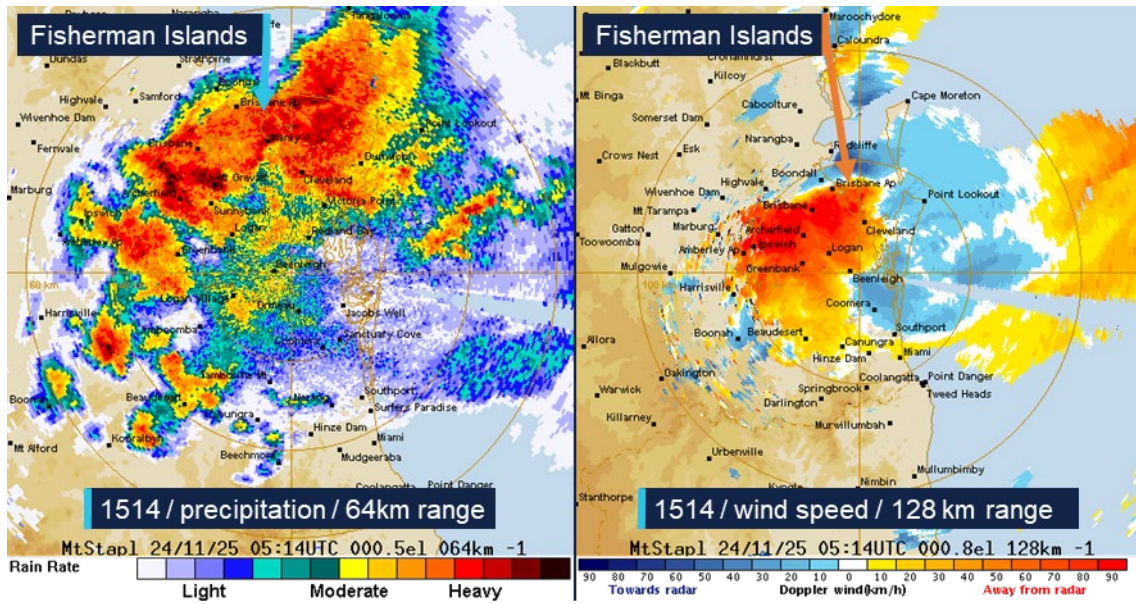
Figure 22: Mount Stapleton weather radar at 1514 on 24 November

- meteorological warnings and forecasts through METAREA X, as part of the Global Maritime Distress and Safety System (GMDSS)
- coastal waters forecast for Moreton Bay
- severe weather briefing for Queensland
- general area forecasts available through the BoM website and app
- weather radar information including precipitation density and doppler windspeed to and from the radar (Figure 22).
