Collision between Aurizon train 9M48 and Qube train 9277

Oonoomurra, Queensland, on 17 August 2022

ATSB Transport Safety Report

RO-2022-010

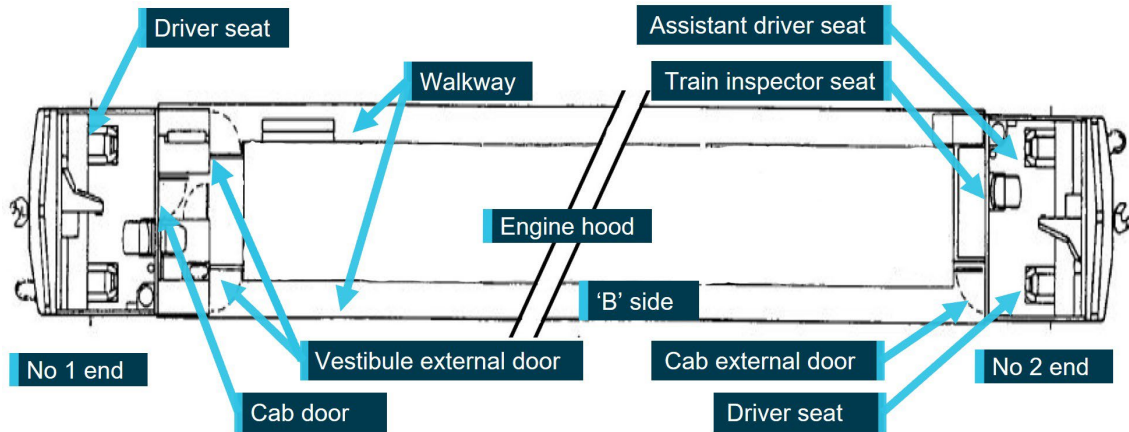
Figure 3: Top view of the Goninan CM30-8 diesel electric locomotive

Access and egress for the No 1 end operator's cab was through a rear facing internal door that opened into a vestibule. External doors provided access/egress to the walkways on both sides next to the engine hood. The No 2 end operator's cab was accessed through a rear facing external door that led directly to the walkway on the 'B' side of the engine hood only. The locomotive was designed to be operable in either direction from the respective operator's cab. At the time of the derailment, the driver was operating the locomotive from the No 1 end (Figure 3). These access and egress pathways were also the primary emergency escape paths.²⁵

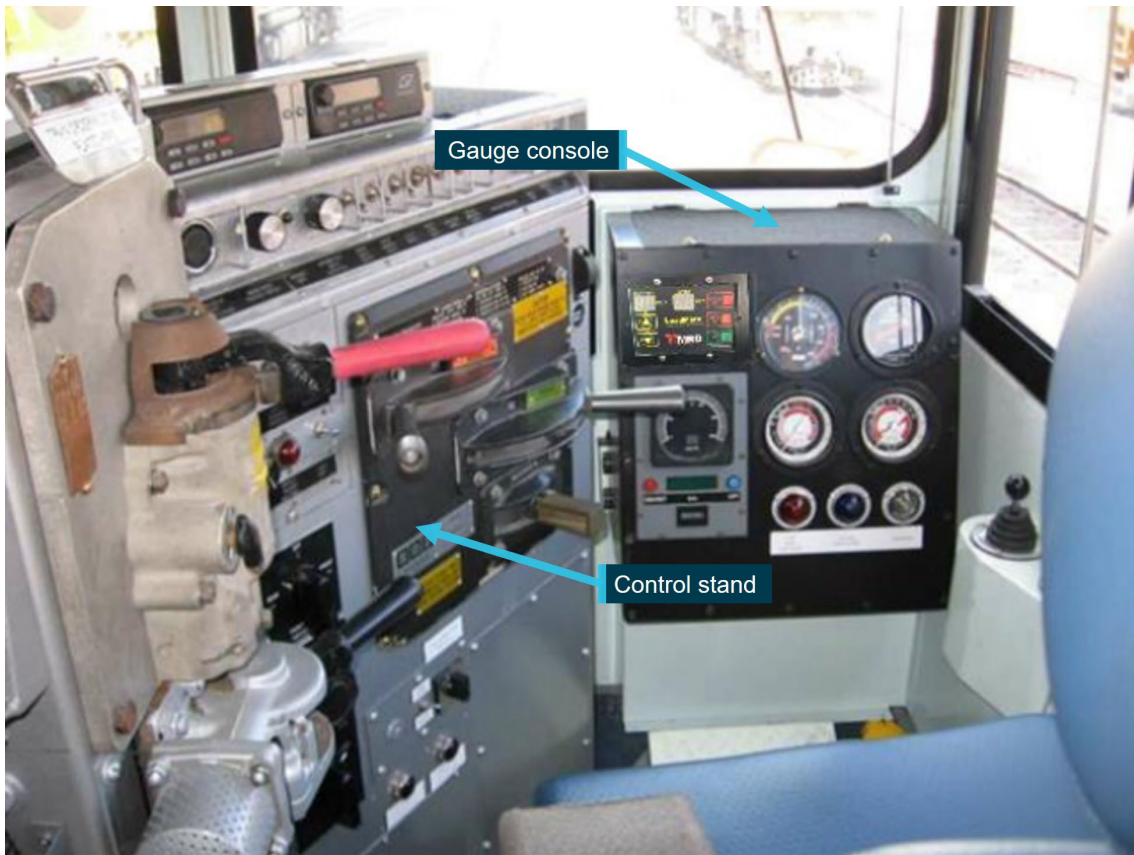
Figure 4: Driving position control stand and console arrangement

The locomotive was a GT22C-3 diesel electric locomotive (originally built by Clyde Engineering). The locomotive was equipped with a single driver's cab at the short hood end. The driver's console featured a control stand beside the driver and a gauge console in front of the driver (Figure 4).

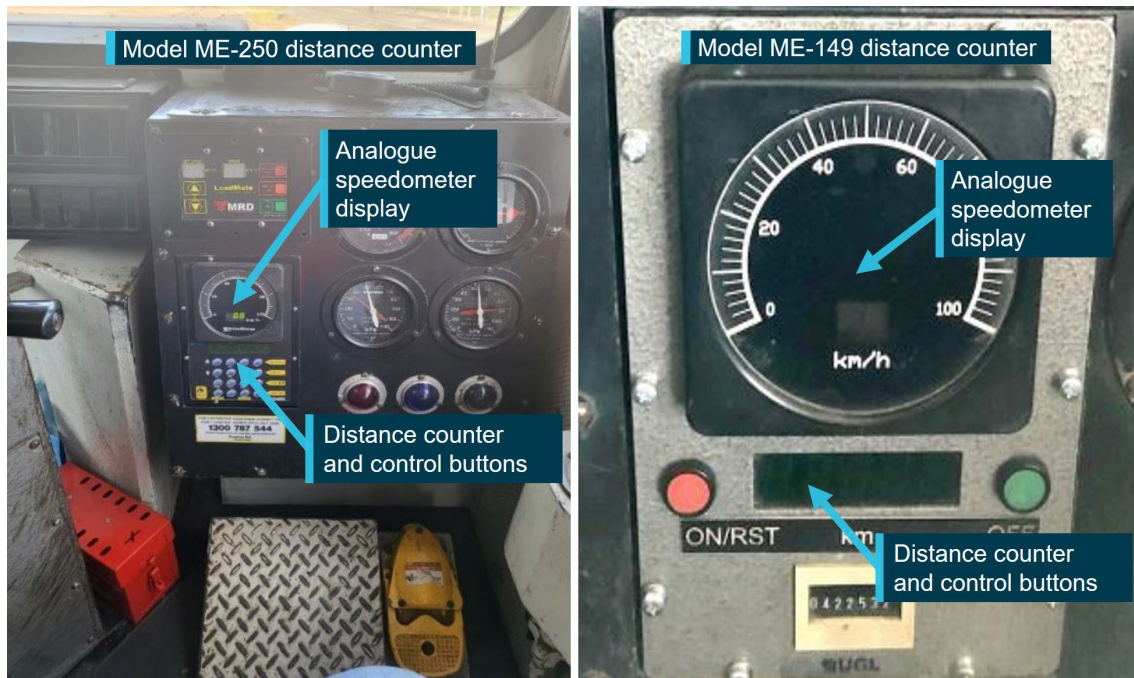
Figure 5: Models of speedometer and distance counter fitted to PRL class locomotives

A variety of counter models, each with different methods of operation may be fitted to the PRL locomotive. The method of operation may be as simple as dedicated on/off buttons on the ME-149 model (Figure 5, right) or more complex requiring a level of programming via additional inputs from the driver to pre-select the correct function, as with the ME-250 model (fitted to locomotive PRL201) (Figure 5, left).

The PRL class locomotive operational features and procedures were documented in an operator’s manual.²⁹ The manual included a brief description of the controls and indications used by the operating crew. Information was provided for the ME-149 type speedometer and distance counter device. However, other than a mention of the ME-250 as an option, no information was provided on its operation.

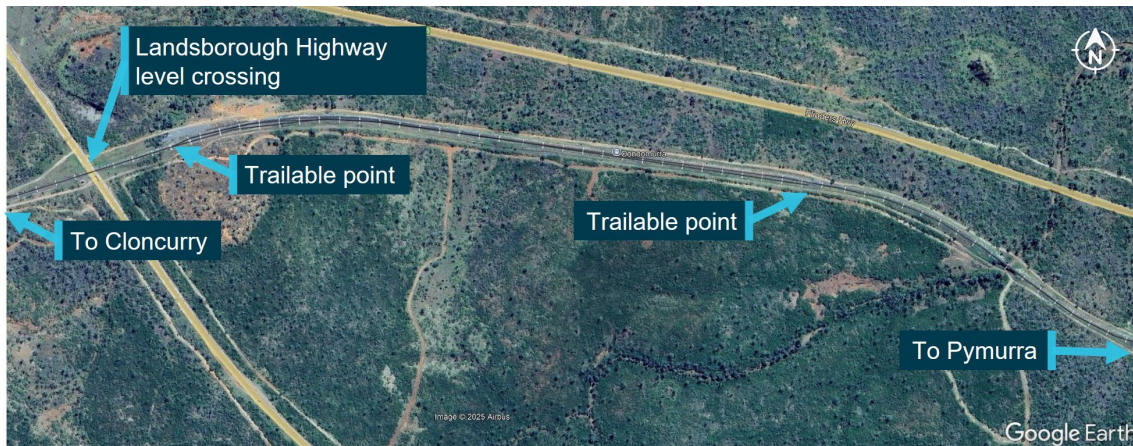
Figure 6: Oonoomurra station track alignment

Oonoomurra was a directional travel station³³ extending for 1,033 m and equipped at each end with a trailable point. The points were set to divert an approaching train to the right-side track alignment in the direction of travel (Figure 6).

The track alignment was primarily tangent and the terrain relatively flat with low open woodland vegetation trackside. Approximately 280 m prior to the western end point the track transitioned from tangent through an 805 m radius curve, before returning to tangent track at the Landsborough Highway.

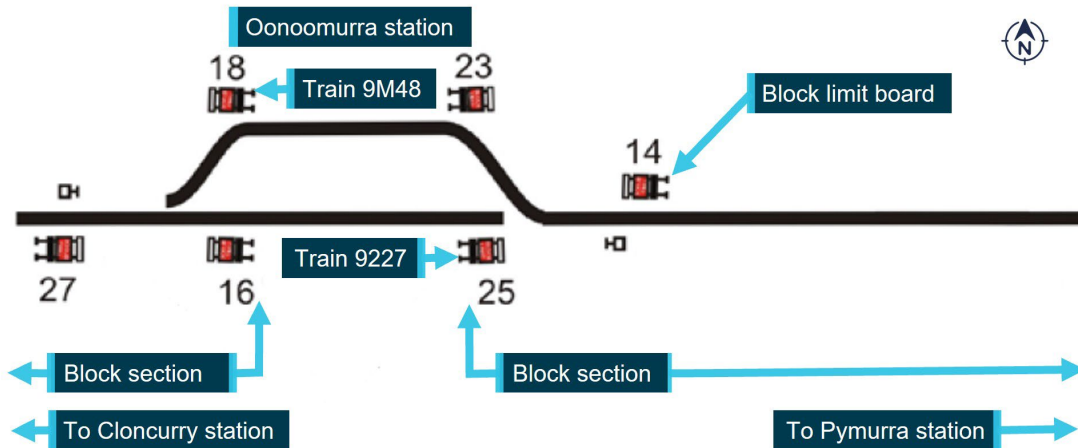
Figure 7: Oonoomurra block limit boards

The DTC territory was divided into distinct block sections. Directional travel stations, such as Oonoomurra, were equipped with trackside location boards (BLBs) that marked the limit of the respective block and station track sections (Figure 7).
